Section/division Accident and Incident Investigations Division

LIMITED OCCURRENCE INVESTIGATION REPORT - FINAL

Reference Number	CA18/2/3/10502													
Classification	A	Accident			Dat	e 2	29 September 2024			Time	1500Z			
Type of Operation Private (Part 94)														
Location														
Place of Departure	ace oi Reestekraal n			Private Airstrip in ear Brits, North				Place of Intended Landing			Bush n Buck Private Airstrip in Beestekraal near Brits, North West Province			
Place of Occurrence	Bush n Buck Private Airstrip in Beestekraal near Brits													
GPS Co-ordinates		Latitud	le	25° 22' 29.00		00" S	Lo	Longitude		027° 34' 49.00" E		Elevat	Elevation 3 800	
Aircraft Information														
Registration	stration ZU-DFP													
Make; Model; S/N Jabiru; J400 (S/N: 109)														
Damage to Aircraft S			Substantial					Tot	Total Aircraft Hours			3977.7		
Pilot-in-command														
Licence Type	e Private Pilot Li			cence (PPL)			Gender		Ма	Male		Age	70	
Licence Valid	Yes			Total Hours		6	600		Total Ho		urs on Type		20.3

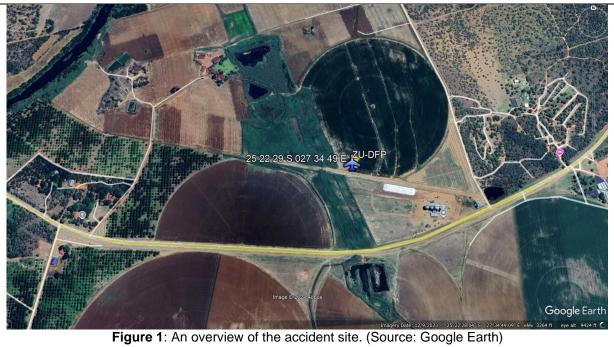
Figure 2: The aircraft as it came to rest. (Source: Pilot)

It is likely that the aircraft's height on approached was too high, and the pilot reduced the engine power and flared the aircraft. This caused the aircraft to drop on the runway and touch down hard, which damaged the aircraft.
