**LIMITED OCCURRENCE INVESTIGATION REPORT – FINAL**

<b>Reference Number</b>	CA18/2/3/10503						
<b>Classification</b>	Accident		<b>Date</b>	1 October 2024		<b>Time</b>	0755Z
<b>Type of Operation</b>	Training Part 141						
<b>Location</b>							
<b>Place of Departure</b>	Mafikeng Aerodrome (FAMM), North West Province			<b>Place of Intended Landing</b>	Mafikeng Aerodrome (FAMM), North West Province		
<b>Place of Occurrence</b>	Runway 22 at Mafikeng Aerodrome (FAMM)						
<b>GPS Co-ordinates</b>	<b>Latitude</b>	25° 47' 35.2" S	<b>Longitude</b>	025° 33' 02.1" E	<b>Elevation</b>	4200 ft	
<b>Aircraft Information</b>							
<b>Registration</b>	ZS-LCC						
<b>Make; Model; S/N</b>	Piper Aircraft Corporation; Piper PA-28-181 (Serial Number: 28-8190301)						
<b>Damage to Aircraft</b>	Substantial			<b>Total Aircraft Hours</b>	5036.1		
<b>Pilot-in-command</b>							
<b>Licence Type</b>	Student Pilot Licence (SPL)		<b>Gender</b>	Female		<b>Age</b>	19
<b>Licence Valid</b>	Yes	<b>Total Hours</b>	46.9	<b>Total Hours on Type</b>	46.9

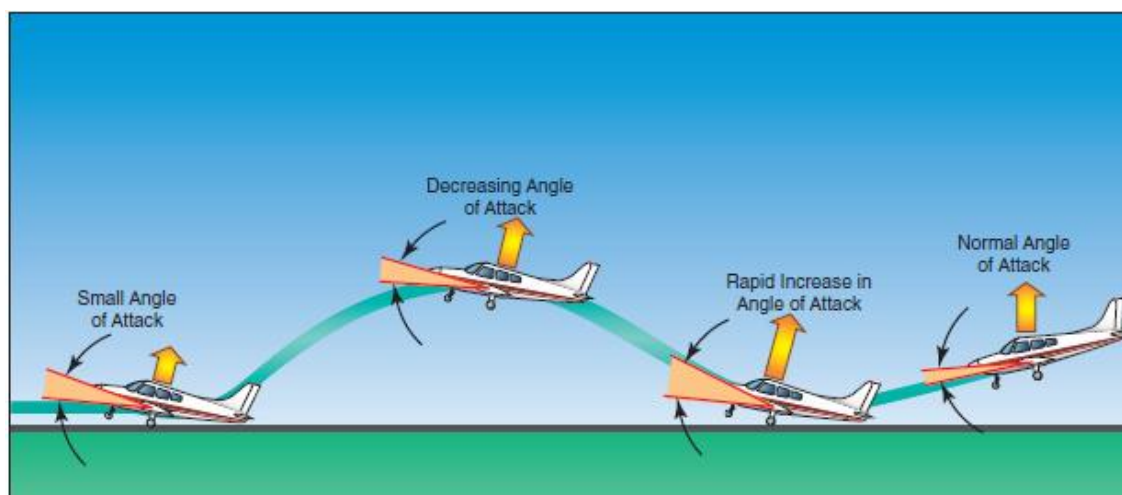
**Figure 3:** Illustration of a bounce landing.

When the airplane contacts the ground with a sharp impact as the result of an improper attitude or an excessive rate of sink, it tends to bounce back into the air. Though the airplane's tires and shock struts provide some springing action, the airplane does not bounce like a rubber ball. Instead, it rebounds into the air because the wing's angle of attack was abruptly increased, producing a sudden addition of lift. [Figure 3]. The abrupt change in the angle of attack is the result of inertia instantly forcing the airplane's tail downward when the main wheels contact the ground sharply. The severity of the bounce depends on the airspeed at the moment of contact and the degree to which the angle of attack or pitch attitude was increased. Since a bounce occurs when the airplane makes contact with the ground before the proper touchdown attitude is attained, it is almost invariably accompanied by the application of excessive back-elevator pressure. This is usually the result of the pilot realizing too late that the airplane is not in the proper attitude and attempting to establish it just as the second touchdown occurs.

Extreme caution and alertness must be exercised any time a bounce occurs, but particularly when there is a crosswind. Inexperienced pilots will almost invariably release the crosswind correction. When one main wheel of the airplane strikes the runway, the other wheel will touch down immediately afterwards, and the wings will become level. Then, with no crosswind correction as the airplane bounces, the wind will cause the airplane to roll with the wind, thus exposing even more surface to the crosswind and drifting the airplane more rapidly.

The corrective action for a bounce is the same as for ballooning and similarly depends on its severity. When it is very slight and there is no extreme change in the airplane's pitch attitude, a follow-up landing may be executed by applying sufficient power to cushion the subsequent touchdown and smoothly adjusting the pitch to the proper touchdown attitude. In the event a very slight bounce is encountered while landing with a crosswind, crosswind correction must be maintained while the next touchdown is made. Remember that since the subsequent touchdown will be made at a slower airspeed, the upwind wing will have to be lowered even further to compensate for drift.
