LIMITED OCCURRENCE INVESTIGATION REPORT – FINAL

Reference Number	CA18/2/3/10505						
Classification	Accident	Date	28 September 2024		Time	1050Z	
Type of Operation	Private (Part 91)						
Location							
Place of Departure	Bundu Inn Airfield, North West Province		Place of Intended Landing	Middleburg Airfield (FAMB), Mpumalanga Province			
Place of Occurrence	Left of Runway 32 at Middleburg Airfield (FAMB), Mpumalanga Province						
GPS Co-ordinates	Latitude	25° 41.14' S	Longitude	029° 26.43' E	Elevation	4 886 ft	
Aircraft Information							
Registration	ZS-JUA						
Make; Model; S/N	Piper Aircraft; Cherokee PA-28-181 (S/N: 28-7690106)						
Damage to Aircraft	Substantial		Total Aircraft Hours	7 337.87			
Pilot-in-command							
Licence Type	Private Pilot Licence (PPL)		Gender	Male		Age	23
Licence Valid	Yes	Total Hours	95.8		Total Hours on Type	23.2	
Total Hours 30 Days	5.3		Total Flying on Type Past 90 Days	8.8			
People On-board	1 + 1	Injuries	0	Fatalities	0	Other (on ground)	0

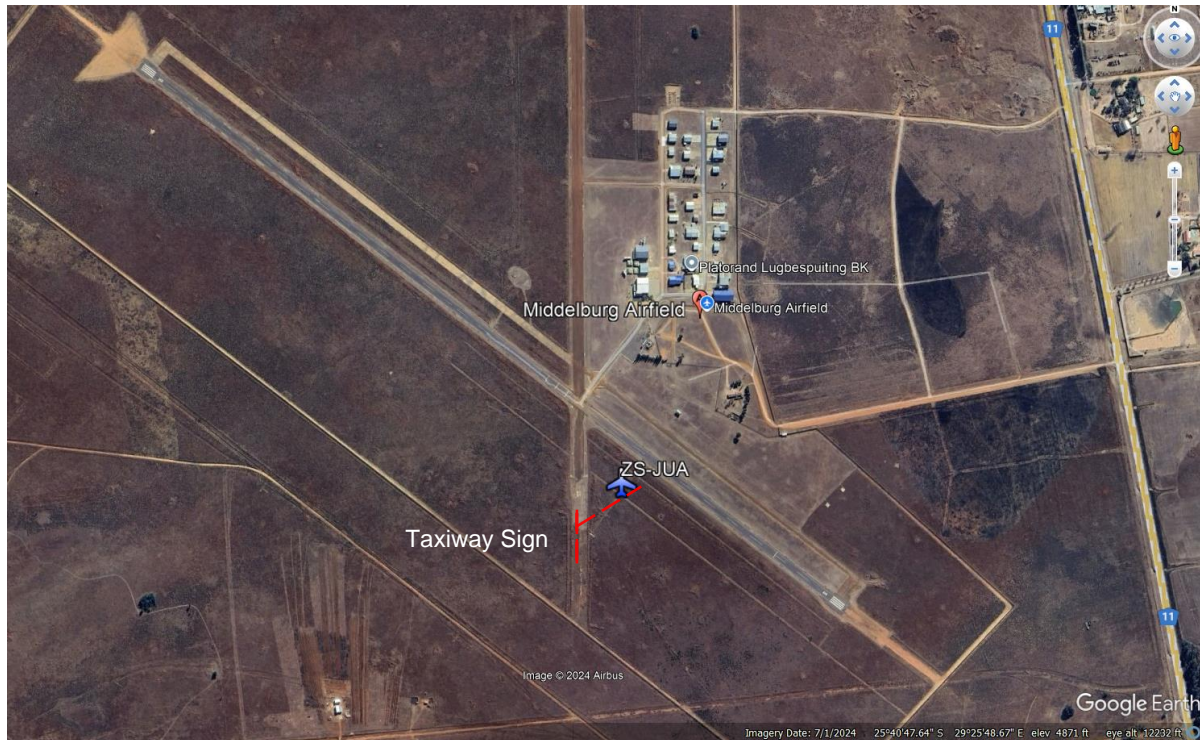
pilot lost directional control, and the nose gear impacted the taxiway sign. As a result, the nose gear strut broke off and the propeller struck the ground. The aircraft came to a stop on the gravel area approximately 7 metres (m) to the left of the runway. The pilot and the passenger were not injured; however, the aircraft sustained substantial damage to the nose gear, propeller and lower engine cowling.

Figure 1: An overview of FAMB and the accident site. (Source: Google Earth)
