LIMITED OCCURRENCE INVESTIGATION REPORT – FINAL

Reference Number	CA18/2/3/10514						
Classification	Accident	Date	10 October 2024	Time	1517Z		
Type of Operation	Private (Part 91)						
Location							
Place of Departure	Bethlehem Aerodrome (FABM), Free State Province			Place of Intended Landing	New Tempe Aerodrome (FATP), Free State Province		
Place of Occurrence	Left of the N5 Road between Senekal and Winburg, Free State Province						
GPS Co-ordinates	Latitude	28°24'19.40" S	Longitude	027°25'59.80" E	Elevation	4 795 feet	
Aircraft Information							
Registration	ZS-MCY						
Make; Model; S/N	Beech Aircraft Corporation; 58 (Serial Number: TH764)						
Damage to Aircraft	Substantial			Total Aircraft Hours	6 234.9		
Pilot-in-command							
Licence Type	Private Pilot Licence (PPL)		Gender	Male		Age	56
Licence Valid	Yes	Total Hours	604.3		Total Hours on Type	93.5	
Total Hours Past 30 Days	6.8		Total Hours on Type Past 90 Days			16.6	
People On-board	1 + 0	Injuries	0	Fatalities	0	Other (on ground)	0

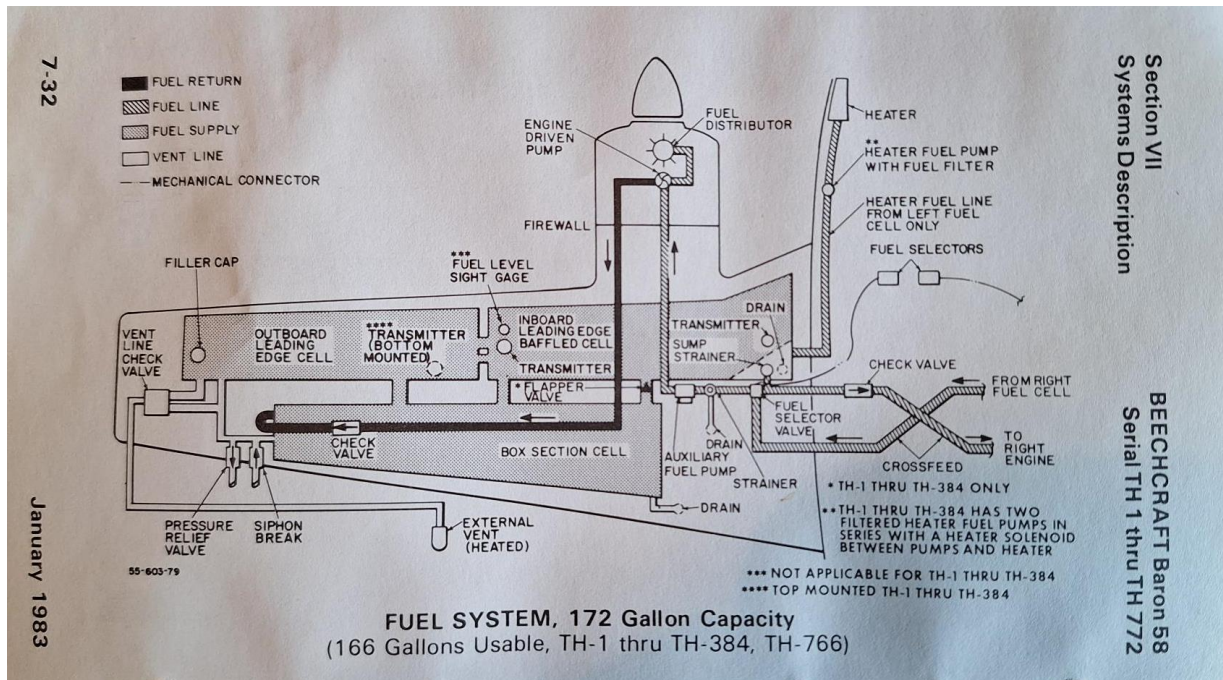
Diagram 1: The fuel system of the aircraft. (Source: POH)

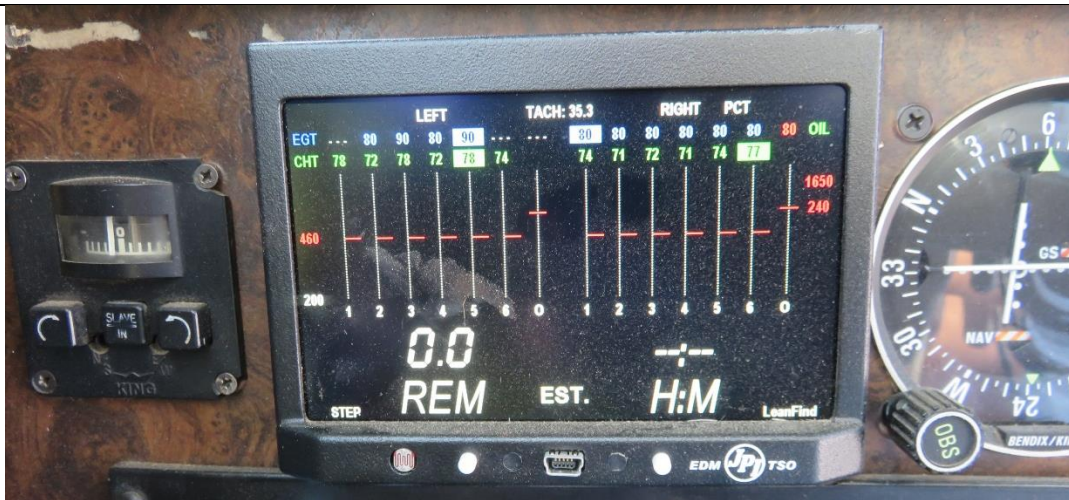
The aircraft was fitted with a JPI EDM 790 engine data management system. The unit also had a fuel flow monitoring capability. The unit records several engine parameters, including Exhaust Gas Temperature (EGT), Cylinder Head Temperature (CHT), Oil Temperature (OILT), and Fuel Flow (FF) in gallons per hour (GPH) for reciprocal engines.

Based on data that was downloaded from the unit (Graphs 1 and 2), the two engines shut down at the same time.

Figure 9: The JPI EDM 790 unit that was installed in the aircraft.
