**LIMITED OCCURRENCE INVESTIGATION REPORT – FINAL**

| <b>Reference Number</b> | | CA18/2/3/10515 | | | | | |
| <b>Registration</b> | ZU-KFJ | | | | | | |
| <b>Make; Model; S/N</b> | Airplane Factory; Sling 4 High Wing (Serial Number: 016G) | | | | | | |

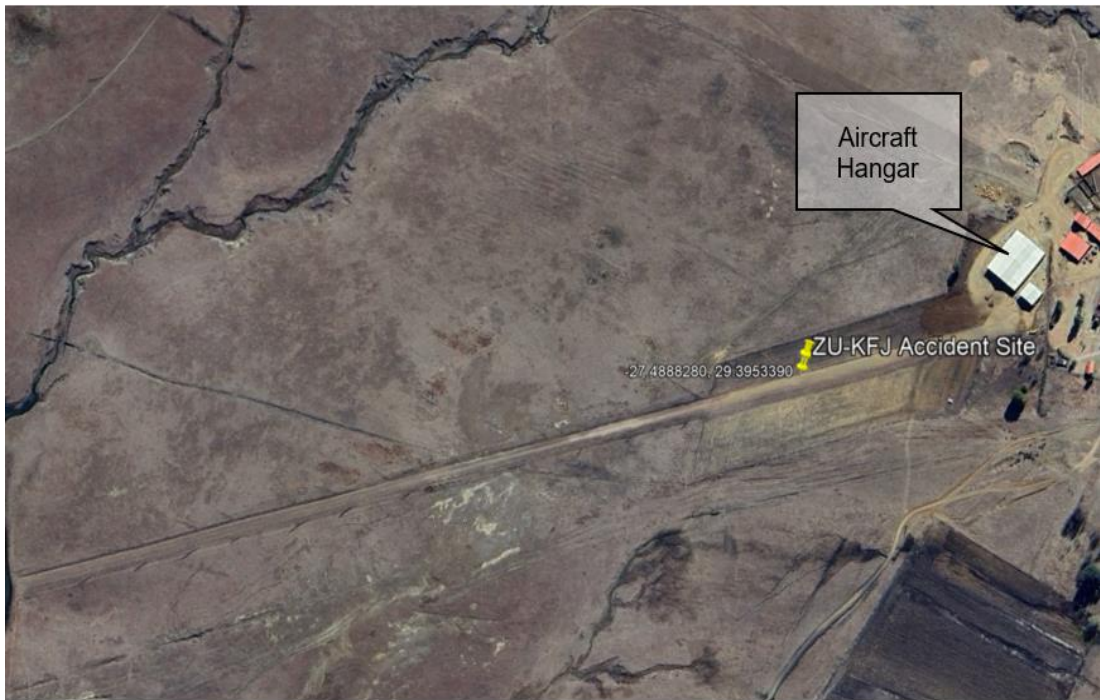
**Figure 1:** The view of the accident site. (Source: Google Maps)

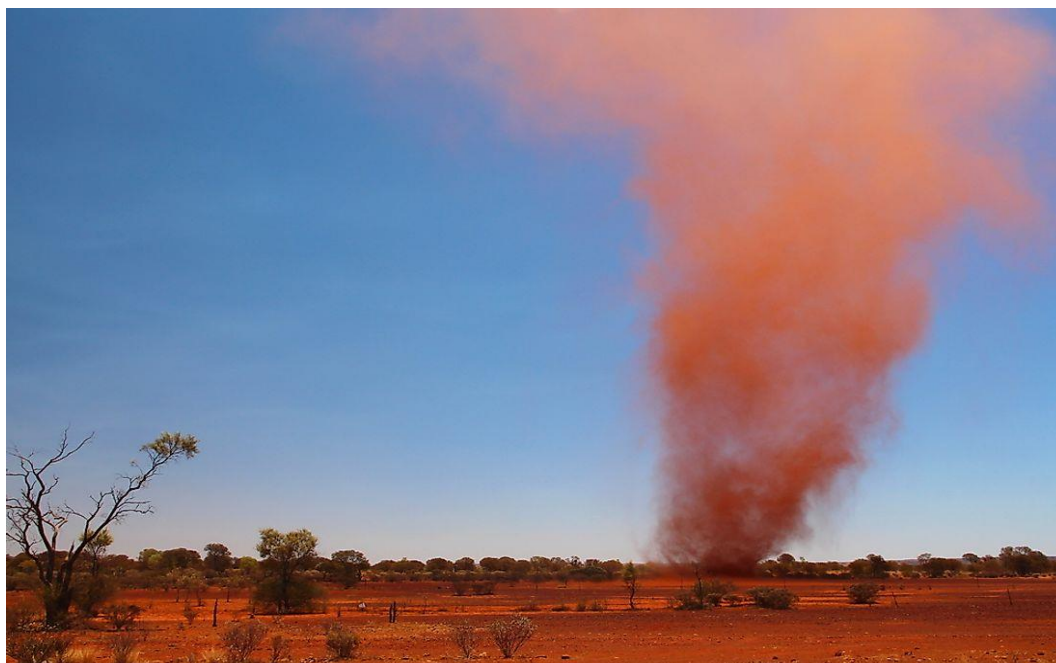
**Figure 6:** An example of a whirlwind. (Source: <https://www.worldatlas.com/articles/how-many-types-of-whirlwinds-are-there.html>)

2.4. Whirlwinds are inherently unpredictable and could occur in open areas. Their rapid rotation and vertical air movement, including updrafts and downdrafts, are challenging for small aircraft. The pilot's lack of awareness of such a phenomenon at the time of landing contributed to the accident. The pilot lost control of the aircraft upon landing due to the encountered whirlwind which caused the aircraft to land hard and, subsequently, veer off to the left of the runway before it nosed over.
