AIRCRAFT ACCIDENT REPORT AND EXECUTIVE SUMMARY

Reference:		CA18/2/3/10518	
Aircraft Registration	ZU-RGR	Date of Accident	15 October 2024		Time of Accident	0730Z
Type of Aircraft	Magni Gyro M-24		Type of Operation		Private (Part 94)	
Pilot-in-command Licence Type	National Pilot Licence		Age	52	Licence Valid	Yes
Pilot-in-command Flying Experience	Total Flying Hours		938.0		Hours on Type	Unknown
Last Point of Departure	Nelspruit Airport (FANS), Mpumalanga Province					
Next Point of Intended Landing	Musina Aerodrome (FAMH), Limpopo Province					
Damage to Aircraft	Destroyed					
Location of the accident site with reference to easily defined geographical points (GPS readings if possible)						
Hanglip Mountain in Louis Trichardt at Global Positioning System (GPS) co-ordinates determined to be 22°59' 38.6" South 29°54' 19.9" East, at an elevation of 4 770 feet (ft)						
Meteorological Information	Surface wind: 060°/6kt; temperature: 11°C; dew point: 0°C; Cloud base: overcast

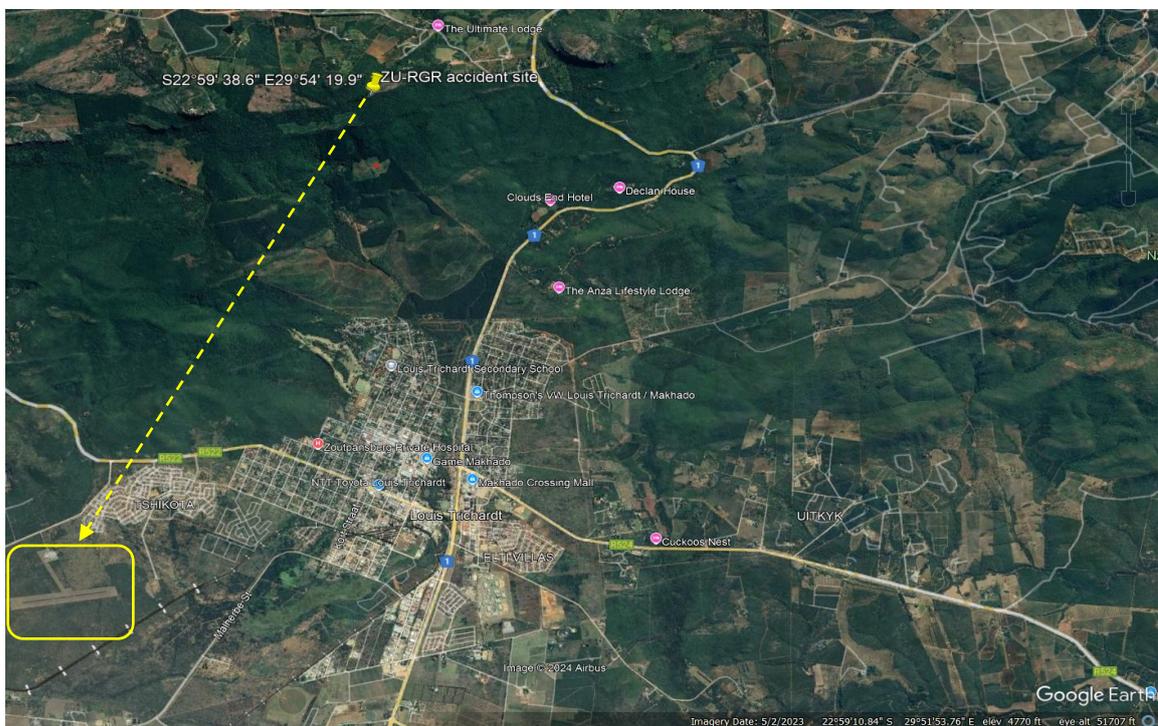
1.1.5 The accident occurred during daytime at Global Positioning System (GPS) co-ordinates determined to be 22°59' 38.6" South 29°54' 19.9" East, at an elevation of 4 770 feet (ft).

Figure 1: The accident site and Louis Trichardt Civil Airfield (FALO). (Source: Google Earth)

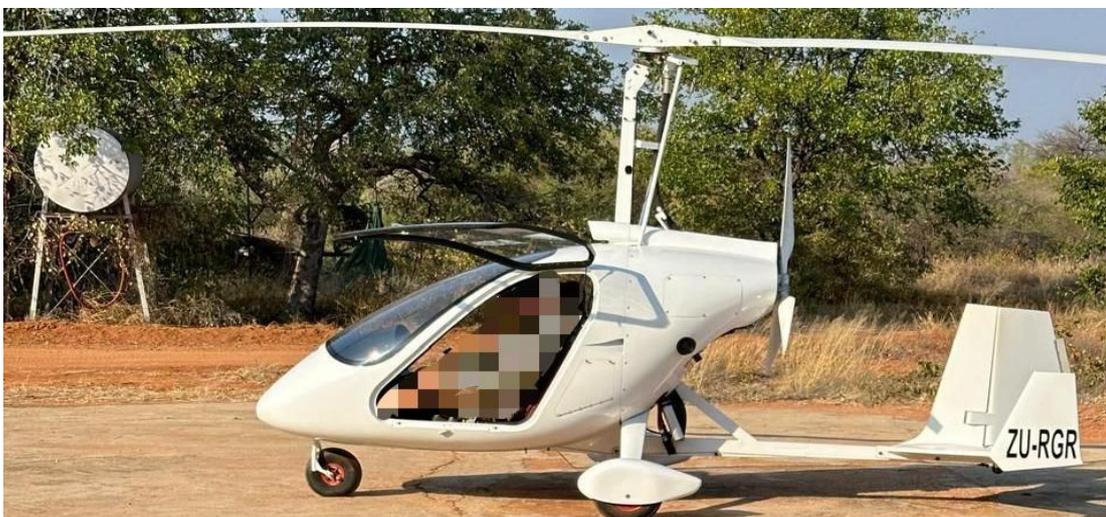
Figure 3: The file picture of the ZU-RGR aircraft. (Source: The rescue team)
