AIRCRAFT ACCIDENT REPORT AND EXECUTIVE SUMMARY

Reference:		CA18/2/3/10522	
Aircraft Registration	ZU-IBE	Date of Accident	1 November 2024		Time of Accident	1747Z	
Type of Aircraft	Jabiru J170			Type of Operation	Training (Part 141)		
Pilot-in-command Licence Type	Commercial Pilot Licence		Age	49	Licence Valid	Yes	
Pilot-in-Command Flying Experience	Total Flying Hours		437.9		Hours on Type	119.4	
Last Point of Departure	Rhino Park Aerodrome, Gauteng Province						
Next Point of Intended Landing	Wonderboom Aerodrome (FAWB), Gauteng Province						
Damage to Aircraft	Destroyed						
Location of the accident site with reference to easily defined geographical points (GPS readings if possible)							
Carlsruhe Private Game Reserve (GPS position: 25°40'50.70" South 028°29'21.05" East), elevation: 4 734 feet							
Meteorological Information	Surface wind: 030°/5kts, temperature: 26°C, dew point: 6°C						
Number of People on Board	2 + 0	Number of People Injured	0	Number of People Killed	2	Other (On Ground)	0

SACAA (AIID)	FAILURE INVESTIGATION REPORT: CYLINDER, JABIRU J170 ENGINE, AIRCRAFT No ZU-IBE	FA-0012-04-25	
		DATE 2025-04-25	ISSUE 1

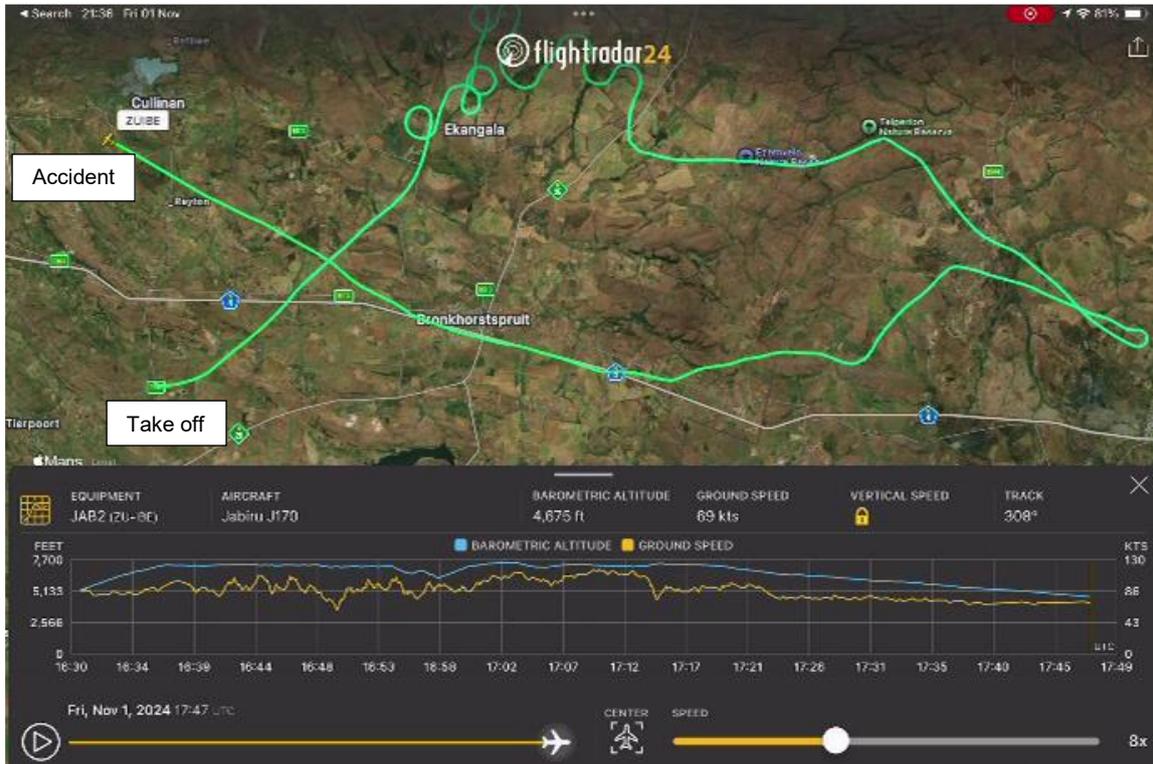
Figure 1: The green line shows the route flown by the ZU-IBE aircraft. (Source: Flightradar24.com)

When evaluating the flight profile in Figures 1 and 18, it is clear that no circuit work was conducted at an aerodrome that was suitable for night operations. The crew conducted upper air work on the aircraft, which was associated with several turns. Thereafter, they flew to FAWI to intercept the VOR, which was their turning point. They then headed west with the intention to return to FAWB for a full-stop landing. The training exercise on the day did not meet the training guidance as outlined in the South African Flight Instructor's Manual for Training Procedures. This was probably a sequence that the flight instructor regarded as appropriate for the pilot's first flight towards obtaining his night rating.

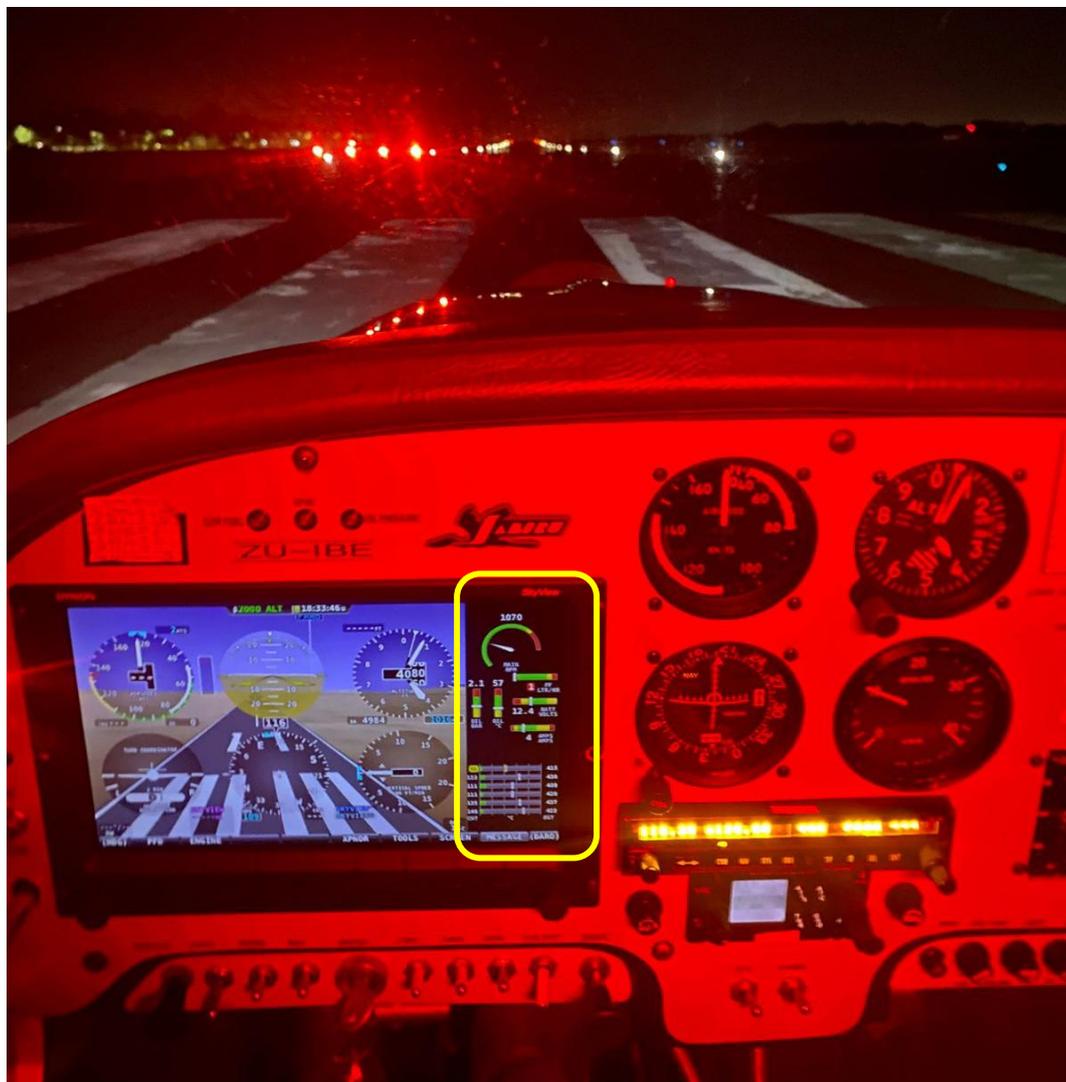
Figure 16: A view of the instrument panel of ZU-IBE taken at night. The content displayed in the yellow window indicates the engine parameters. (Source: ATO)

It could not be determined which PFD flight display the crew had opted for. If it were the same screen as displayed in Figure 16, the crew would have been able to monitor the engine oil pressure and temperature during flight, as well as several other engine parameters. Following the cracked cylinder, oil seepage would have occurred, which would have resulted in a decay in oil pressure and an increase in oil temperature because the oil quantity in the engine would have reduced as the flight progressed. It is evident from Figure 15 that the No.6 cylinder displayed discolouration which was caused by the oil seepage coming in contact with the hot cylinder barrel and crankcase. The WhatsApp messages sent by the pilot did not mention any oil pressure or temperature deviations, or a decrease in engine power, which must have occurred during the flight.

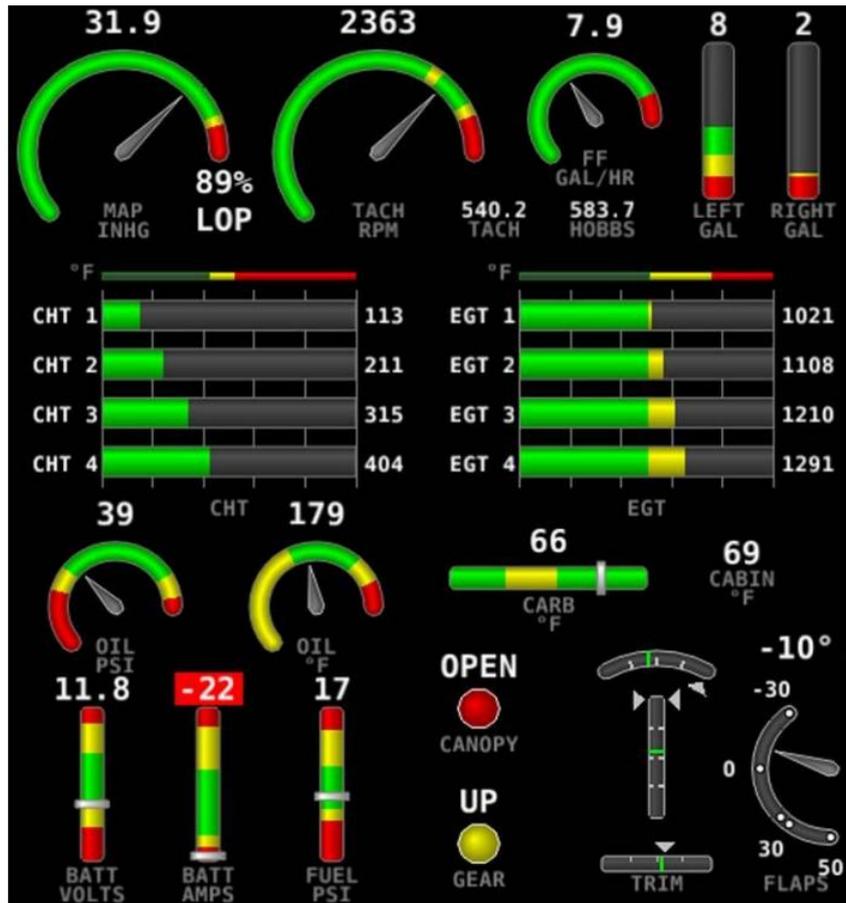
Figure 17: An example of a 50% engine page for single engine.

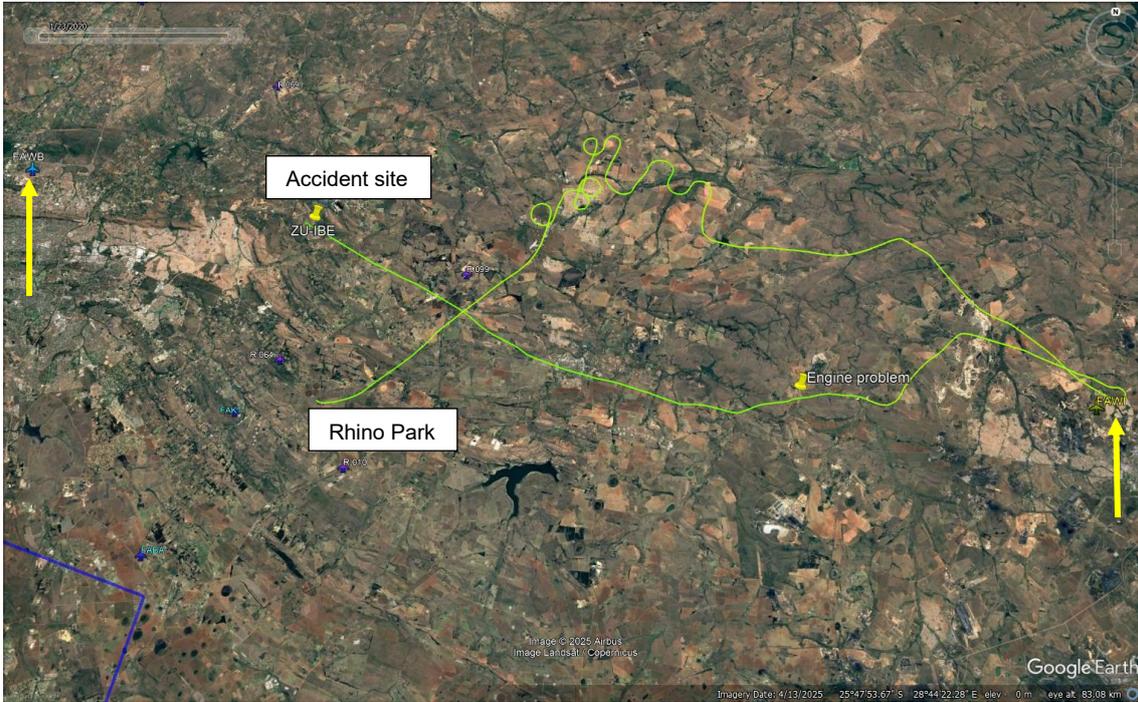
The pilot sent a WhatsApp message to a flight instructor on the ground at 1728Z, stating “Abnormality on engine”. At that stage of the flight, the aircraft was 14nm west of Witbank Aerodrome (FAWI), 22nm from Rhino Park Aerodrome (departure aerodrome), and 41nm from FAWB. The crew opted to continue with the flight to FAWB and, later, impacted high-tension wires after they had flown a further 27nm, which was shortly after engine failure. Figure 18 shows the position of the aircraft at 1728Z and the vicinity of the different aerodromes mentioned above.

Figure 18: The flight profile indicates the locations for FAWB, FAWI, Rhino Park and the position of the aircraft when the engine abnormality was reported.

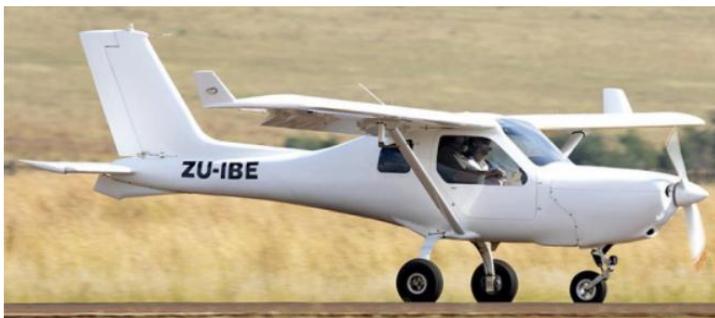
The No. 6 Cylinder (Photo 2) originating from Jabiru J170 3300A engine assembly (serial No. 33A2114), aircraft registration No. ZU-IBE (Photo 1), serial No. 6061, was submitted to determine the most probable contributing factors towards failure during operation.

Photo 1: Accident aircraft, ZU-IBE¹

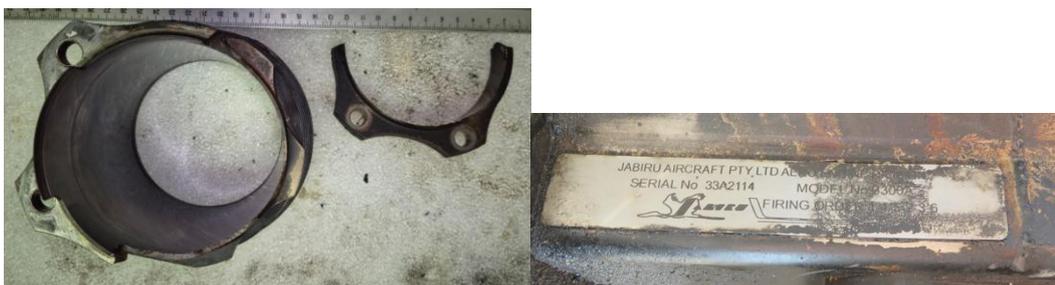
Photo 2: Fractured cylinder, as supplied (digital)

The visual inspection revealed a circumferential fracture at the cylinder base flange (Photo 2). The fracture initiated from 2 locations, A and E (Photo 5), within the lipped section (Photo 4, red arrow) (inside the crankcase) and progressed within the flange until the final fast fracture.

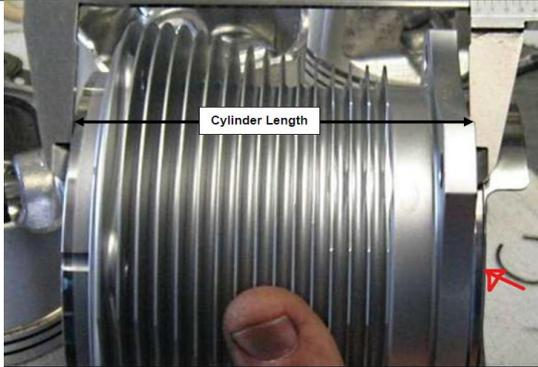
Photo 4: Cylinder layout⁴

- (a) The visual inspection revealed a circumferential fracture at the cylinder base flange. The fracture initiated from 2 locations within the lipped section (Photo 4, red arrow) (inside the crankcase) and progressed inward (towards the top of the bore), and then parallel with the flange during the final fast fracture.
- (b) No other possible contributing factors were noted from the single cylinder supplied to this investigation.

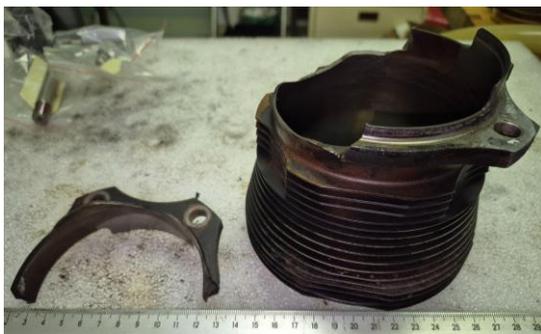
Photo 6: Cylinder condition, outer surfaces (digital)

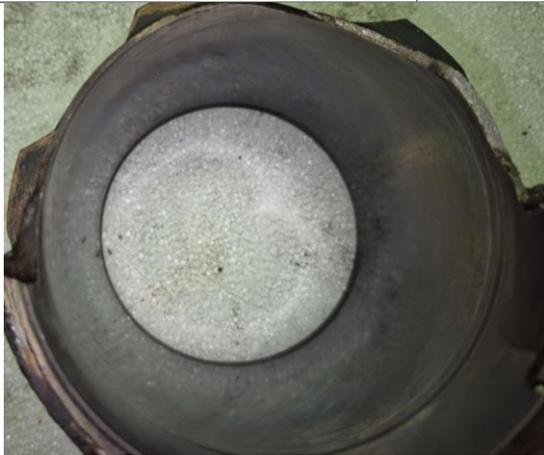
No clear indications of excessive wear, corrosion, or other discrepancies relating to the cylinder bore area (Photo 7) were noted.

Photo 7: Cylinder condition, inner bore area (digital)
