LIMITED OCCURRENCE INVESTIGATION REPORT

Reference Number	CA18/2/3/10528				
Classification	Accident	Date	24 November 2024	Time	0825Z
Type of Operation	Private (Part 91)				
Location					
Place of Departure	Bram Fischer International Airport (FABL), Free State Province		Place of Intended Landing	Wonderboom Aerodrome, (FAWB) Gauteng Province	
Place of Occurrence	About 200m from the threshold of Runway 06 at Wonderboom Aerodrome (FAWB)				
GPS Co-ordinates	Latitude	25°39'57" S	Longitude	28°12'44.76" E	Elevation 4 060 ft
Aircraft Information					
Registration	N441AG				
Make; Model; S/N	Textron Aviation, Cessna 172P (Serial Number: 17276091)				
Damage to Aircraft	Substantial		Total Aircraft Hours	14 350	
Pilot-in-command					
Licence Type	Private Pilot Licence (PPL)		Gender	Male	Age 24
Licence Valid	Yes	Total Hours	160.5	Total Hours on Type	25.2
Total Hours Past 30 Days	25.2		Total Flying Hours on Type Past 90 Days	25.2	
People On-board	1 + 2	Injuries	0	Fatalities	0

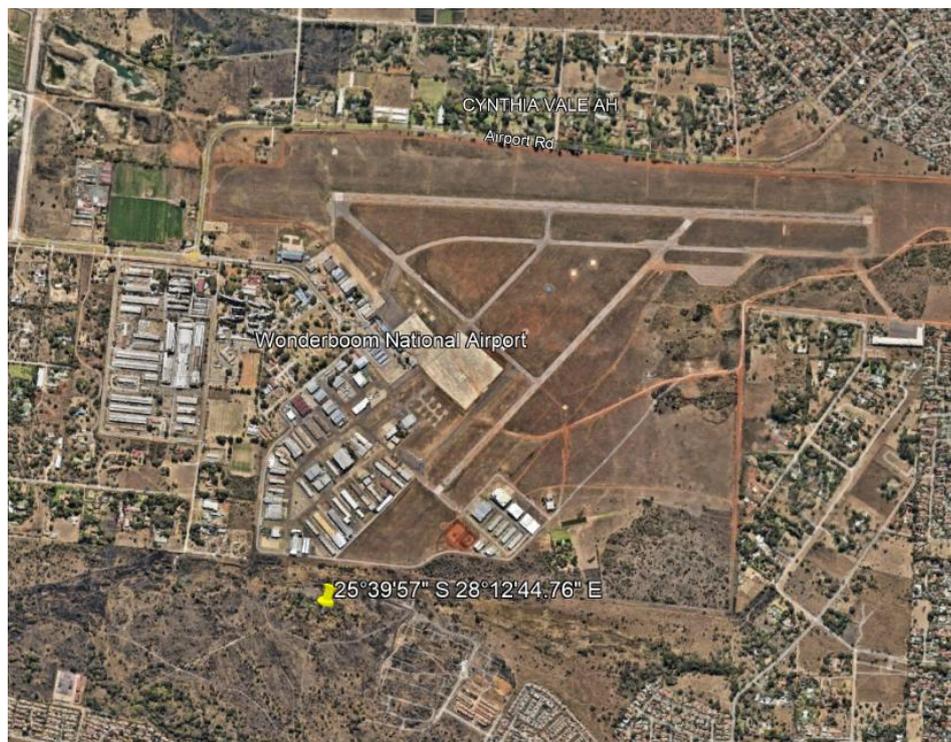
Figure 1: The yellow pin indicates the spot at which the aircraft came to rest. (Source: Google Earth)

The aircraft crashed 200m before the threshold of Runway 06 at FAWB due to fuel exhaustion.
