**AIRCRAFT ACCIDENT REPORT AND EXECUTIVE SUMMARY**

<b>Reference:</b>		CA18/2/3/10533	
<b>Aircraft Registration</b>	ZU-DWY	<b>Date of Accident</b>	1 December 2024		<b>Time of Accident</b>	1330Z	
<b>Type of Aircraft</b>	Cubby		<b>Type of Operation</b>		Private (Part 94)		
<b>Pilot-in-command Licence Type</b>	National Pilot Licence (NPL)		<b>Age</b>	50	<b>Licence Valid</b>	Yes	
<b>Pilot-in-command Flying Experience</b>	<b>Total Flying Hours</b>		797.7		<b>Hours on Type</b>	Unknown	
<b>Last Point of Departure</b>	Highway Airfield, Western Cape Province						
<b>Next Point of Intended Landing</b>	Highway Airfield, Western Cape Province						
<b>Damage to Aircraft</b>	Substantial						
<b>Location of the accident site with reference to easily defined geographical points (GPS readings if possible)</b>							
Forest View Farm at Global Positioning System (GPS) position: 33° 56' 57.6" South 022° 58' 10.3" East, at an elevation of 790 feet (ft)							
<b>Meteorological Information</b>	Surface wind: 170° / 07 kt; Temperature: 20°C; Dew point: 15°C; Visibility: CAVOK

**Reference Number** : CA18/2/3/10533  
**Occurrence Category** : Accident (Category 1)  
**Type of Operation** : Private (Par

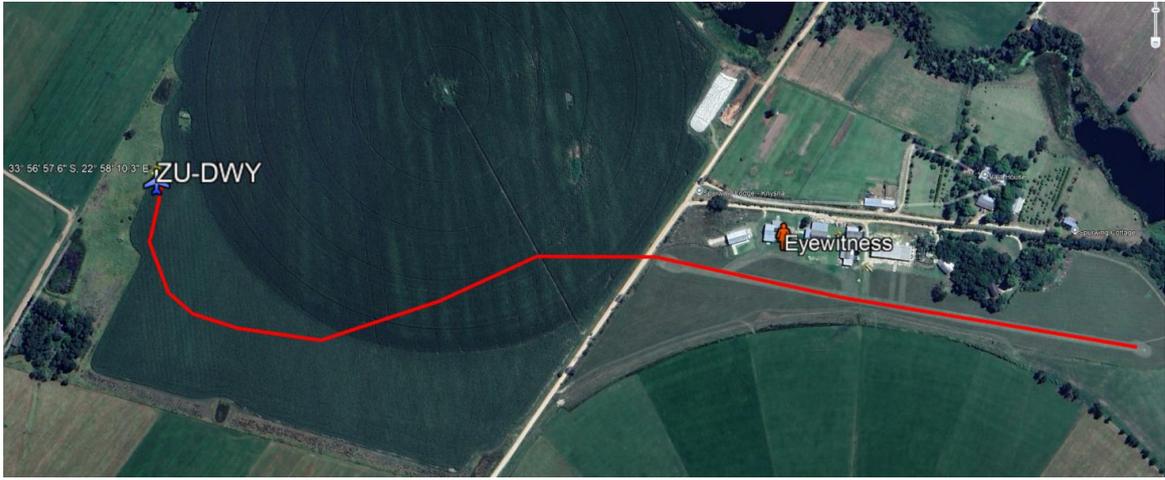
- 1.1.4. The accident occurred on a cultivated field in a private farm situated 0.35 nautical miles (nm) from Highway Airfield, at Global Positioning System (GPS) co-ordinates determined to be 33° 56' 57.6" South 22° 58' 10.3" East, at an elevation of 790 feet (ft).

**Figure 1:** The accident site and the flight path after take-off. (Google Earth)
