AIRCRAFT ACCIDENT REPORT AND EXECUTIVE SUMMARY

| | | Reference: | | CA18/2/3/10534 | | | |
| Aircraft Registration | ZS-NDO | Date of Accident | 7 December 2024 | Time of Accident | 0632Z | | |
| Type of Aircraft | Cessna 177RG | | Type of Operation | Private (Part 91) | | | |

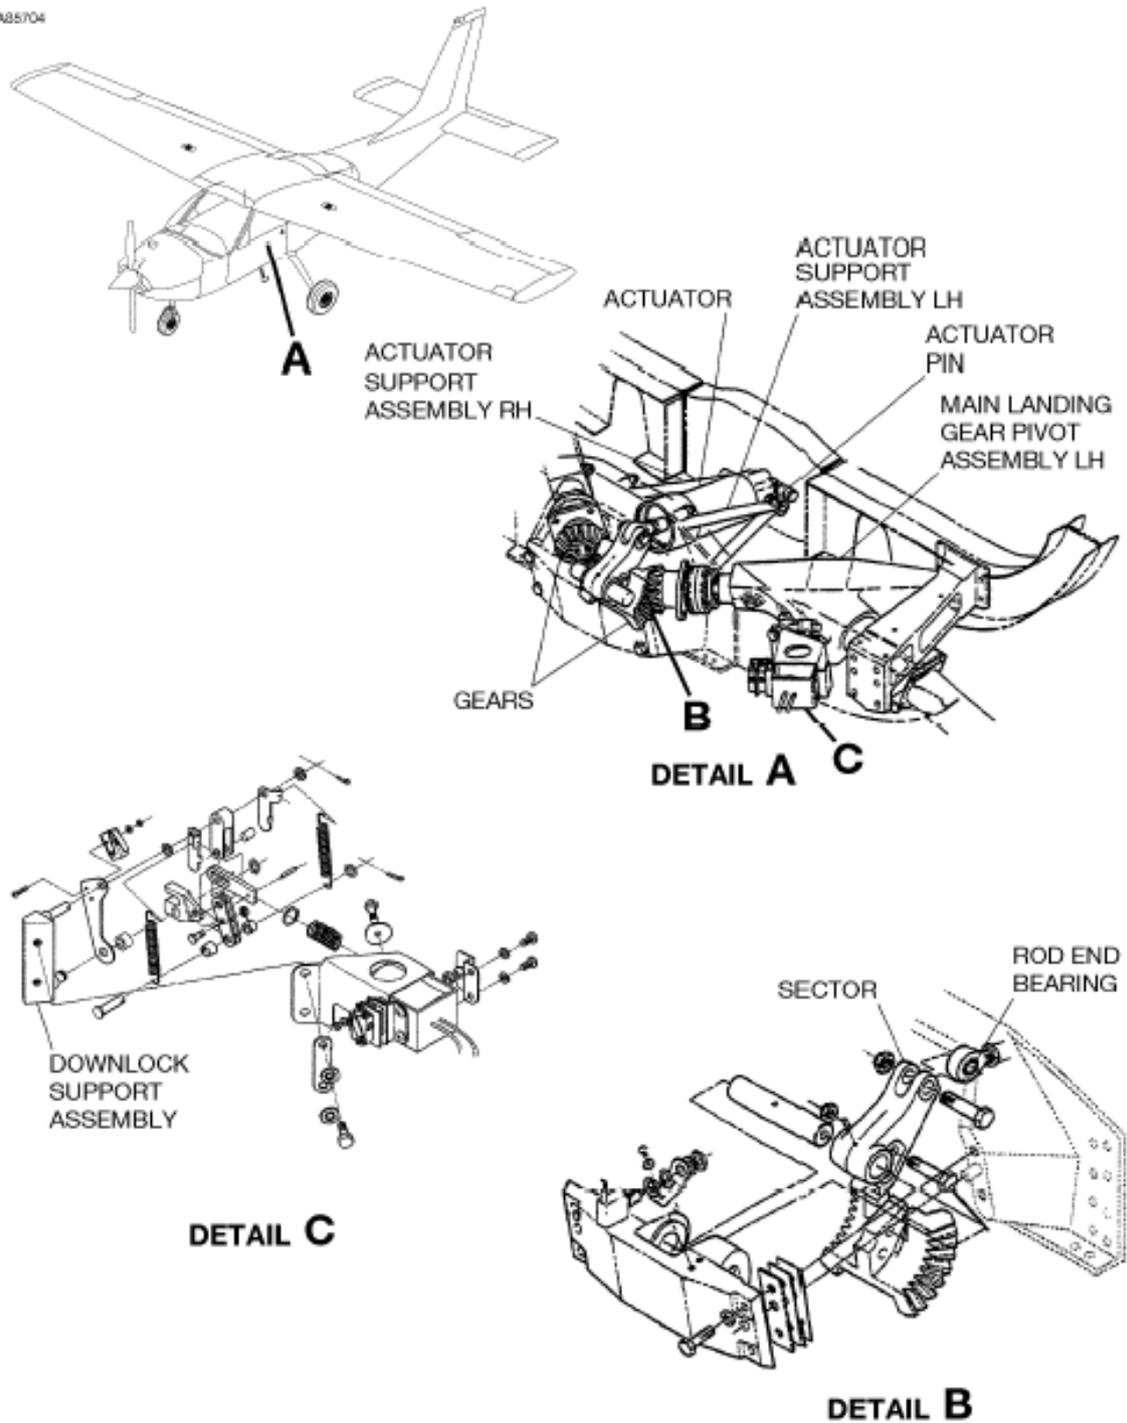
MAIN LANDING GEAR RETRACTION SYSTEM INSPECTION
 Figure 1 (Sheet 1)

3. **PURPOSE**
To ensure integrity of main landing gear retraction system.
4. **INSPECTION INSTRUCTIONS**
 - A. Check airplane records to verify that SE79-37 has been incorporated. If not, complete SE79-37 with this inspection.
 - B. Remove seats and carpeting as required to gain access to the plate above the actuator. Refer to the Model 177RG Service Manual.
 - C. Clean areas before inspecting if grime or debris are present.
 - D. Inspect the actuator, the actuator support assembly, and the rod end bearings for cracks and corrosion. Refer to Figure 1.
 - E. Inspect the actuator pins, gears, and sector arm for cracks and wear.
 - F. Inspect the main landing gear pivot fittings for cracks and corrosion.
 - G. Inspect the downlock support assembly for cracks or corrosion.
 - H. Install parts removed for access. Refer to the Model 177RG Service Manual.

6. **INSPECTION METHOD**
Visual
7. **REPAIR/MODIFICATION**
 - A. If rod end is cracked, replace in accordance with SE79-37 Rev. 1.
 - B. Replace damaged parts.
8. **COMMENTS**
