AIRCRAFT ACCIDENT REPORT AND EXECUTIVE SUMMARY

Reference:		CA18/2/3/10536	
Aircraft Registration	ZS-ISI	Date of Accident	11 December 2024		Time of Accident	1020Z	
Type of Aircraft	Piper PA-28-180			Type of Operation	Private (Part 91)		
Pilot-in-command Licence Type	Private Pilot Licence		Age	21	Licence Valid	Yes	
Pilot-in-command Flying Experience	Total Flying Hours			113.4	Hours on Type	84.3	
Last Point of Departure	Springs Aerodrome (FASI), Gauteng Province						
Next Point of Intended Landing	Springs Aerodrome (FASI), Gauteng Province						
Damage to Aircraft	Substantial						
Location of the accident site with reference to easily defined geographical points (GPS readings if possible)							
On a field near Springs Aerodrome (FASI) at GPS co-ordinates: 26°14'34.0" South 028°23'50.8" East							
Meteorological Information	Surface wind: 300°/5 kt; visibility: 9999m; temperature: 31°C; CAVOK						
Number of People On-board	1 + 0	Number of People Injured	0	Number of People Killed	0	Other (On Ground)	0

Probable Cause/s and/or Contributory Factors							
Unsuccessful forced landing following an in-flight engine stoppage. The cause of the engine stoppage could not be determined with

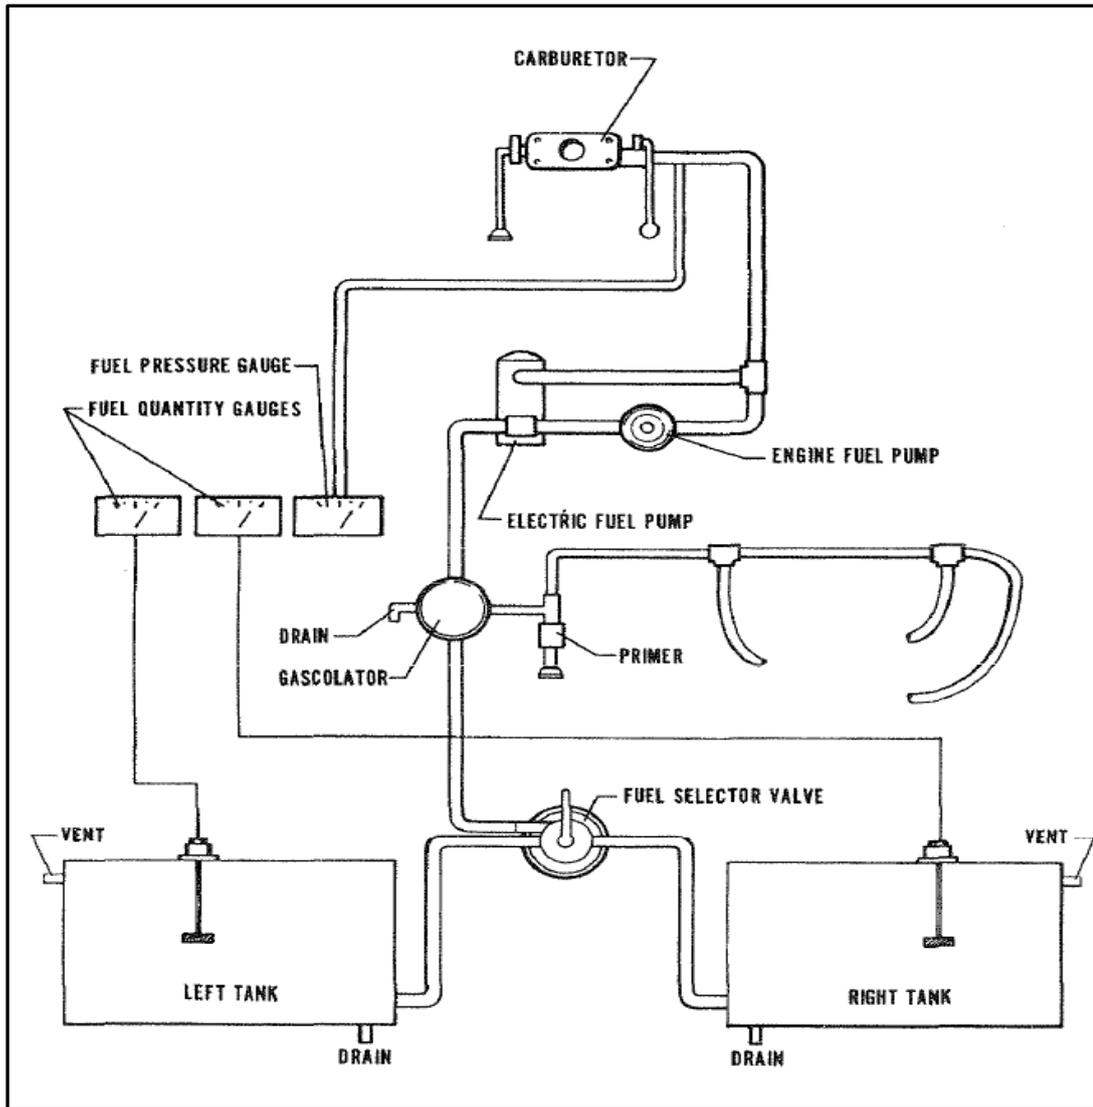
Diagram 1: Schematic of the fuel system.

The fuel is stored in two twenty-five gallon that allows (24. Gal usable) tanks which are secured to the leading-edge structure of each wing by screws and nut plates. This allows easy removal for service or inspection. The fuel selector control is located on the left side panel, forward of the pilot's seat. The button on the selector must be depressed and held while the handle is moved to the OFF position. The button releases automatically when the handle is moved back into the ON position. An auxiliary electric fuel pump is provided in case of failure of the engine-driven pump. The electric pump should be on for all take-offs and landings, and when switching tanks. The pump switch is located in the switch panel above the throttle quadrant. Each tank has an individual quick drain located at the bottom, inboard rear corner, and should be drained to check for water before each flight. The fuel strainer, which is also equipped with a quick drain, is located on the front lower left corner of the firewall. This strainer should be drained regularly to check for water or sediment accumulation. To drain the lines from the tank selector valve must be switched to each tank in turn, with the electric pump on, and the gascolator drain
