**LIMITED OCCURRENCE INVESTIGATION REPORT – FINAL**

| <b>Reference Number</b> | CA18/2/3/10538 | | | | | | |
| <b>Registration</b> | ZU-JBU | | | | | | |
| <b>Make; Model; S/N</b> | Jabiru J430 (Serial Number: 1019) | | | | | | |

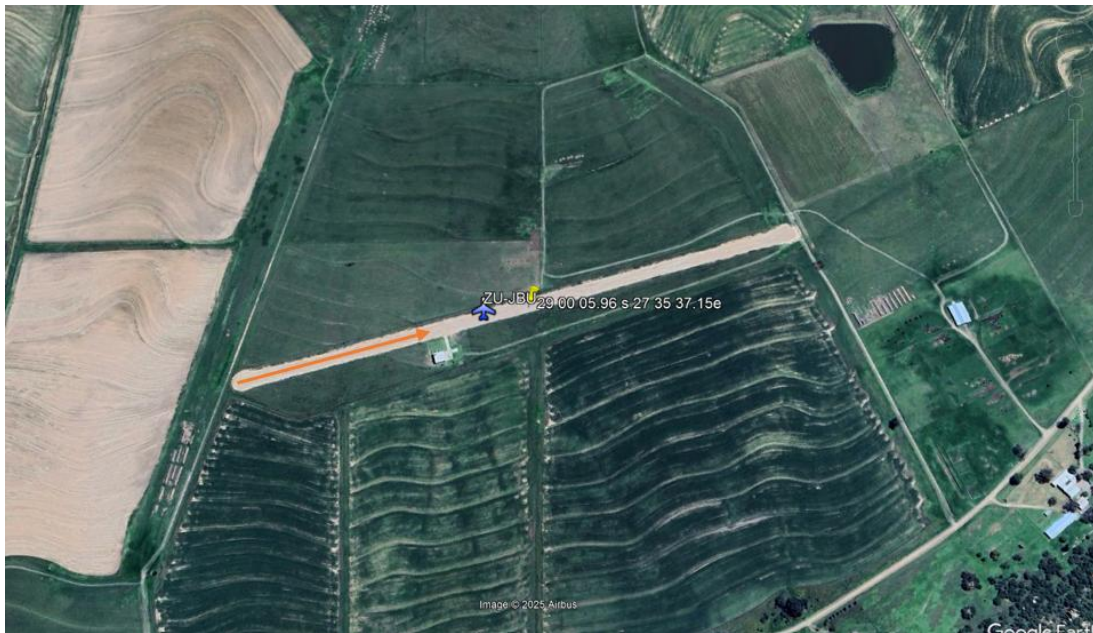
**Figure 1:** Aerial view of the runway, take-off direction and the accident site. (Source: Google Earth)

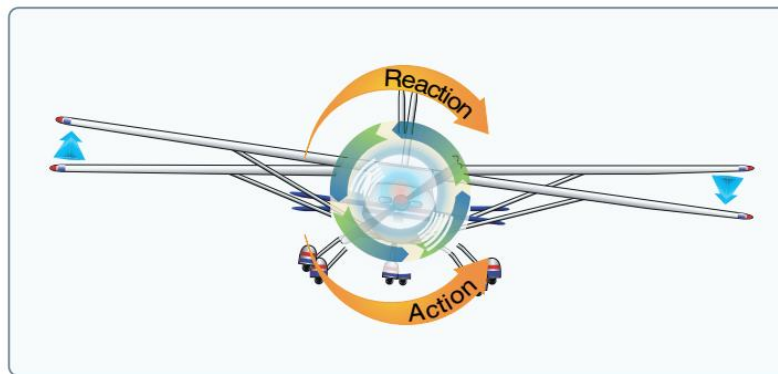
**Figure 5-47.** *Torque reaction.*

*Torque reaction involves Newton's Third Law of Physics— for every action, there is an equal and opposite reaction. As applied to the aircraft, this means that as the internal engine parts and propeller are revolving in one direction, an equal force is trying to rotate the aircraft in the opposite direction. [Figure 5-47]*

*When the aircraft's wheels are on the ground during the take-off roll, an additional turning moment around the vertical axis is induced by torque reaction. As the left side of side of the aircraft is being forced down by torque reaction, more weight is being placed on the left main landing gear. This results in more ground friction, or drag, on the left tire than on the right, causing a further turning moment to the left. The magnitude of this moment is dependent on many variables. Some of these variables are:*
