**LIMITED OCCURRENCE INVESTIGATION REPORT – FINAL**

| <b>Reference Number</b> | CA18/2/3/10540 | | | | | | |
| Registration | ZU-LBD | | | | | | |
| Make; Model; S/N | Shadow Lite CC, Jabiru J430 (Serial Number: 940) | | | | | | |

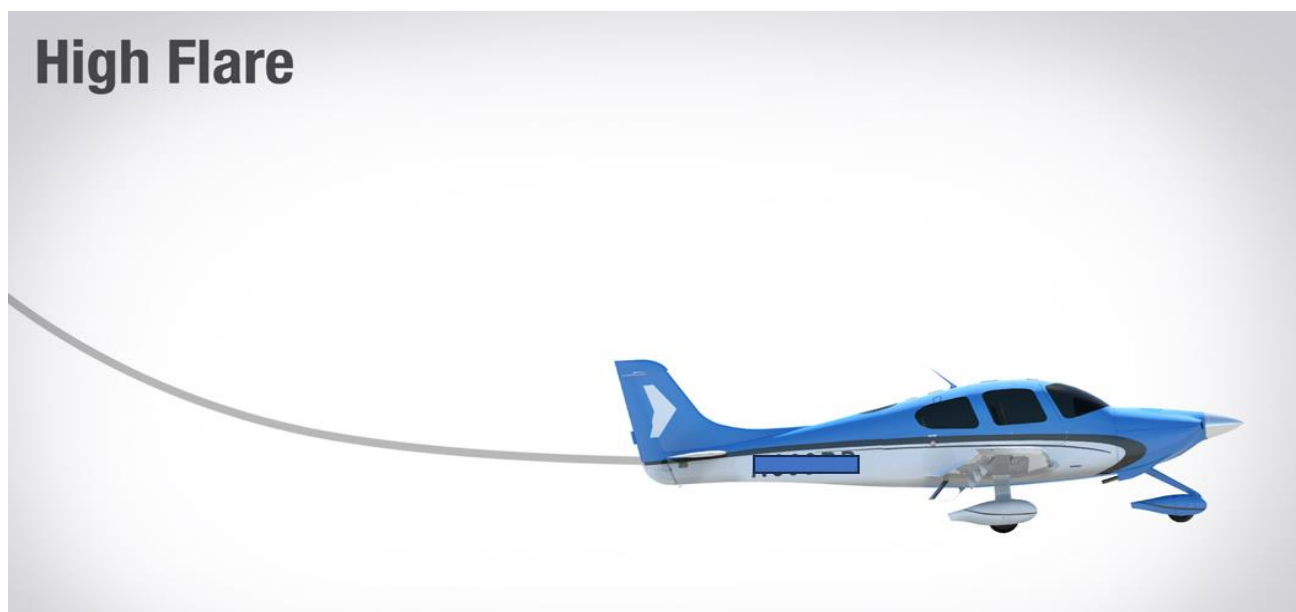
**Illustration 1:** Illustration of high flaring. (Source: Boldmethod)

During a high roundout (flare), continuing the round out further reduces the airspeed and increases the AOA to the critical angle. This results in the airplane stalling and dropping hard onto the runway. To prevent this, the pitch attitude is held constant until the airplane decelerates enough to again start descending. Then the round out is continued to establish the proper landing attitude. This procedure is only used when there is adequate air speed. It may be necessary to add a slight amount of power to keep the air speed from decreasing excessively and to avoid losing the lift too rapidly.
