AIRCRAFT ACCIDENT REPORT AND EXECUTIVE SUMMARY

Reference:		CA18/2/3/10551		
Helicopter Registration		ZS-RAC	Date of Accident		5 February 2025		Time of Accident	0705Z
Type of Helicopter		Bell 206L-4 Long Ranger IV		Type of Operation		Private (Part 91)		
Pilot-in-command Licence Type		Commercial Pilot Licence (CPL) Helicopter		Age	34	Licence Valid	Yes	
Pilot-in-command Flying Experience		Total Flying Hours		1 675.5		Hours on Type	230.9	
Last Point of Departure		Rand Airport (FAGM), Gauteng Province						
Next Point of Intended Landing		Polokwane Civil Airport (FAPI), Limpopo Province						
Damage to the Helicopter		Destroyed						
Location of the accident site with reference to easily defined geographical points (GPS readings if possible)								
On the border of Polokwane Game Reserve at Global Positioning System (GPS) co-ordinates determined to be 23°56'54"South 029°27'23"East, at an elevation of 4 265 feet (ft)								
Meteorological Information		Wind velocity: 020° at 3KT; Temperature: 26°C; Dew Point: 18°C; Visibility: ≥10000m; Cloud ceiling: FEW020; QNH: 1021 hPa

The engine failed due to loss of lubrication which resulted in a rapid loss of engine power, subsequently followed

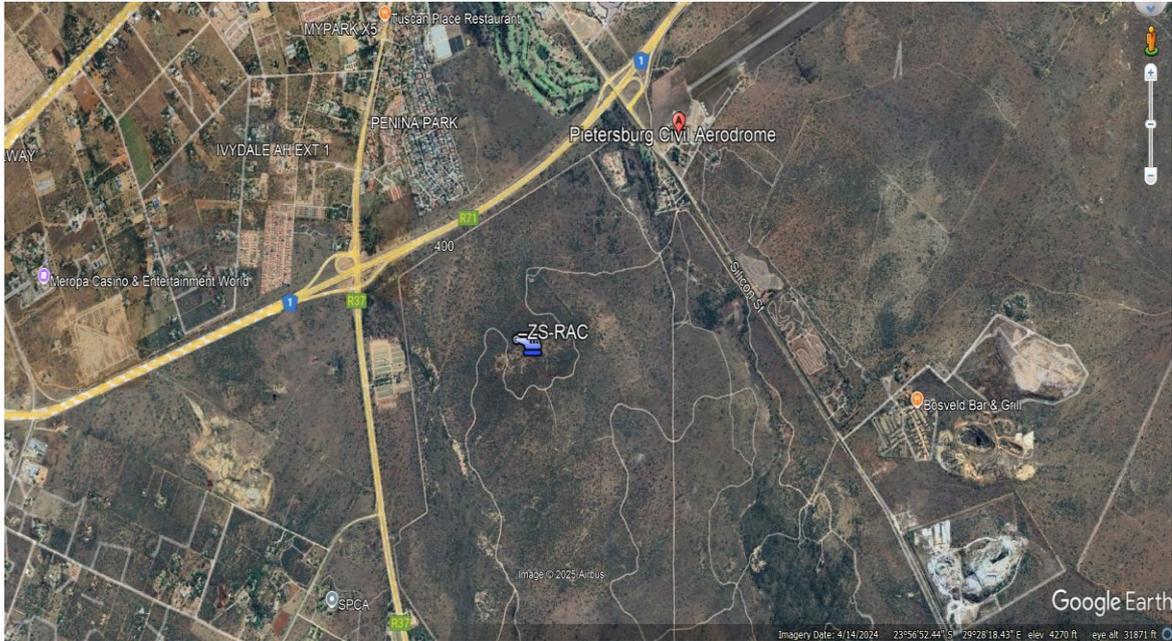
Figure 4: An overview of the accident site. (Source: Google Earth)

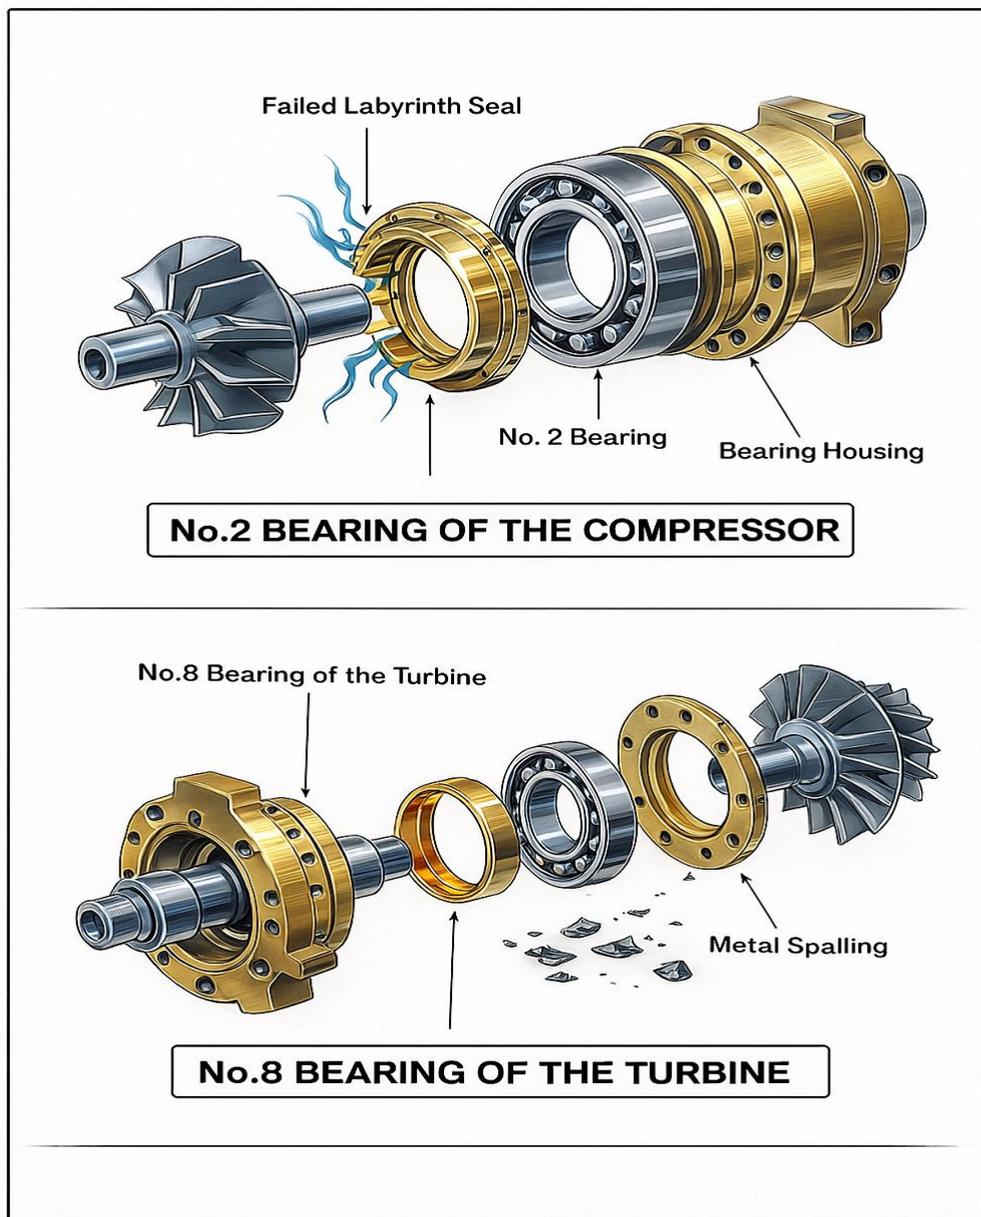
1.6.6. During maintenance, the engine compressor and turbine modules were removed and sent to a Rolls-Royce approved engine shop for Metal in Oil Inspection (MIO). According to the Rolls Royce maintenance manuals, the MIO inspection should be conducted on the entire engine stages including the compressor, turbine and gearbox stages. The Number 2 bearing (Illustration 1) on the compressor was inspected by the engine shop as this was believed to be the reason for metal particle detection warning light illuminating. Further teardown of the compressor revealed that the labyrinth seal had failed. This was given by the engine shop as the reason for the higher-than-normal oil consumption. The engine shop stripped the turbine assembly to determine any other sources of metal chips, and the Number 8 bearing (Illustration 1) was found to have spalling. The decision was made to replace all the bearings in the turbine.

Illustration 1: The schematics of the affected bearings.

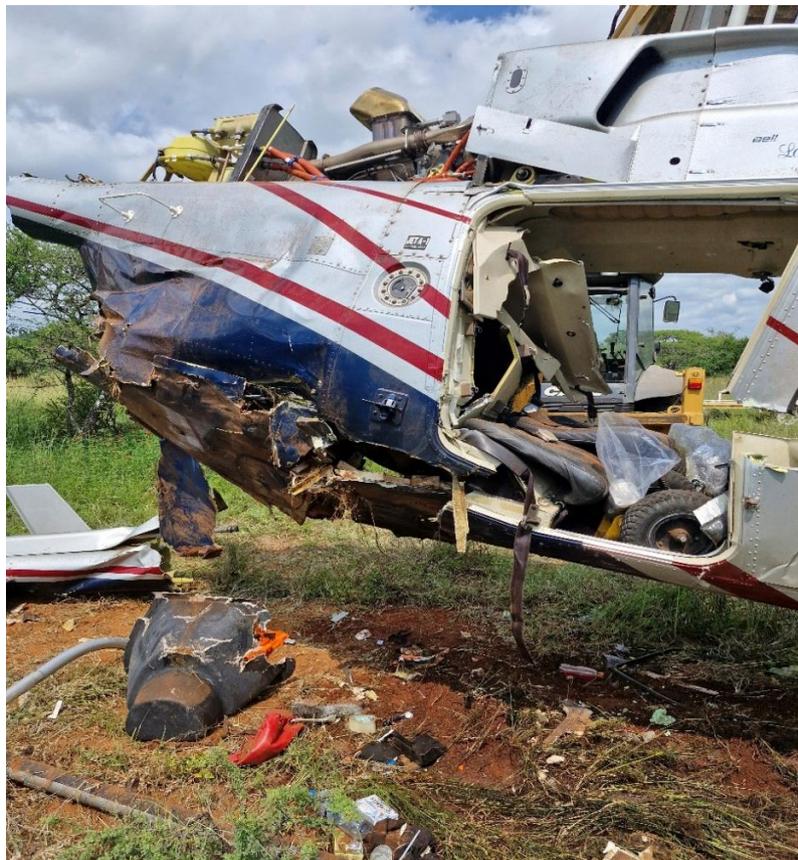
1.12.1 The accident occurred in a bush-type terrain within the Polokwane Game Reserve situated approximately 1.4 nm west of FAPI. The damage pattern was indicative of a helicopter that had descended in a steep angle before it crashed on the ground in a nose-high attitude and left roll. The tail rotor and vertical fin impacted a tall tree and, subsequently, separated from the tail assembly. The helicopter sustained significant damage to the skid landing gear, fuselage, main rotor and tail boom.

Figure 10: The helicopter during the recovery phase.

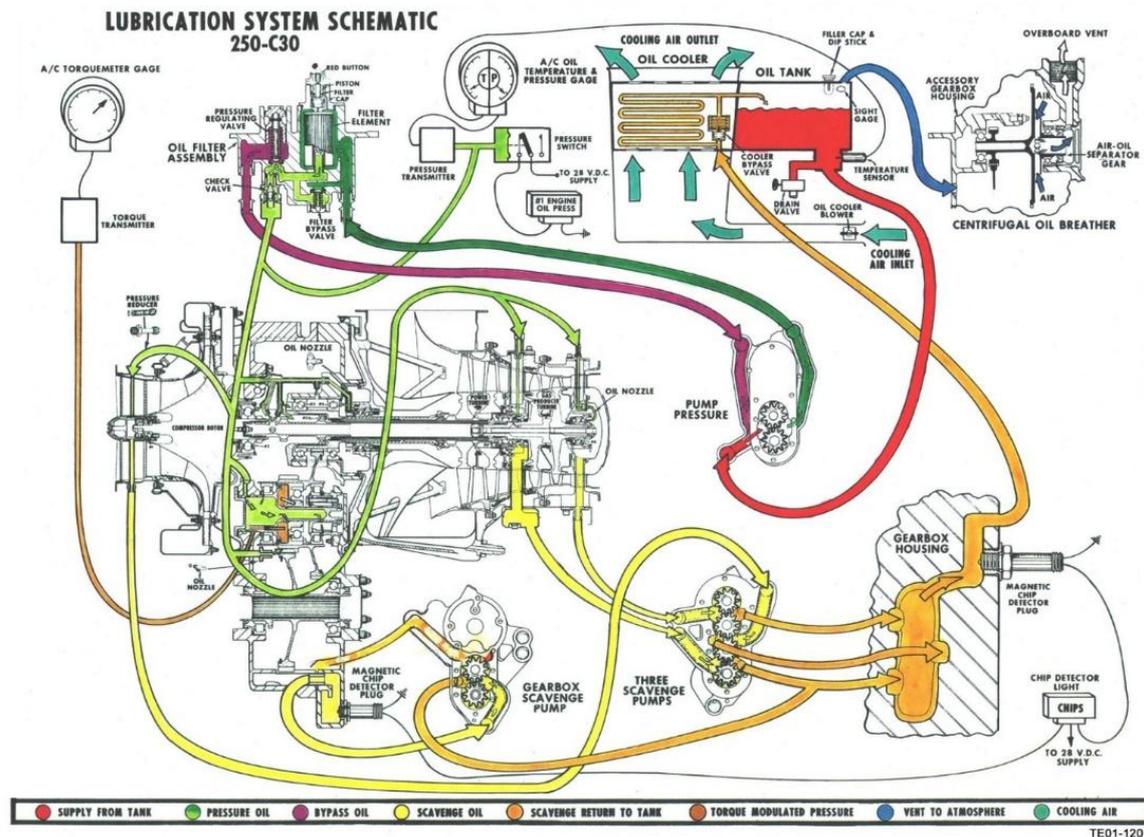
Diagram 1: A Schematic of the lubrication system. (Source: Rolls Royce)

1.16.3 The lubricating system furnishes lubrication, scavenging and cooling as needed for bearings, splines, and gears in all conditions of flight. The system is a circulating, dry sump type, with an external reservoir and oil cooler mounted and furnished by the helicopter manufacturer. The torquemeter in the engine gearbox is hydraulic and uses the engine lubrication system as its oil (hydraulic) pressure source. In order to minimise friction effects and provide accurate measurement of torque, the axial gear thrust on the helical torquemeter gearshaft is high. System pressure must always be greater than the torquemeter oil pressure. Therefore, it is necessary to regulate the system oil pressure to the relatively high value of 115-130 psi. Oil pressure is a function of (1) volume flow, (2) restriction to flow, and (3) viscosity. Volume flow from the pressure element is determined by N_1 RPM...volume flow increases as N_1 RPM increases. Restriction to flow is determined by the size of the passages, lines, and nozzles. Viscosity or fluid friction is a function of oil temperature. Thus, if the oil temperature and restriction to flow remain constant, oil pressure will increase with increases in N_1 RPM until the regulated oil pressure of 115-130 psi is reached. Further increases in N_1 RPM do not result in further increases in pressure because the pressure regulating valve bypasses the excess oil to the inlet of the pump.
