**LIMITED OCCURRENCE INVESTIGATION REPORT – DRAFT**

| <b>Reference Number</b> | CA18/2/3/10558 | | | | | | |
| <b>Registration</b> | ZU-EOA | | | | | | |
| <b>Make; Model; S/N</b> | Storm RG (Serial Number: S8-00E-0026) | | | | | | |

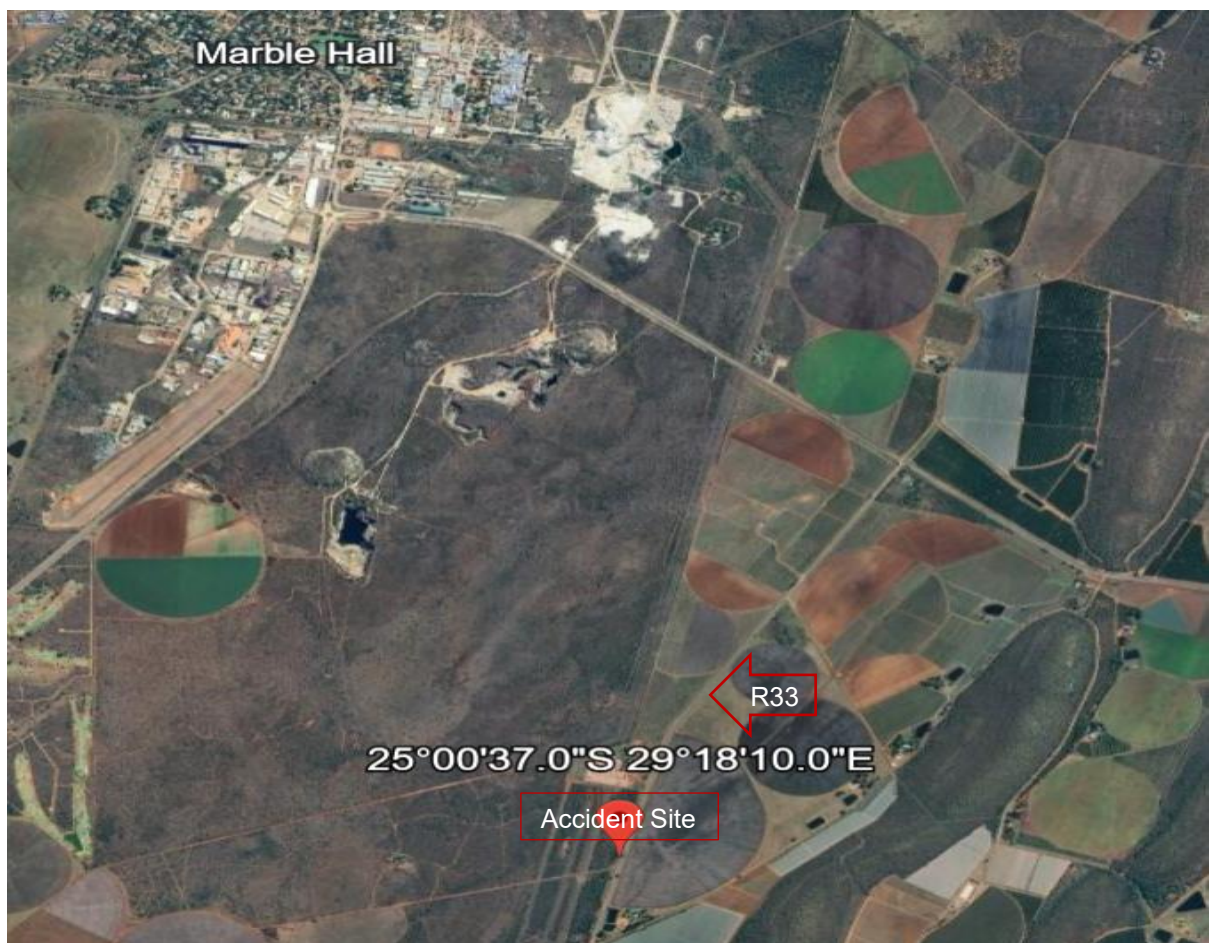
The accident occurred during daylight at Global Positioning System (GPS) co-ordinates determined to be 25°00'37" South 29°18'10" East, at an elevation of 2 998 feet (ft).

**Figure 1:** Aerial view of the accident site. (Source: Google Earth)

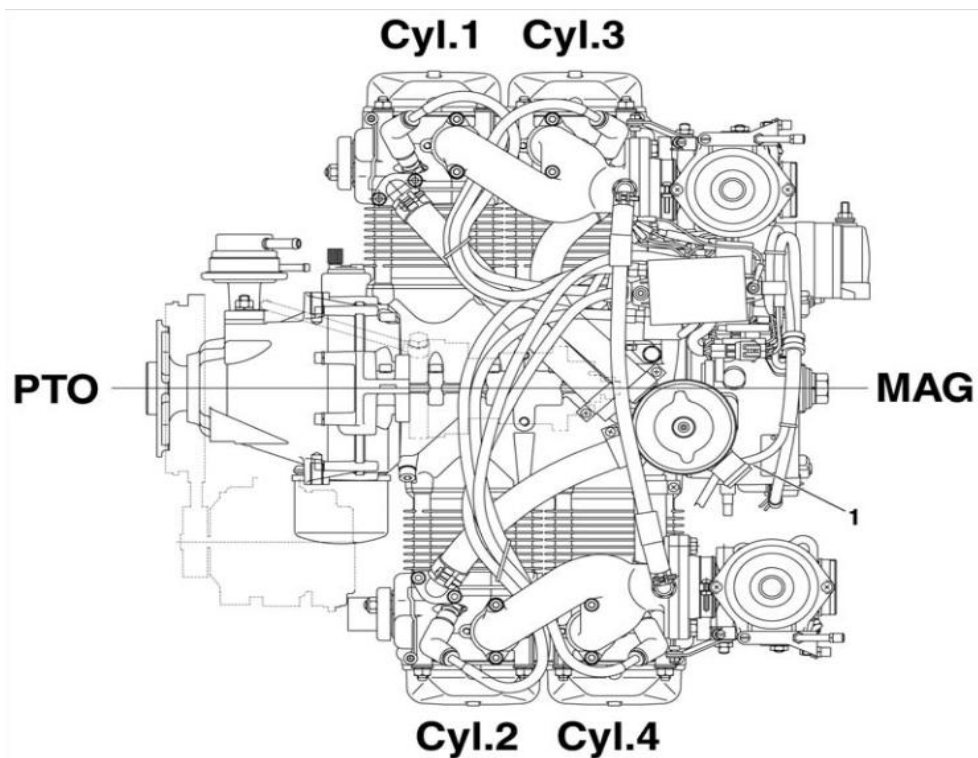
**Figure 6:** Rotax 914 Engine. (Source: Rotax 914 Illustrated Parts Catalogue)
