**LIMITED OCCURRENCE INVESTIGATION REPORT – FINAL**

| <b>Reference Number</b> | CA18/2/3/10562 | | | | | | |
| <b>Registration</b> | ZS-SNR | | | | | | |
| <b>Make; Model; S/N</b> | Piper Seneca II; PA-34-200T (Serial Number: 34-7970428) | | | | | | |

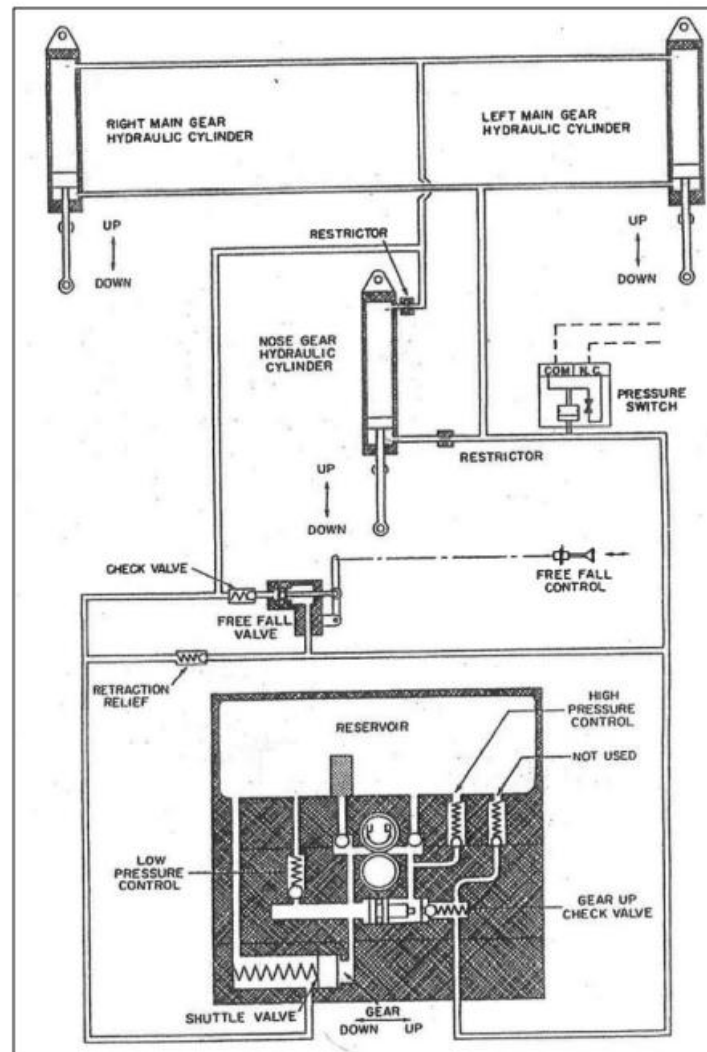
**Diagram 1:** Schematics of the landing gear hydraulic system.

A hydraulic retraction pipe for the nose gear with pressurised hydraulic fluid was found leaking. This caused the loss of hydraulic pressure required to keep the nose gear extended and locked to position, and thus, led to the collapse of the nose gear.

| A leak in the pressurised hydraulic retraction pipe led to insufficient pressure to maintain the nose gear extension, resulting in the collapse of the nose gear. |
