<b>AIRCRAFT ACCIDENT REPORT AND EXECUTIVE SUMMARY</b>
---

<b>Reference:</b>		CA18/2/3/10564	
<b>Aircraft Registration</b>	ZS-NJD	<b>Date of Accident</b>	19 March 2025	<b>Time of Accident</b>	1500Z
<b>Type of Aircraft</b>	Piper Aerostar PA-60-600		<b>Type of Operation</b>	Private (Part 91)	
<b>Pilot-in-command Licence Type</b>	Airline Transport Pilot Licence (ATPL)		<b>Age</b>	29	<b>Licence Valid</b> Yes
<b>Pilot-in-command Flying Experience</b>	<b>Total Flying Hours</b>		2116	<b>Hours on Type</b>	234
<b>Last Point of Departure</b>	Bethlehem Aerodrome (FABM), Free State Province				
<b>Next Point of Intended Landing</b>	Wonderboom Aerodrome (FAWB), Gauteng Province				
<b>Damage to Aircraft</b>	Substantial				
<b>Location of the accident site with reference to easily defined geographical points (GPS readings if possible)</b>					
On a private farm, 750m beyond the end of Runway 11 at FABM at GPS co-ordinates: 28°14'56.91"S 028°20'56.81"E, at a field elevation of 5599 feet (ft)

<div style="border: 1px solid red; width: 100px; height: 15px; margin: 5px auto;"></div>	PAGE 2 OF 13	
COMPILED FOR: AAS (Pty) Ltd		DOCUMENT NUMBER FA-014-04-25	
	<b>INVESTIGATION REPORT: AEROSTAR 600A CSU F

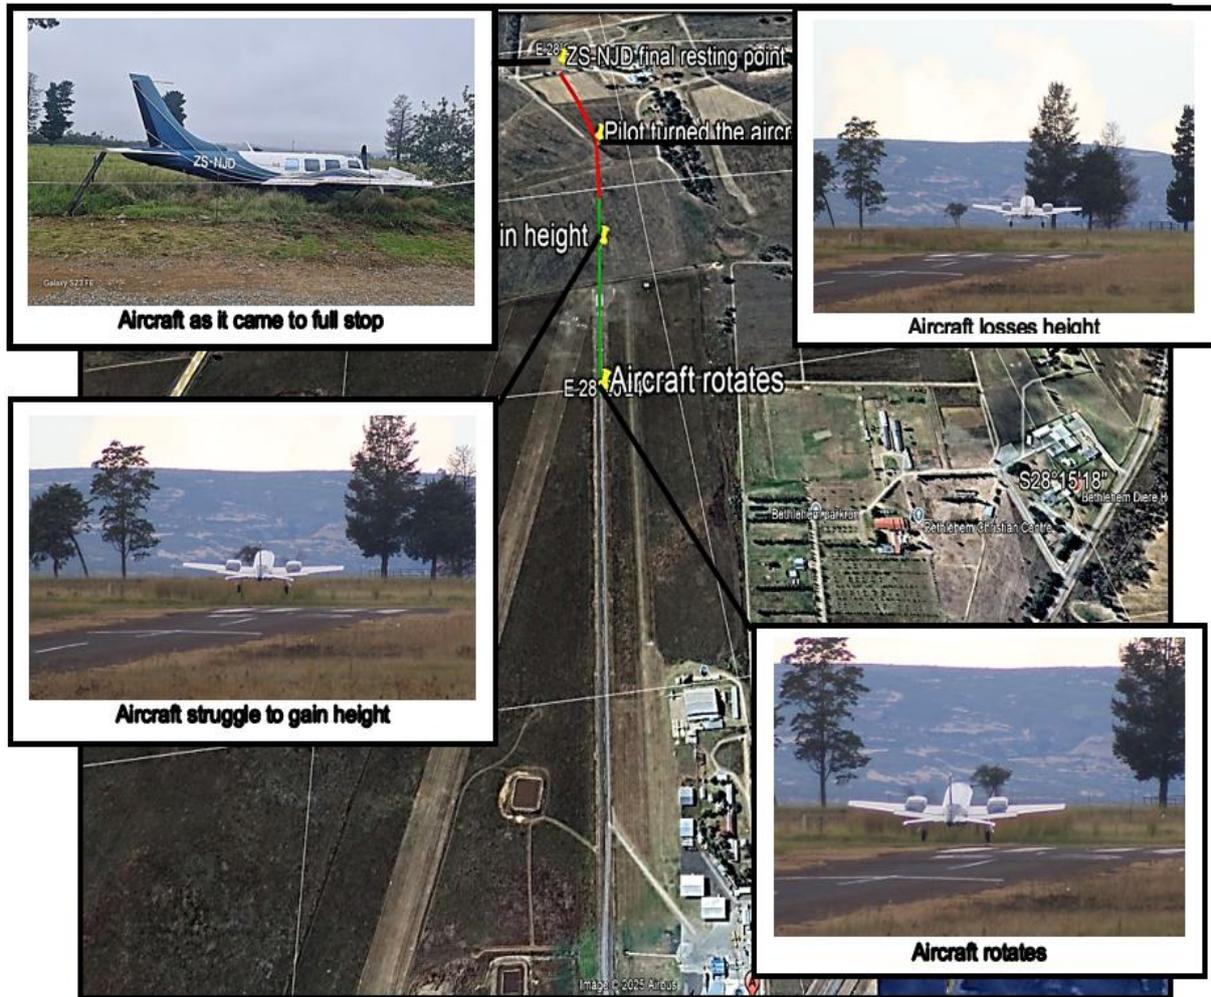
1.1.7. The accident occurred during daylight on a private farm about 750m beyond the end of RWY 11 at Global Positioning System (GPS) co-ordinate determined to be 28°14'56.91"South 028°20'56.81"East, at a field elevation of 5599 feet (ft).

**Figure 1:** An aerial view of the accident site. The inset pictures show the aircraft after take-off. (Source: Google Map)

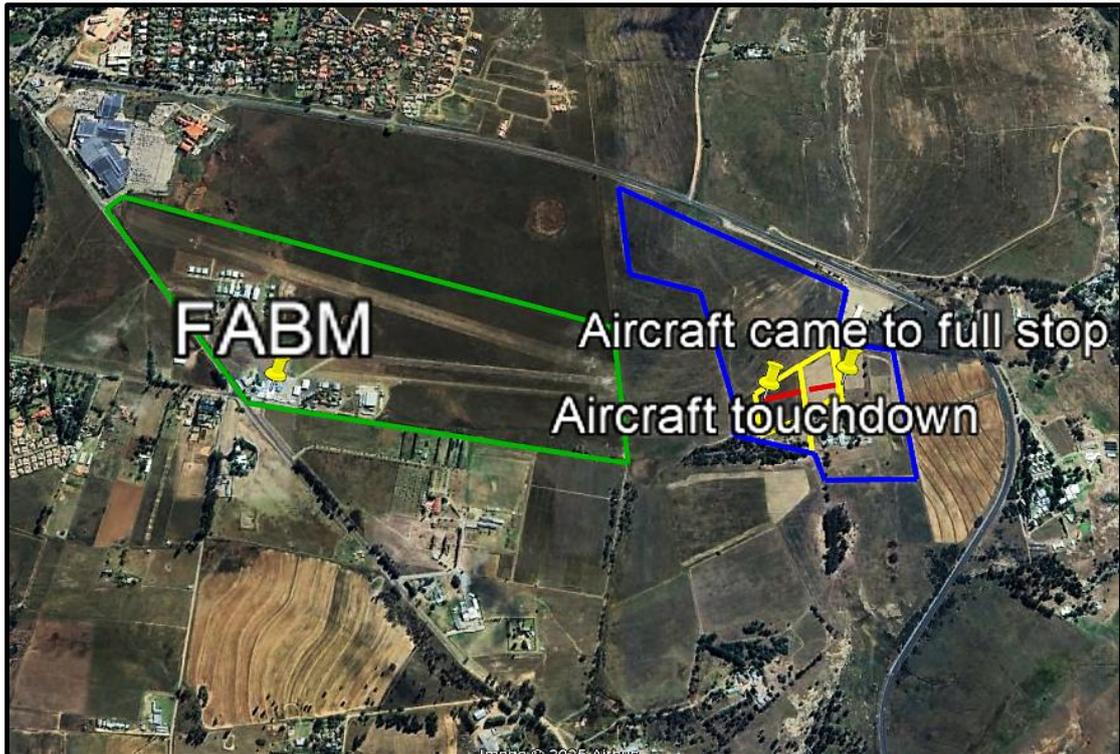
**Figure 7:** An overview of the accident site. (Source: Google Earth Maps)

1.12.1. The accident occurred during the take-off phase from FABM (indicated by the green demarcated area in Figure 7). The accident site was on a private farm (blue demarcated area in Figure 7). The ground skid marks stretched over a distance of approximately 250m after touch down, and about 500m beyond the end of the extended centreline of Runway 11. The aircraft remained largely intact with most structural components still attached to the fuselage. The terrain at the accident site comprised several obstacles, including barrier fences and tall trees (see Figure 8).

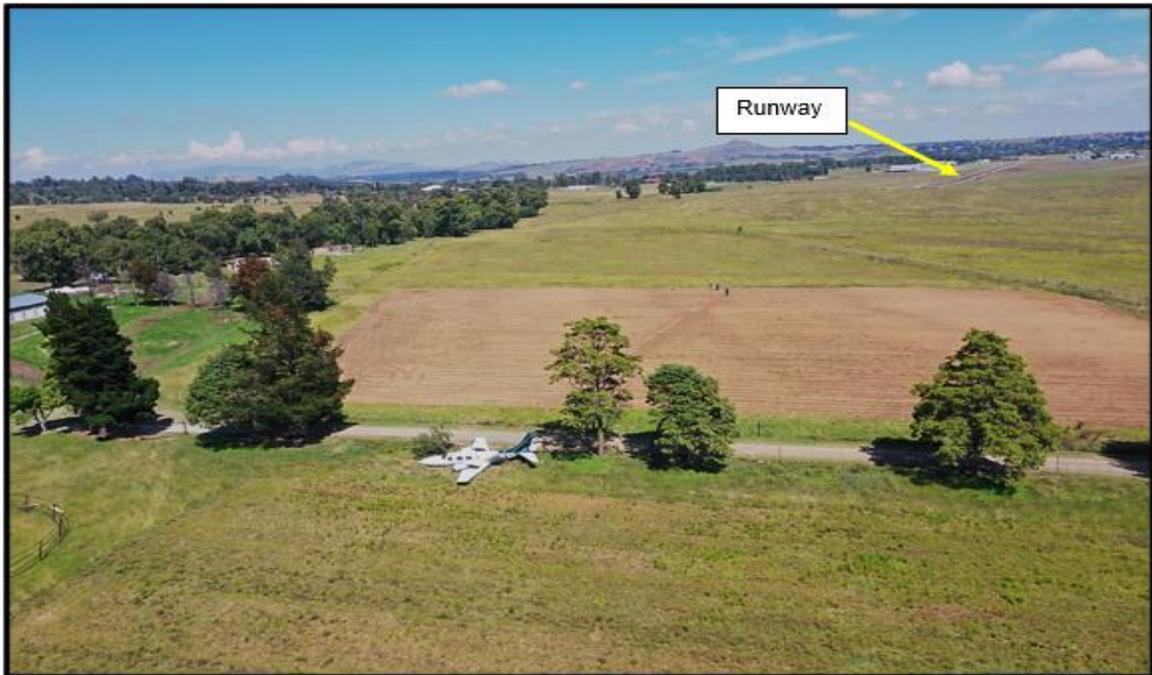
**Figure 8:** The accident site. (Source: Operator)

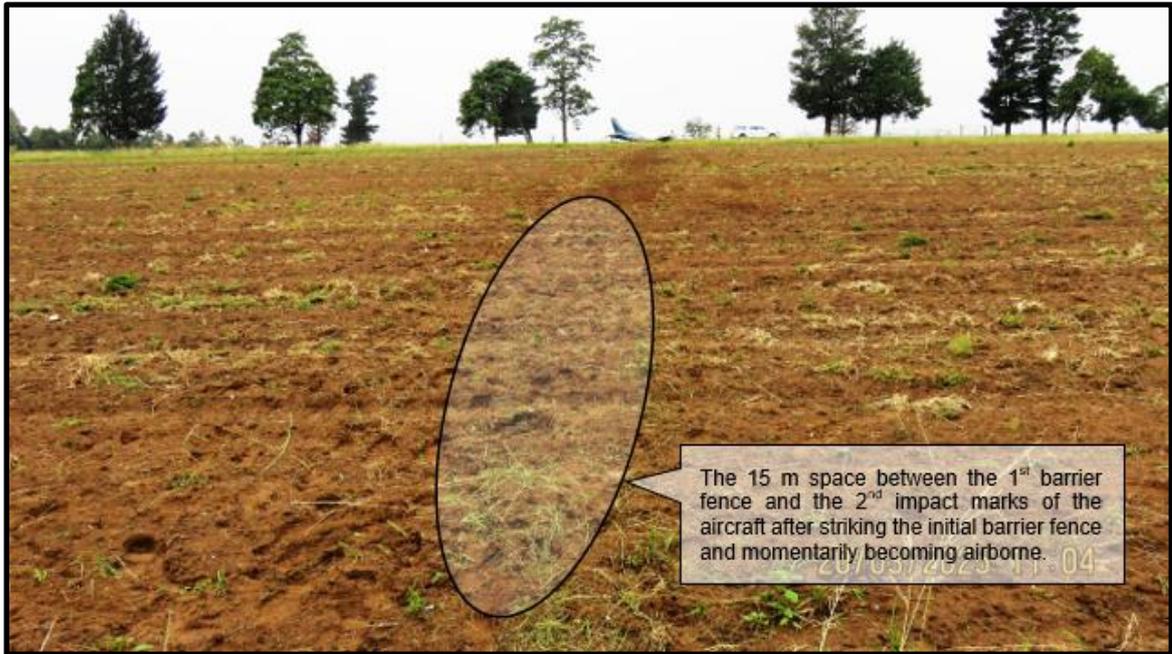
**Figure 11:** The space between the barrier fence and the second impact marks.

After touching down on the ground for the second time, the aircraft continued to skid; the left propeller left a prominent furrow on the ground, stretching approximately 181m before the aircraft impacted the second and third barrier fences, as well as the tree across the road (the tree was located 12m from the road).

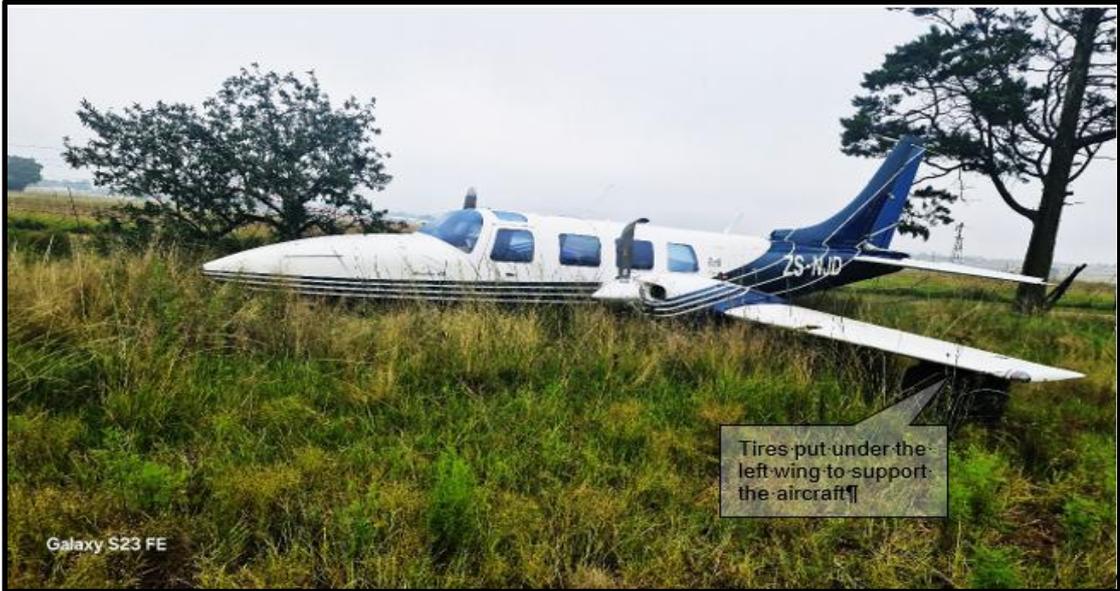
1.12.5. The aircraft came to rest on its belly between the trees. After the accident, four tyres were placed under the left wing to support and prevent fuel from leaking out from the left-wing tank.

**Figure 13:** The aircraft as it was found.

The tyres were placed by the pilot and the eyewitness (who was watching the aircraft take-off from near the hangars at the aerodrome) who had rushed to the accident site; this was to prevent fuel from further leaking out of the damaged left wing. Both the left and the right wings sustained damage due to impact with the barrier fences. The right wing sustained damage caused after impact with the barrier fences and the tree.

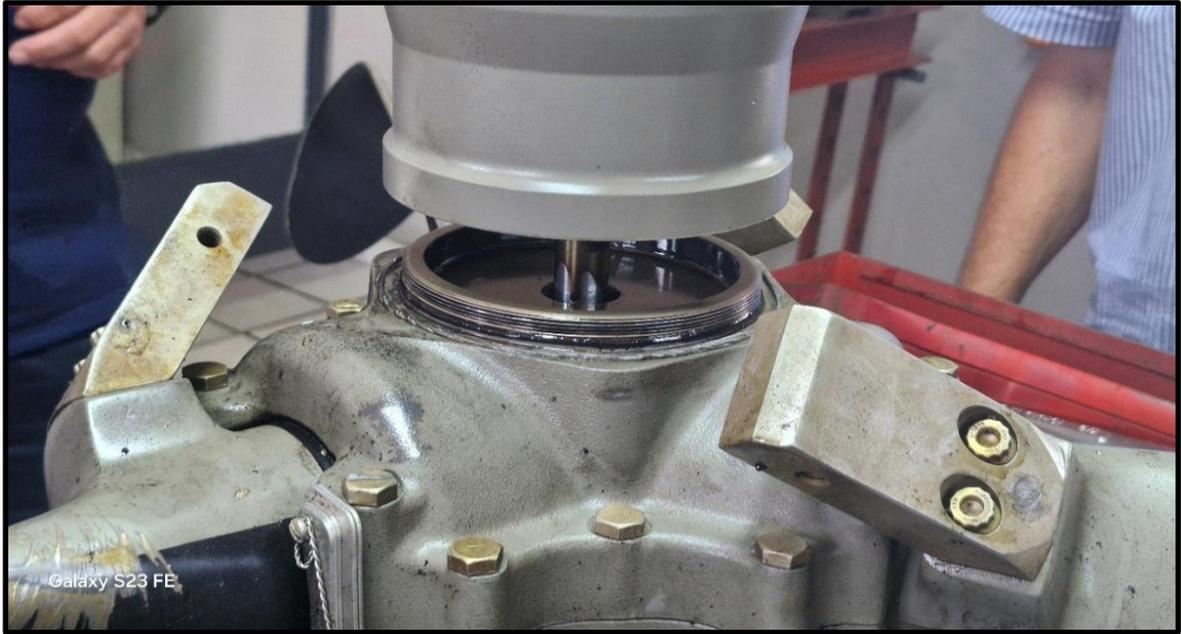
**Figure 16:** The disassembly of the propeller dome-cylinder.

1.16.1. The on-site investigation determined that the propeller fitted to the No.2 (right side) pitch-changing mechanism housing cylinder had detached from its mounting position, which caused oil to leak. The propeller was disassembled at an approved AMO that specialised in propellers on 26 March 2025. Upon inspection, the ON switch screwing threads were found damaged (See Figure 17). A metallurgical analysis was commissioned to establish the root cause of the failure. The report is attached as Appendix A.

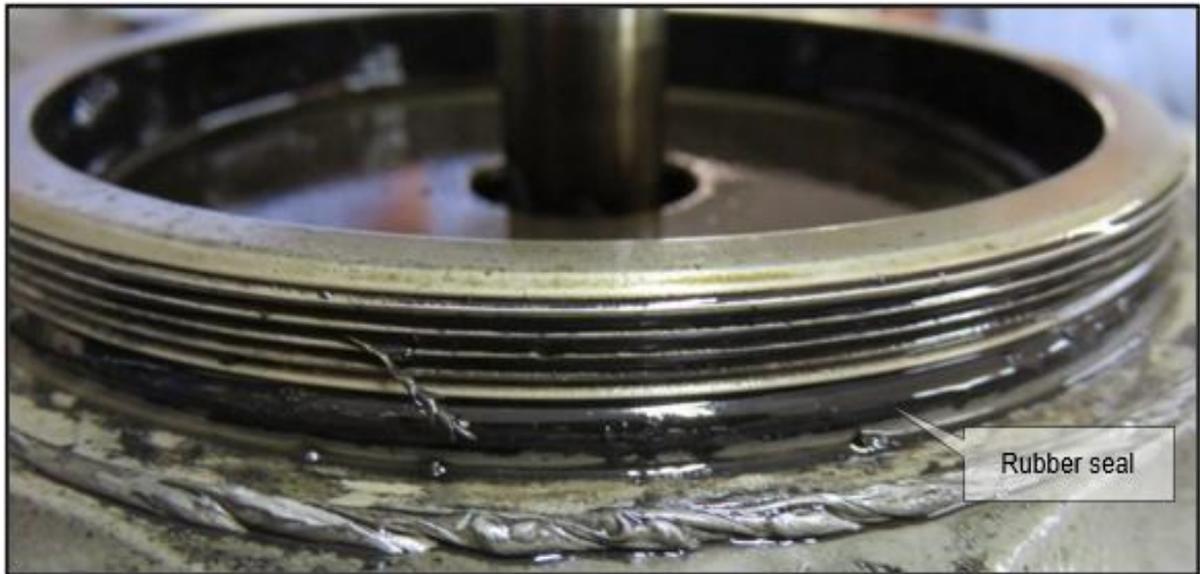
**Figure 18:** The threads of the intact propeller assembly with the rubber seal in place.

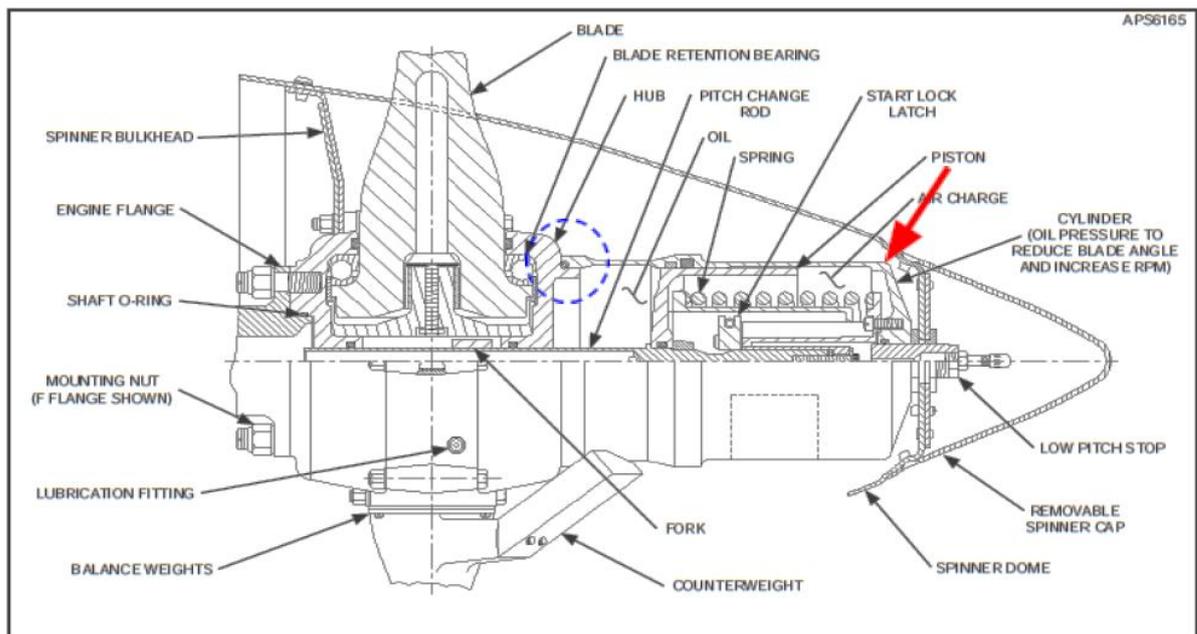
**Diagram 1:** Schematic cutaway of 2 Series Constant Speed feathering propeller. (Source: IPC)

The on-site visual inspection revealed the right-hand Constant Speed propeller Cylinder (Diagram 1, red arrow) separated from the Hub during operation at the threaded section (blue dashed circle). This is considered the primary cause of the uncommanded propeller blade pitch change, resulting in the reported loss of thrust.

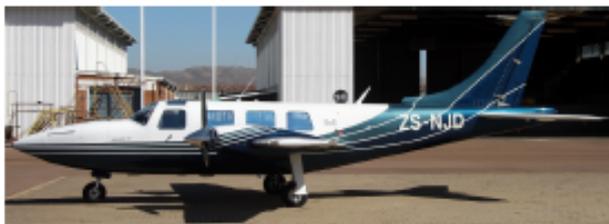
Photo 1: Aerostar 600, ZS-NJD<sup>2</sup>

The right-hand Constant Speed Unit and Propeller assembly (Photo 2) from an Aerostar 600 aircraft, registration ZS-NJD (Photo 1), was submitted to determine the most probable contributing factors to the failure during operation.

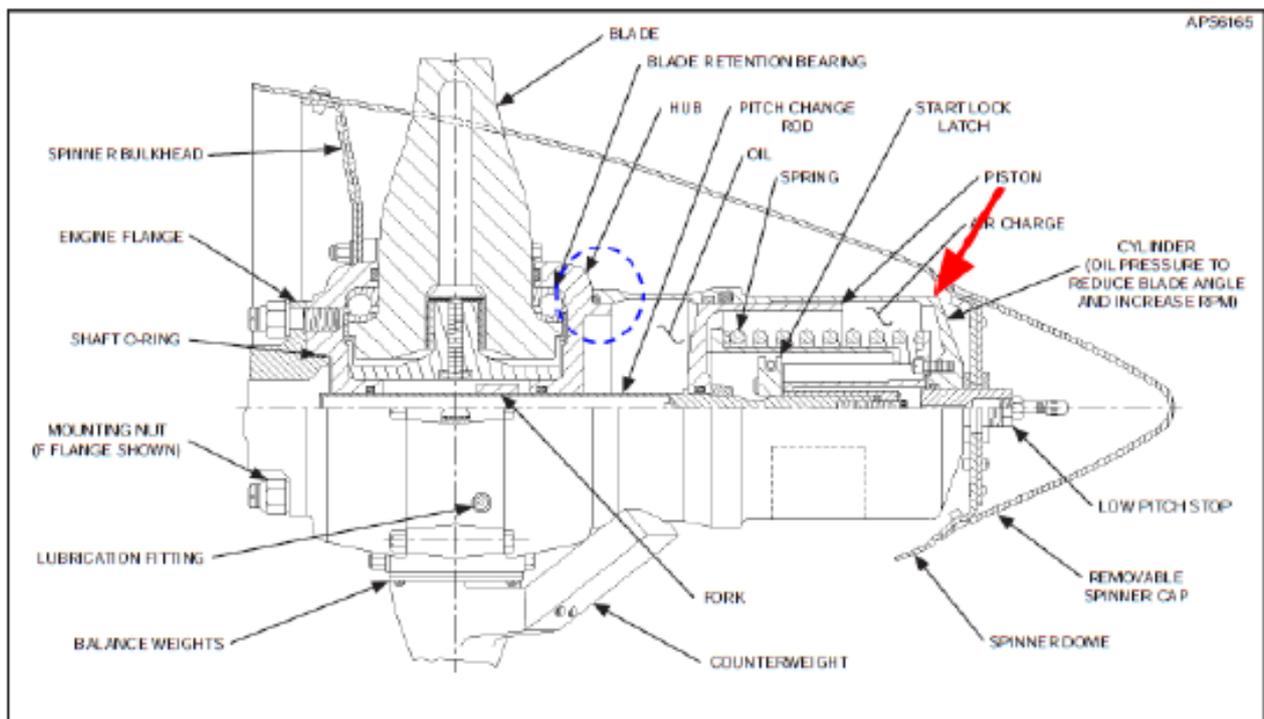
Diagram 1: Propeller Assembly\*

Cutaway of -2 Series Constant Speed, Feathering Propeller ( )HC-( )Y(-)-2  
Figure 2-2
