LIMITED OCCURRENCE INVESTIGATION REPORT – FINAL

Reference Number	CA18/2/3/10566						
Classification	Accident	Date	22 March 2025		Time	0940Z	
Type of Operation	Private (Part 91)						
Location							
Place of Departure	Mossel Bay Aerodrome (FAMO), Western Cape Province		Place of Intended Landing	Mossel Bay Aerodrome (FAMO), Western Cape Province			
Place of Occurrence	Mountainous terrain near Van Wyksdorp in Western Cape Province						
GPS Co-ordinates	Latitude	33°45'25.31" S	Longitude	021°28'48.62" E	Elevation	650 feet	
Aircraft Information							
Registration	ZS-FFG						
Make; Model; S/N	Hawker Beechcraft; Bonanza G36 (Serial Number: E-3845)						
Damage to Aircraft	Substantial		Total Aircraft Hours	1 366.4			
Pilot-in-command							
Licence Type	Private Pilot Licence		Gender	Male		Age	43
Licence Valid	Yes	Total Hours	660.1		Total Hours on Type	158.9	
Total Hours Past 30 Days	11.9		Total Hours on Type Past 90 Days	15.5			
People On-board	1 + 2	Injuries	0	Fatalities	0	Other (on ground)	0

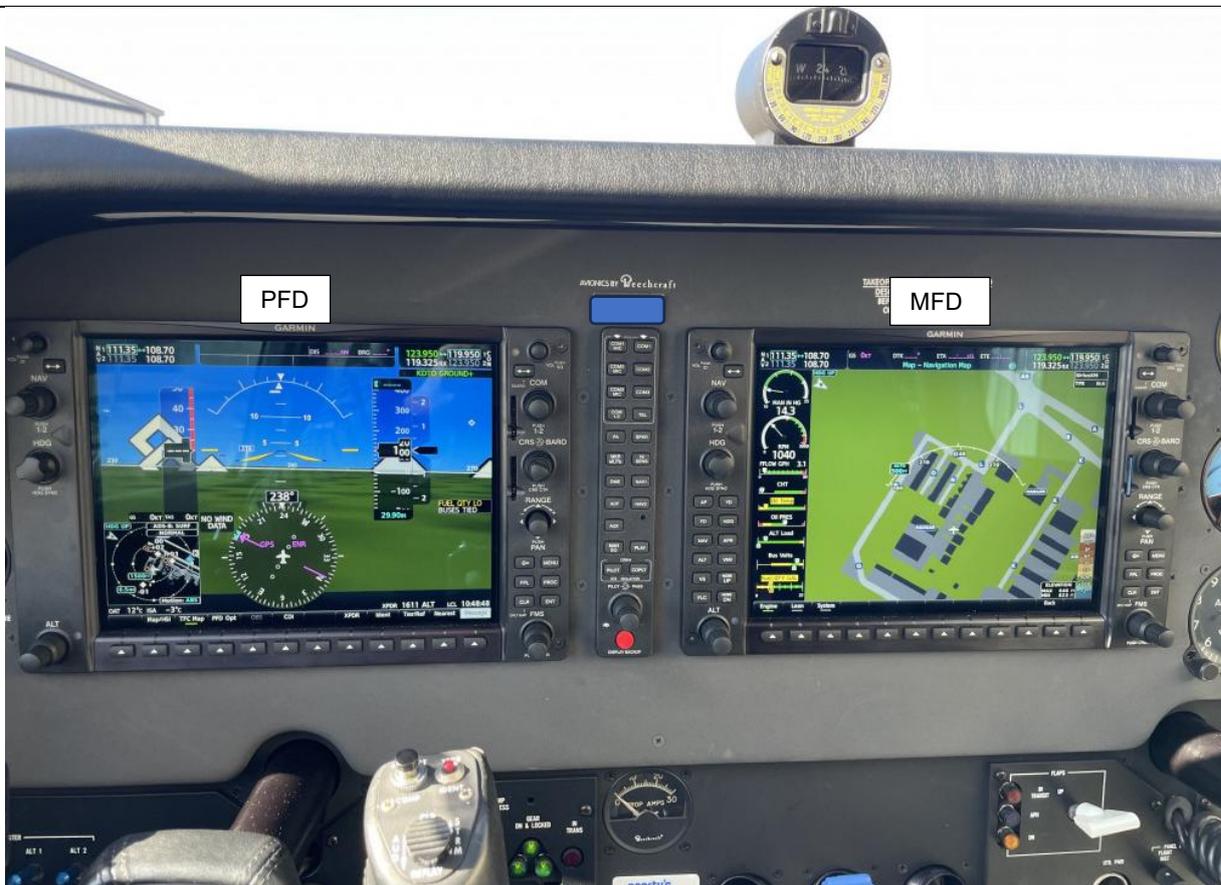
Figure 10: The Garmin 1000 integrated avionics cockpit layout of the Beechcraft G36.

The aircraft was equipped with Garmin G1000 Integrated Avionics System, which is an integrated flight, engine, communication, navigation, autopilot and surveillance instrumentation system. The system consists of a primary flight display (PFD), multi-function display (MFD) and audio panel that make up the instrument panel. Neither the PFD nor the MFD contained any navigational Secure Digital (SD) data cards that could be downloaded to obtain flight data.
