**LIMITED OCCURRENCE INVESTIGATION REPORT – FINAL**

| <b>Reference Number</b> | CA18/2/3/10542 | | | | | | |
| <b>Registration</b> | ZU-IJS | | | | | | |
| <b>Make; Model; S/N</b> | Sling 4 (Serial Number:094) | | | | | | |

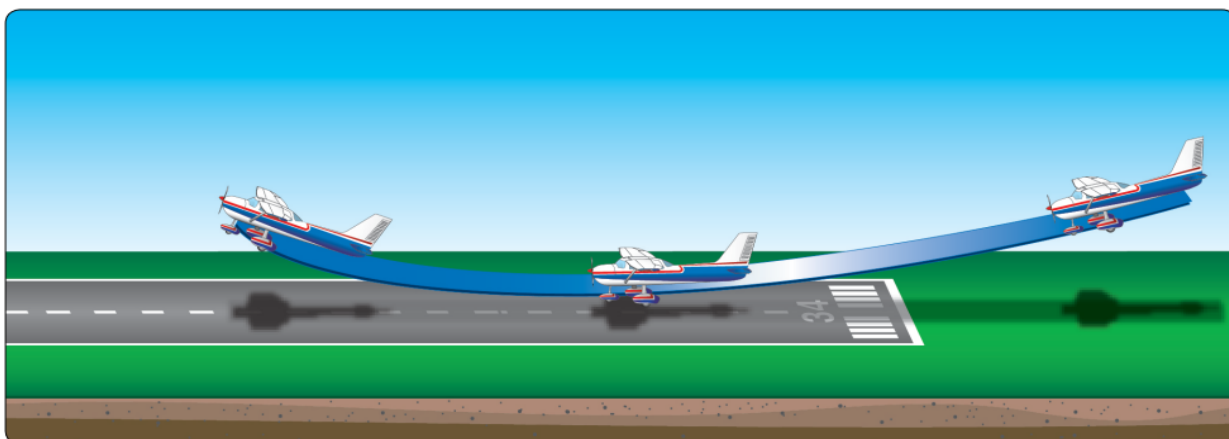
Ballooning During Round-out/Flare (Source: Federal Aviation Administration (FAA) *Airplane Flying Handbook* chapter 8)

*When ballooning is excessive, it is best to execute a go-around immediately; do not attempt to salvage the landing. Power must be applied before the airplane enters a stalled condition. The pilot must be extremely cautious of ballooning when there is a crosswind present because the crosswind correction may be inadvertently released, or it may become inadequate. Because of the lower airspeed after ballooning, the crosswind affects the airplane more. Consequently, the wing will have to be lowered even further to compensate for the increased drift. It is imperative that the pilot makes certain that the appropriate wing is down, and that directional control is maintained with opposite rudder. If there is any doubt, or the airplane starts to drift, execute a go-around.*

**Figure 3:** Ballooning during round out/flare.
