AIRCRAFT ACCIDENT REPORT AND EXECUTIVE SUMMARY

Reference:		CA18/2/3/10572	
Aircraft Registration	ZS-KSL	Date of Accident	1 April 2025		Time of Accident	0730Z	
Type of Aircraft	Cessna 152		Type of Operation		Training (Part 141)		
Pilot-in-command Licence Type		Commercial Pilot License (CPL)	Age	76	Licence Valid	Yes	
Pilot-in-command Flying Experience		Total Flying Hours		6 380	Hours on Type	3 100	
Last Point of Departure		Virginia Aerodrome (FAVG), KwaZulu-Natal Province					
Next Point of Intended Landing		Virginia Aerodrome (FAVG), KwaZulu-Natal Province					
Damage to Aircraft		Substantial					
Location of the accident site with reference to easily defined geographical points (GPS readings if possible)							
Approximately 300 metres from the threshold of Runway 05 (GPS co-ordinates: 29°46'33.5" South 031°03'18.1" East); elevation of 46 feet (ft)							
Meteorological Information		Surface wind: 060°/2kts; temperature: 28°C; dew point: 21°C; Cloud Cover: CAVOK; QNH: 1011hPa

Synopsis

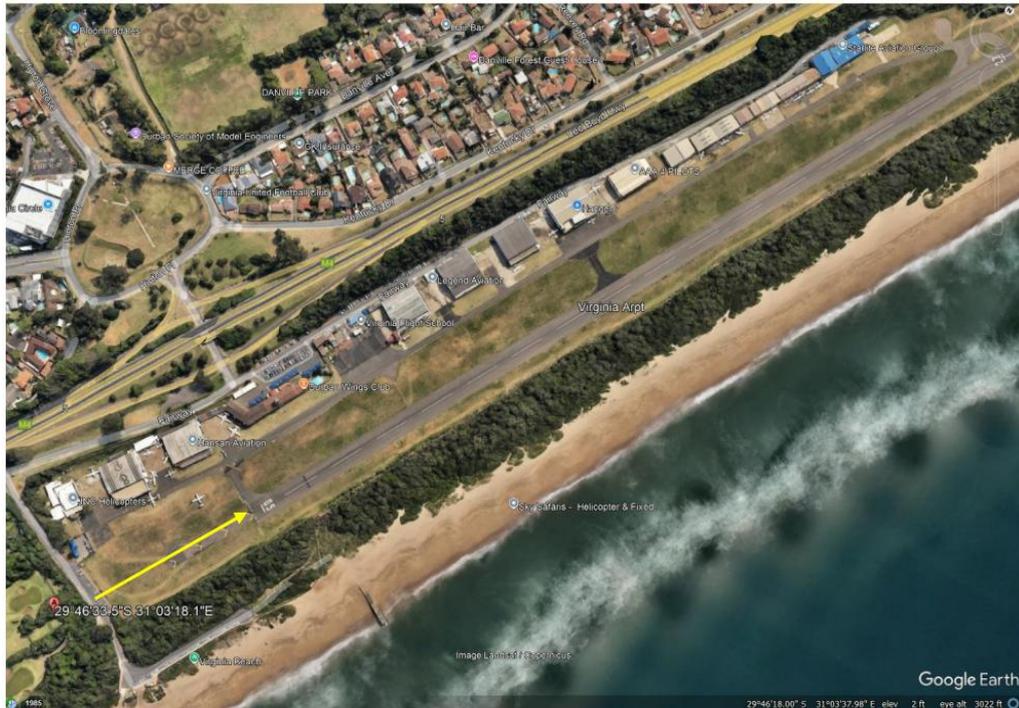
1.1.5. The accident occurred during daylight at Global Positioning System (GPS) co-ordinates determined as 29°46'33.5" South 031°03'18.1" East, at an elevation of 46ft.

Figure 1: Aerial view of the accident site. The yellow arrow indicates the distance between the crash site and FAVG Runway 05 threshold. (Source: Google Earth)
