**LIMITED OCCURRENCE INVESTIGATION REPORT – FINAL**

| <b>Reference Number</b> | CA18/2/3/10573 | | | | | | |
| Registration | ZS-IOG | | | | | | |
| Make; Model; S/N | Thrush; S2R-H80 (Serial Number: H80-157) | | | | | | |

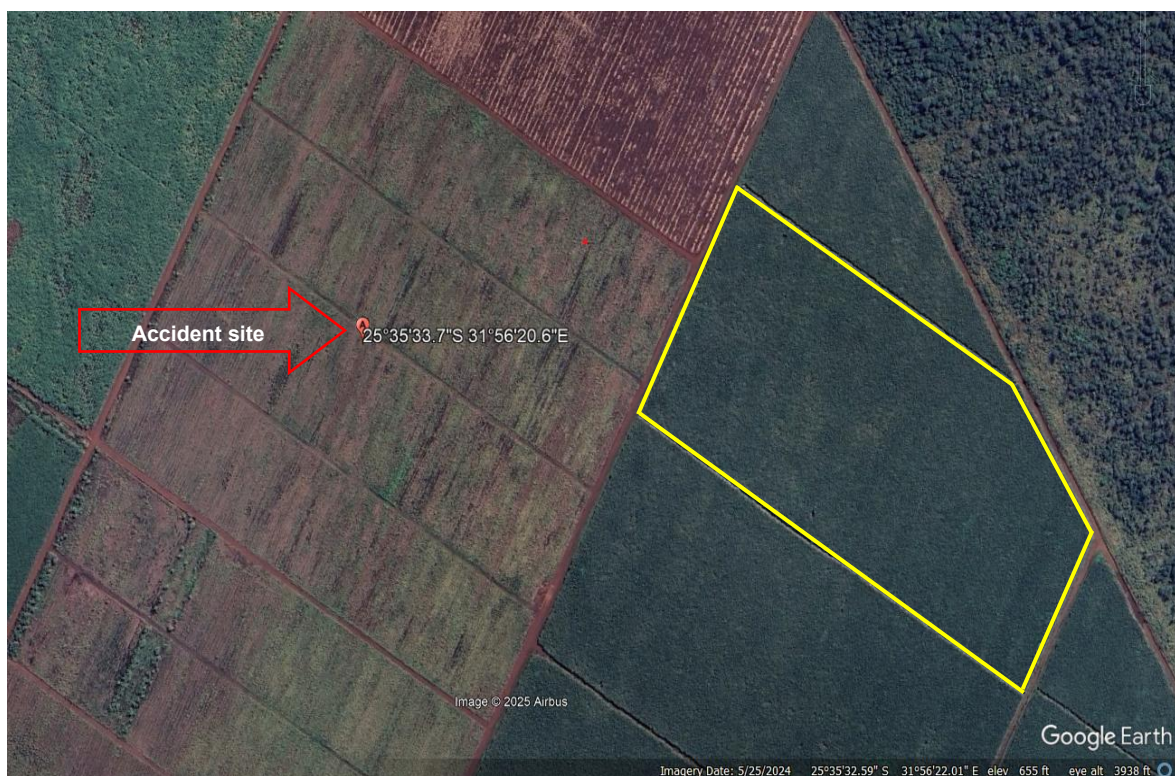
**Figure 1:** Aerial view of accident site and the sugar cane field that was sprayed (marked in yellow).  
(Source: Google Earth)
