AIRCRAFT ACCIDENT REPORT AND EXECUTIVE SUMMARY

Reference:		CA18/2/3/10578	
Aircraft Registration	ZU-TNT	Date of Accident	12 April 2025		Time of Accident	1417Z	
Type of Aircraft	Slick 540		Type of Operation		Private (Part 94)		
Pilot-in-command Licence Type		Private Pilot Licence (PPL) (Aeroplane)	Age	45	Licence Valid	Yes	
Pilot-in-command Flying Experience		Total Flying Hours		512.35	Hours on Type	1.6	
Last Point of Departure		Kitty Hawk Aerodrome (FAKT) near Pretoria, Gauteng Province					
Next Point of Intended Landing		Kitty Hawk Aerodrome (FAKT) near Pretoria, Gauteng Province					
Damage to Aircraft		Destroyed					
Location of the accident site with reference to easily defined geographical points (GPS readings if possible)							
On a private farm, approximately 2.8 nautical miles (nm) east of FAKT at Global Positioning System (GPS) co-ordinates determined to be 25°52'12.88"S 028°29'51.72"E							
Meteorological Information		Wind direction: 218°; wind speed: 3 kts; visibility: 10km; cloud cover: CAVOK; cloud base: 1 000ft; temperature: 23°C; dew point: 12°C; QNH: 1024

Synopsis

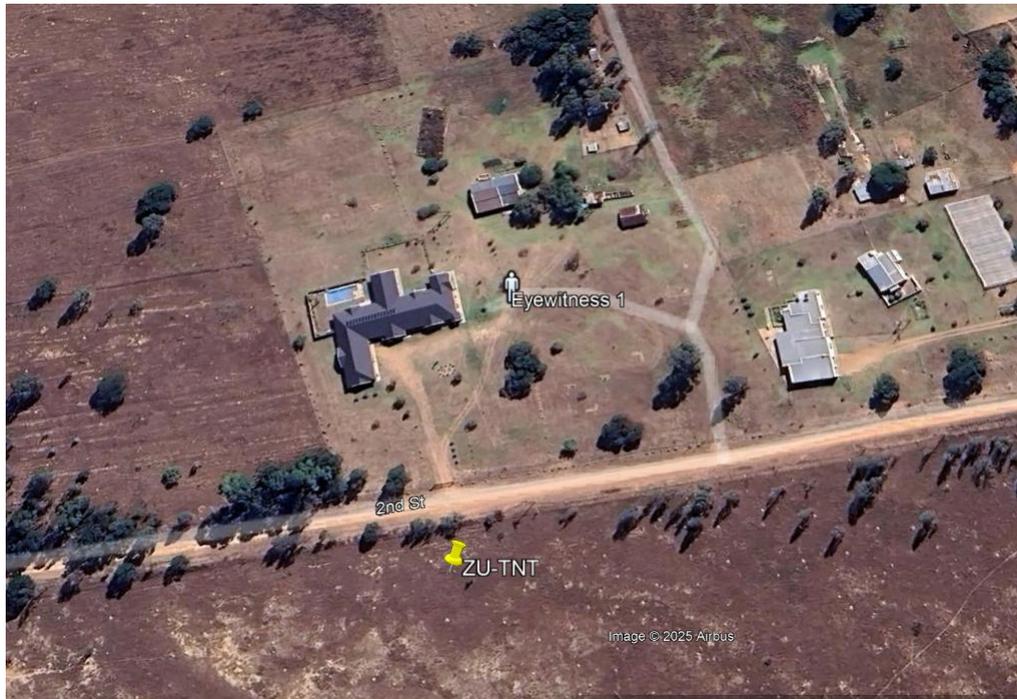
Figure 2: An aerial view of the approximate accident location and the first eyewitness. (Source: Google Earth)

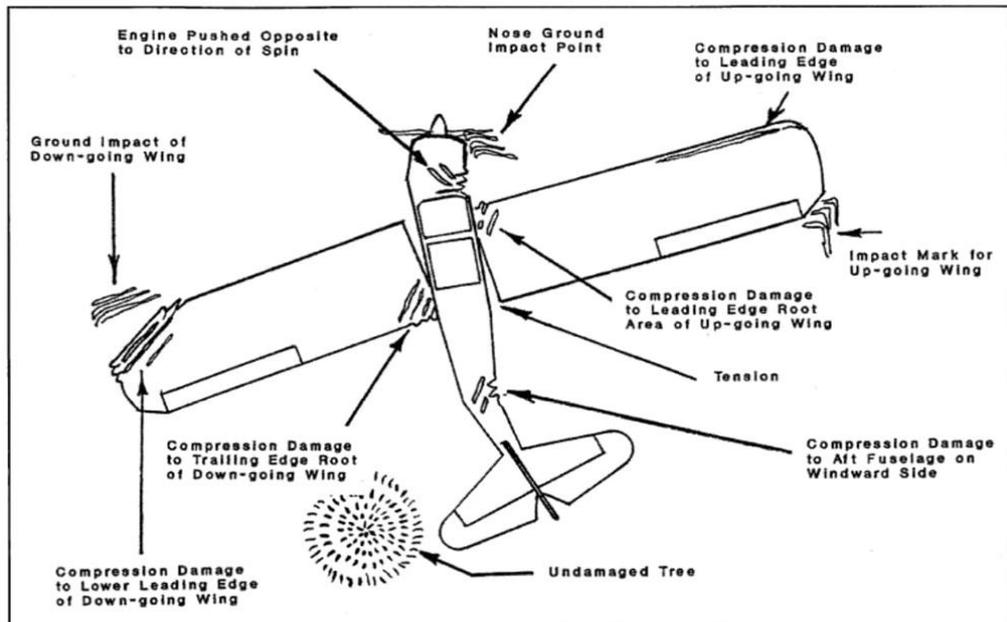
1.12.6. The condition of the wreckage and debris pattern suggested a flat spin with a limited forward speed.

Figure 13: The wreckage distribution at the accident site. (Source: EMS personnel)

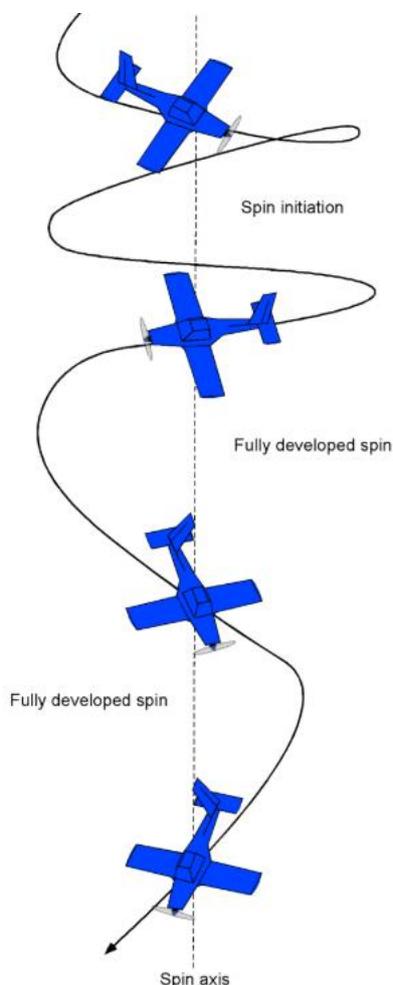
Two seconds after the beginning of the video, immediately after the recovery to the vertical down line, it looked like there was an aggressive pitch up/pull on the stick. The energy/speed of the aircraft was low and power was at idle, resulting in a high-speed stall and wing drop. There was an attempt to level the wings; it was not clear what control input were used as the footage was not clear, but there was evidence of continued wing loading and no apparent release of the stick or attempt to reduce the angle of attack. The rotation reversed to the left following the attempt to stop the initial right-wing drop. This opposite rotation was consistent with the aircraft remaining stalled while attempting to level the wings. As a result, the aircraft remained in a stalled condition, resulting in an increased rate of descent. The video sound indicated an increase of power at approximately 7 seconds. Due to the distance of the videographer and time delay, the power application would have happened a few seconds earlier, the resultant torque and slipstream could have contributed to induce or enhance the left spin as well as increase the pitch up tendency.

The initial high-speed stall was not recovered from, and the angle of attack was not reduced. As a result, the aircraft remained in a stall and (thus, the) resultant spin until it disappeared from view of the videographer.

Illustration 1: Stall-spinning aircraft diagram
