**LIMITED OCCURRENCE INVESTIGATION REPORT – FINAL**

| <b>Reference Number</b> | CA18/2/3/10580 | | | | | |
| Registration | ZS-KHR | | | | | |
| Make; Model; S/N | Piper Aircraft; PA-36-375 Pawnee Brave (Serial Number: 36-7802059) | | | | | |

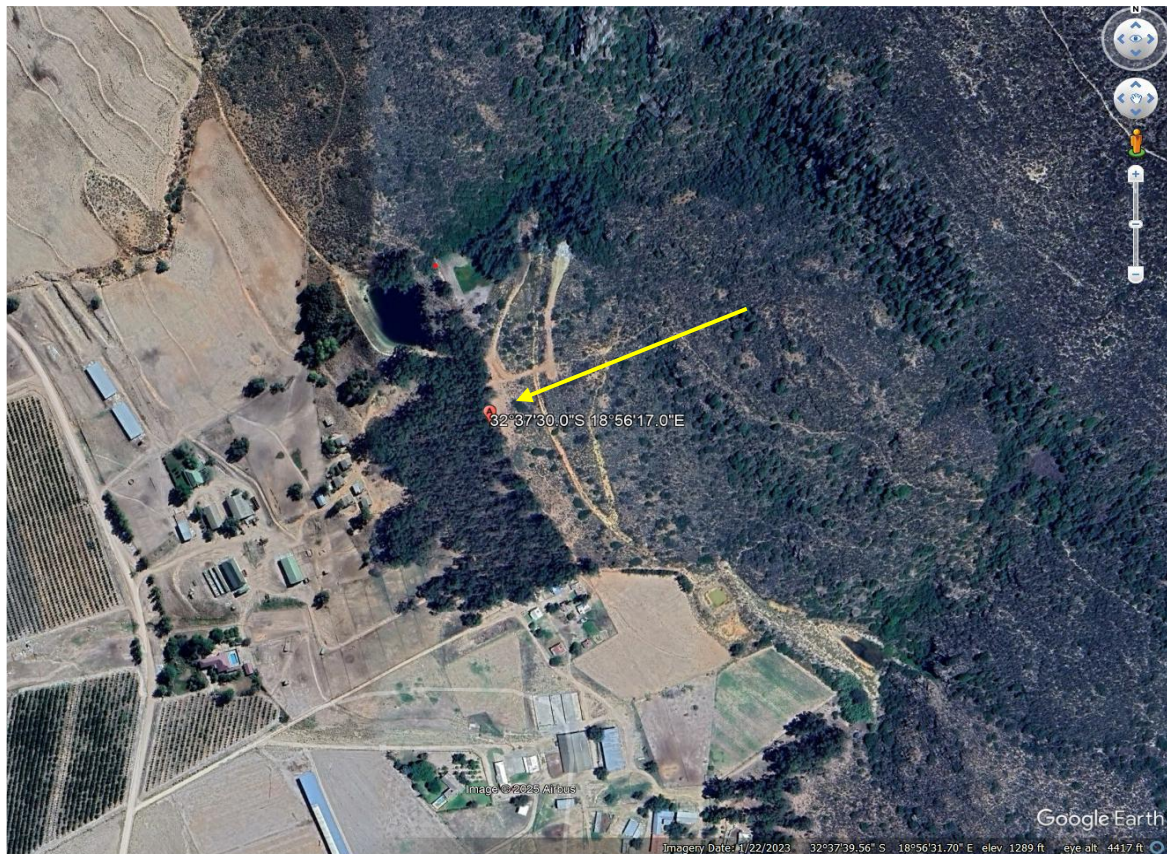
The accident occurred during daylight at Global Positioning System (GPS) co-ordinates determined to be 32°37'30.0" South 18°56'17.0" East, at an elevation of 442ft.

**Figure 1:** Aerial view of the approximate accident site (yellow arrow) on the leeward side of the mountain.  
(Source: Google Earth)
