AIRCRAFT ACCIDENT REPORT AND EXECUTIVE SUMMARY

Reference:		CA18/2/3/10585	
Aircraft Registration		ZS-WXE	Date of Accident		18 May 2025	Time of Accident	1330Z
Type of Aircraft		RANS S-10 Sakota		Type of Operation		Private (Part 94)	
Pilot-in-command Licence Type		Commercial Pilot Licence		Age	39	Licence Valid	Yes
Pilot-in-Command Flying Experience		Total Flying Hours		5956.4	Hours on Type	±2.6	
Last Point of Departure		Middleburg Aerodrome (FAMB), Mpumalanga Province					
Next Point of Intended Landing		Middleburg Aerodrome (FAMB), Mpumalanga Province					
Damage to Aircraft		Destroyed					
Location of the accident site with reference to easily defined geographical points (GPS readings if possible)							
Approximately 200m left of Runway 32 at Middleburg Aerodrome (FAMB) at GPS position: 25°41'25.94" South 029°26'39.04" East, an elevation of 4 860 feet (ft)							
Meteorological Information		Surface wind: 360°/5kt, temperature: 22°C, dew point 17°C, visibility: 9999m; QNH: 1022hPa

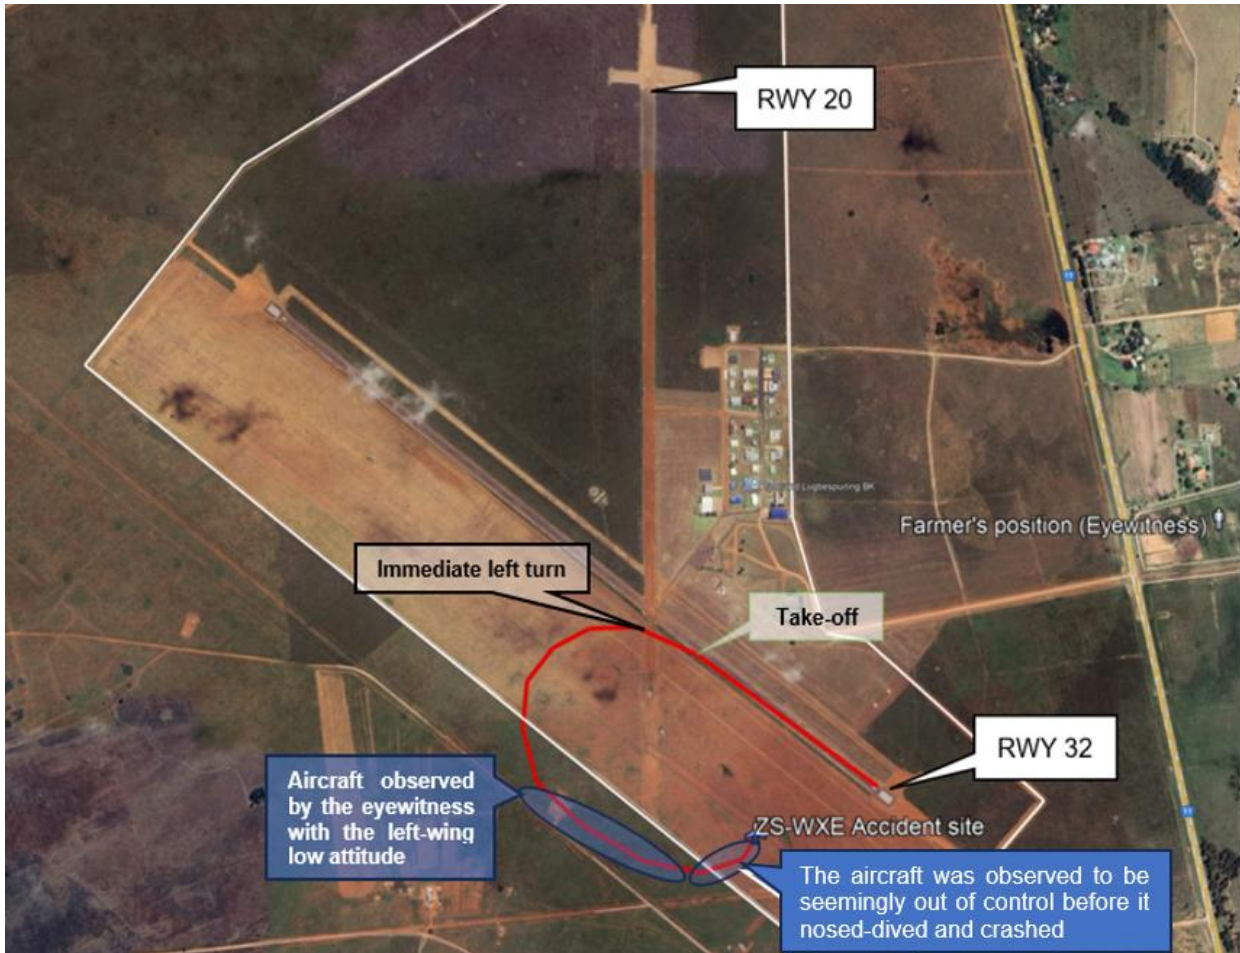
- 1.1.4. During the turn whilst at a left-wing low attitude, it appeared as though the pilot had lost control of the aircraft and it nose-dived before it crashed approximately 200 metres (m) to the left of RWY 32. A post-impact fire erupted and consumed the aircraft. A farmer who was approximately 1 kilometre (km) from the accident site rushed to the scene with a fire extinguisher after he had witnessed the crash. However, by the time he arrived at the scene, the aircraft was destroyed. Both occupants were fatally injured.

- 1.1.5. The accident occurred within the parameters of FAMB at Global Positioning System (GPS) co-ordinates determined to be 25°41'25.94" South 029°26'39.04" East, at an elevation of 4 860 ft.

Figure 1: An aerial view of the aircraft's approximate flight path and the accident site.
(Source: Google Earth)
