AIRCRAFT ACCIDENT REPORT AND EXECUTIVE SUMMARY

Reference:		CA18/2/3/10588	
Aircraft Registration	ZS-CZU	Date of Accident	8 June 2025		Time of Accident	1630Z	
Type of Aircraft	Piper PA-28-180		Type of Operation		Private (Part 91)		
Pilot-in-command Licence Type	Private Pilot Licence		Age	22	Licence Valid	Yes	
Pilot-in-command Flying Experience	Total Flying Hours		139.8		Hours on Type	118.5	
Last Point of Departure	Virginia Aerodrome (FAVG), KwaZulu-Natal Province						
Next Point of Intended Landing	Ladysmith Aerodrome (FALY), KwaZulu-Natal Province						
Damage to Aircraft	Substantial						
Location of the accident site with reference to easily defined geographical points (GPS readings if possible)							
Bloemhof Farm near Greytown (GPS position: 29°06'13.60" South 030°32'13.22" East)							
Meteorological Information	Instrument meteorological conditions prevailed with no reference to the ground						
Number of People On-board	2 + 0	Number of People Injured	1	Number of People Killed	0	Other (On Ground)	0

Synopsis							
<p>A Piper PA-28-180 aircraft with registration ZS-CZU was one of three aircraft that took off on a private flight from Virginia Aerodrome (FAVG) in KwaZulu-Nata

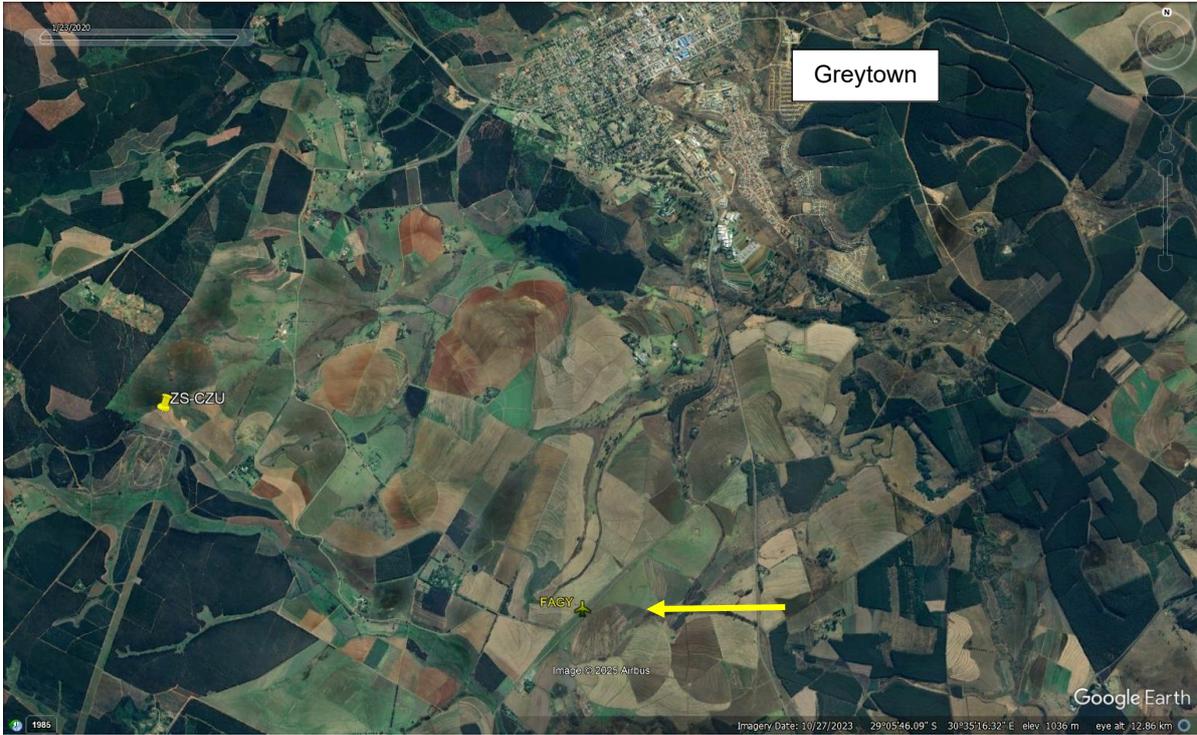
Figure 2: The position of ZS-CZU with reference to FAGY and Greytown. (Source: Google Earth)

3.2.18 Greytown Aerodrome (FAGY) was the crew's selected second alternate aerodrome on the filed flight plan. FAGY is licensed with runway lights and approach lights for Runway 24; however, the runway lights needed to be activated from the aircraft. The crew was unfamiliar with the procedure of switching on the lights. There was also a DVOR navigational beacon at the aerodrome. Furthermore, the aerodrome chart stated that "*to land at this facility at night, pilot(s) need to be IF-rated*"; neither of the crew members complied with this requirement. The accident site was 2.8nm west of FAGY (see Figure 2).

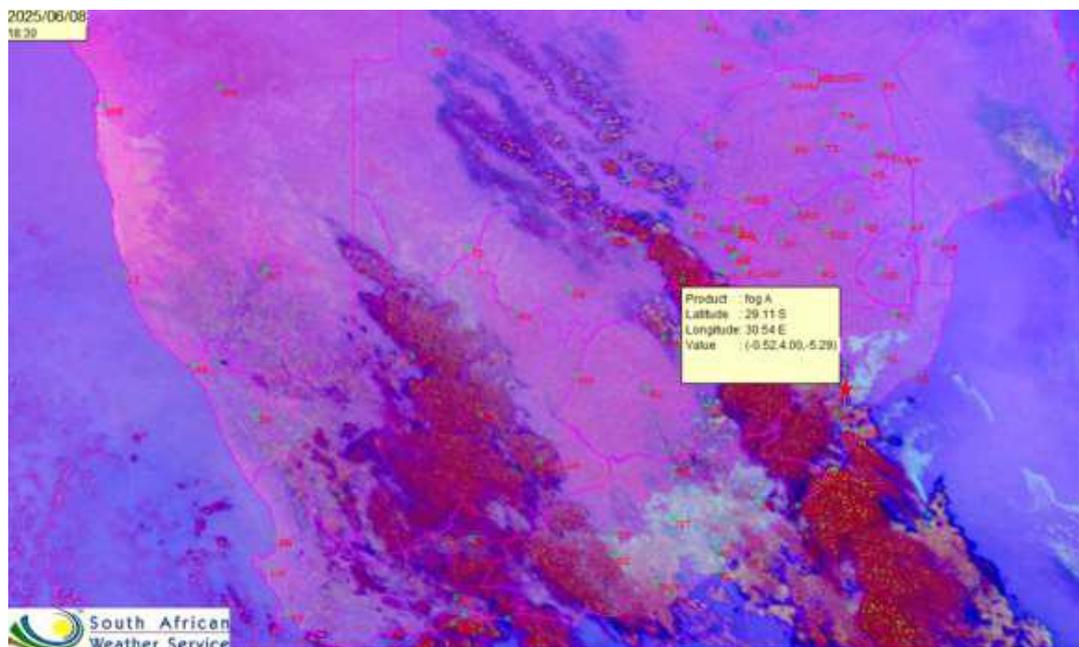
Satellite Image

The Night Microphysical RGB satellite imagery of the MeteoSat Second Generation (MSG) from EUMETSAT taken at 1830Z indicated low clouds in greyish colour with possible low visibility (see imagery). There were active thunderstorms to the south/south-west of the accident site.

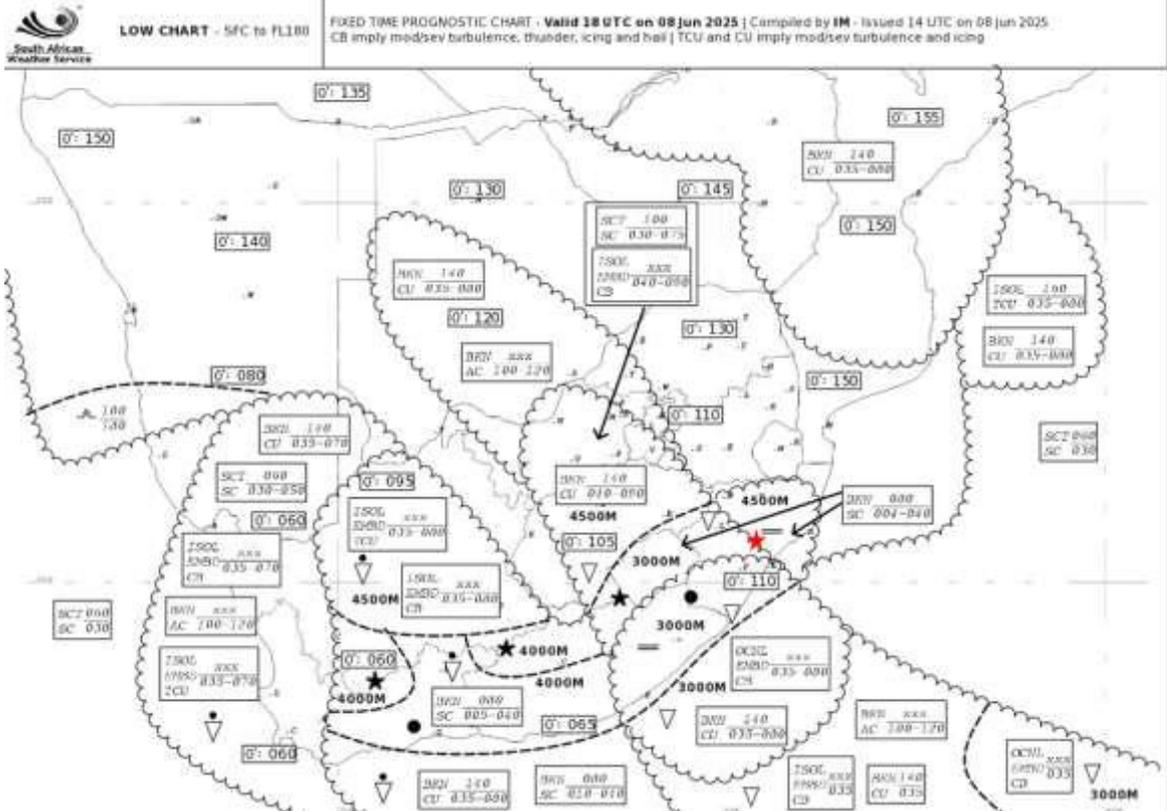
The low-level Significant Weather (SigWx) chart that was issued at 1400Z and valid for 1800Z on 8 June 2025, forecasted low-level cloud with reduced visibility in mist (see low-level chart). The forecast also showed that there were embedded cumulonimbus clouds in the vicinity where visibility was expected to reduce to 3000m in thundershowers. The site of the accident is approximated with a red star.

The 1800Z low-level SigWx chart for 8 June 2025.

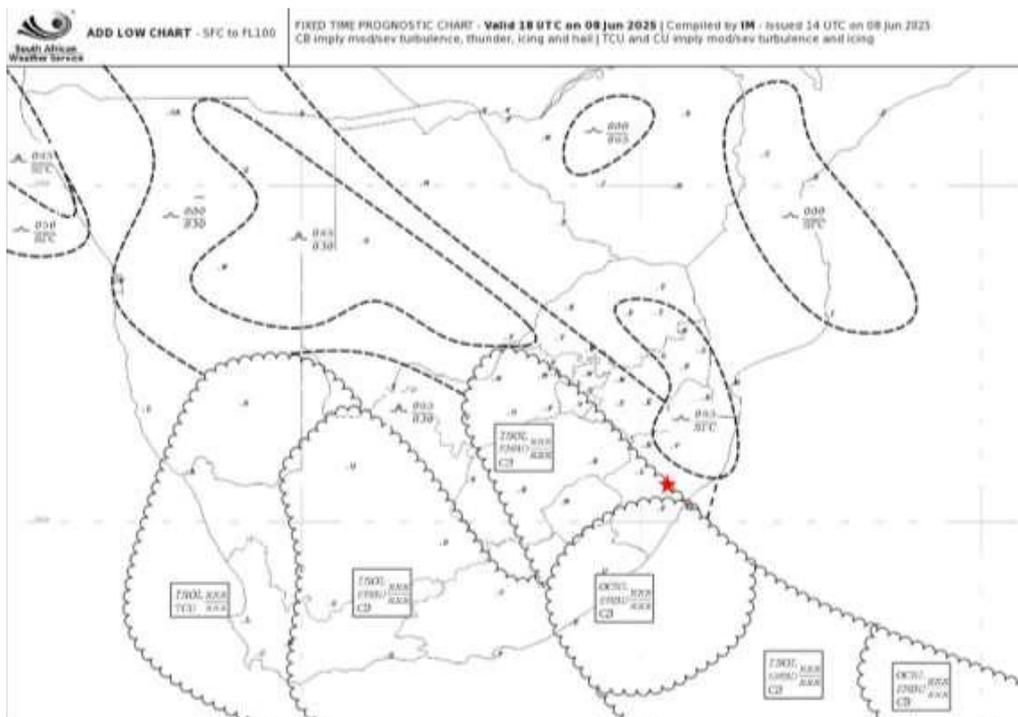
An additional low-level SigWx chart that was issued at 1400Z and valid for 1800Z on 8 June 2025 forecasted embedded cumulonimbus cloud with moderate low-level turbulence from surface to 8000ft, east/north-east of the accident site (see Figure 7). The red star (below) indicates the accident site.

The 1800Z additional low-level SigWx chart for 8 June 2025.

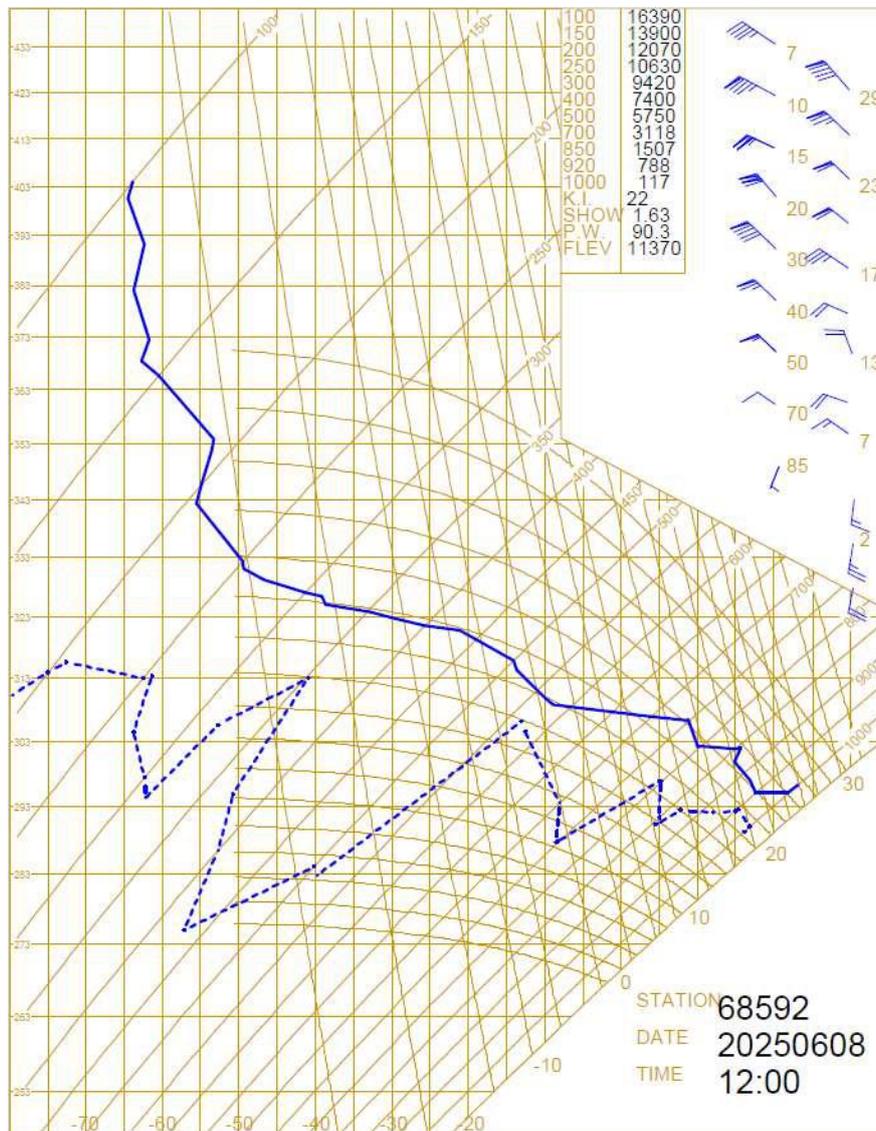
The 1200Z midday upper air ascent from FALE (68592) showed moist and unstable (K-index was 22) conditions. There was inversion at the surface, and the wind at the surface was a moderate to a strong southerly to south-westerly (20 to 25 kts above 850hPa in the lower level of the atmosphere).

The 1200Z midday upper air ascent from FALE for 8 June 2025.
