AIRCRAFT ACCIDENT REPORT AND EXECUTIVE SUMMARY

Reference:		CA18/2/3/10589	
Aircraft Registration	ZS-KFB	Date of Accident	08 June 2025		Time of Accident	Unknown	
Type of Aircraft	Piper 28-181 Archer II		Type of Operation		Private (Part 91)		
Pilot-in-command Licence Type	Private Pilot Licence (PPL)		Age	22	Licence Valid	Yes	
Pilot-in-command Flying Experience	Total Flying Hours		94.3	Hours on Type	88.3		
Last Point of Departure	Virginia Aerodrome (FAVG), KwaZulu-Natal Province						
Next Point of Intended Landing	Ladysmith Aerodrome (FALY), KwaZulu-Natal Province						
Damage to Aircraft	Destroyed						
Location of the accident site with reference to easily defined geographical points (GPS readings if possible)							
Approximately 3.6 nautical miles (nm) north-east of Hylton in KwaZulu-Natal Province (GPS position 29°12'07.2" South 030°22'32.4" East)							
Meteorological Information	Wind direction: 240° at 07 kts; visibility: 5000m; temperature: 14°C; dew point: 10°C; QNH: 1016 hPa

Synopsis

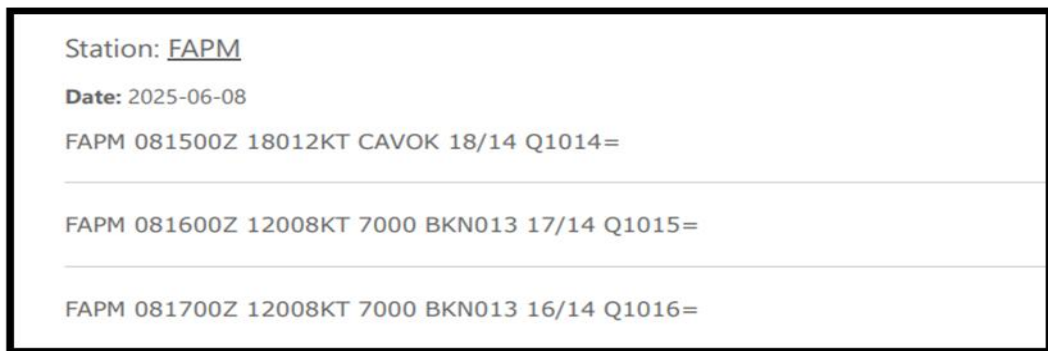
Figure 2: Metar on the day of the accident. (Source SAWS)

Wind Direction	240°	Wind Speed	07kt	Visibility	5000m
Temperature	14°C	Cloud Cover	Broken	Cloud Base	300 - 1500ft
Dew Point	10°C	QNH	1016hPa

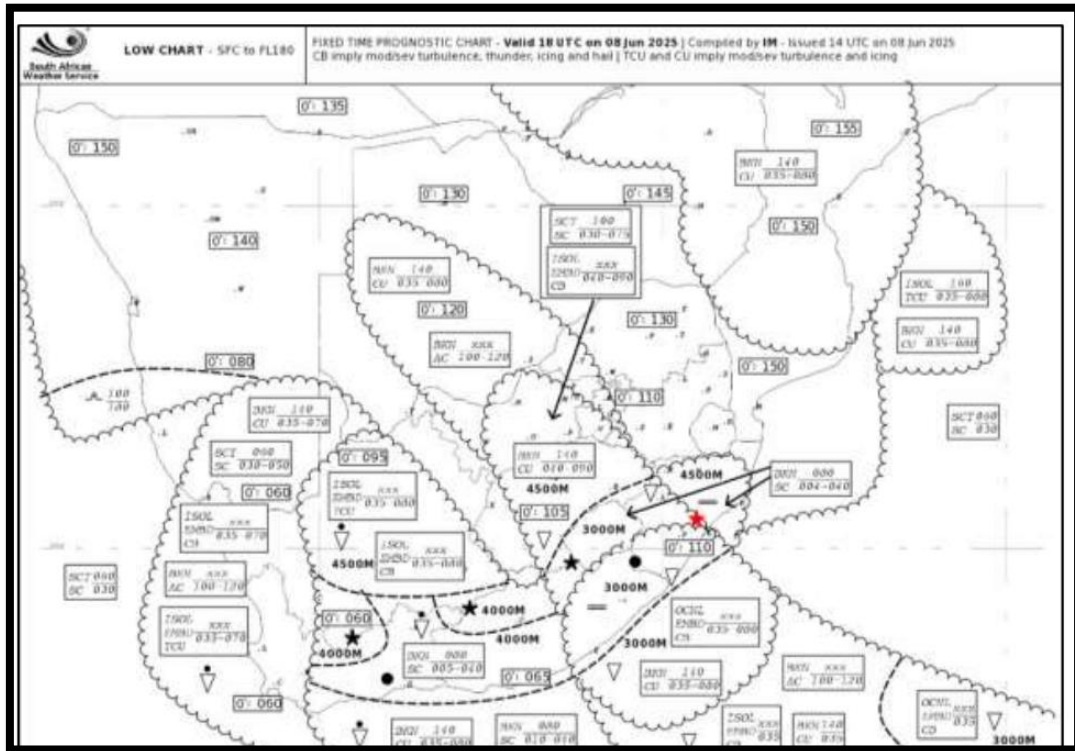
Figure 3: Low-level Significant Meteorological Information. (Source: SAWS)

1.7.3. *There was expected change in clouds becoming broken at 1500ft above ground level. The probability of thundershowers with cumulonimbus cloud at 3000ft and broken low-level cloud at 300ft above ground level were expected to reduce visibility to 5000m between 1800Z and 2100Z during the (approximated) time of accident.*

1.7.4. The low-level Significant Weather (SigWX) charts that were issued at 1400Z and valid for 1800Z on 8 June 2025, forecasted low-level cloud with reduced visibility in mist (see Figure 3). The forecast also showed embedded cumulonimbus clouds where visibility was expected to reduce to 3000M in thundershowers. The area of the accident is approximated with a red star.
