AIRCRAFT ACCIDENT REPORT AND EXECUTIVE SUMMARY

Reference:		CA18/2/3/10590	
Aircraft Registration	ZS-HFH	Date of Accident	22 June 2025		Time of Accident	0202Z	
Type of Aircraft	Robinson R44, Raven II		Type of Operation		Agricultural Operations (Part 137)		
Pilot-in-command Licence Type	Commercial Pilot Licence		Age	39	Licence Valid	Yes	
Pilot-in-command Flying Experience	Total Flying Hours		1 908.0		Hours on Type	Unknown	
Last Point of Departure	Metsi Berries Farm, Modimolle-Mookgopong, Limpopo Province						
Next Point of Intended Landing	Metsi Berries Farm, Modimolle-Mookgopong, Limpopo Province						
Damage to Aircraft	Destroyed						
Location of the accident site with reference to easily defined geographical points (GPS readings if possible)							
In a flooded ditch, approximately 600 metres (m) from the berries field at Global Positioning System (GPS) co-ordinates determined to be S24° 16'.40" E28° 39'.38", at an elevation of approximately 4 067ft

Occurrence Details

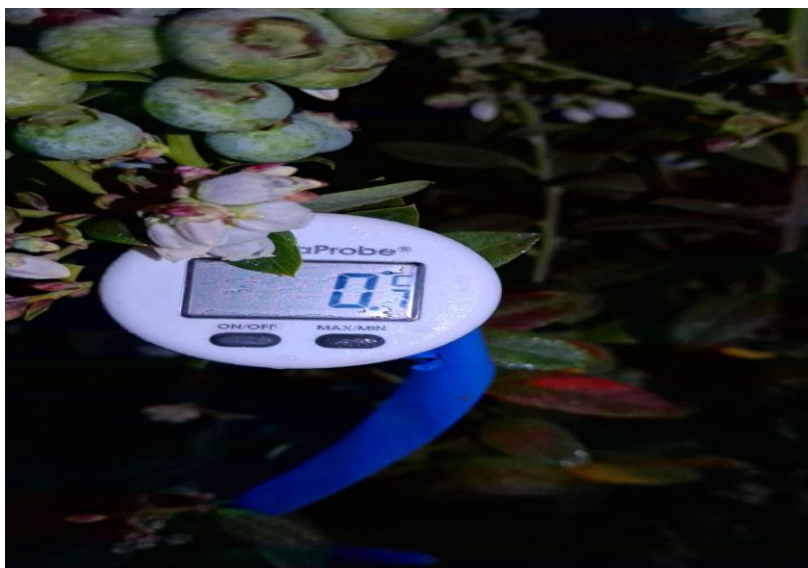
Figure 1: One of the temperature probes fitted to the berry crops (berries not ripe yet).
(Source: Farm production manager)

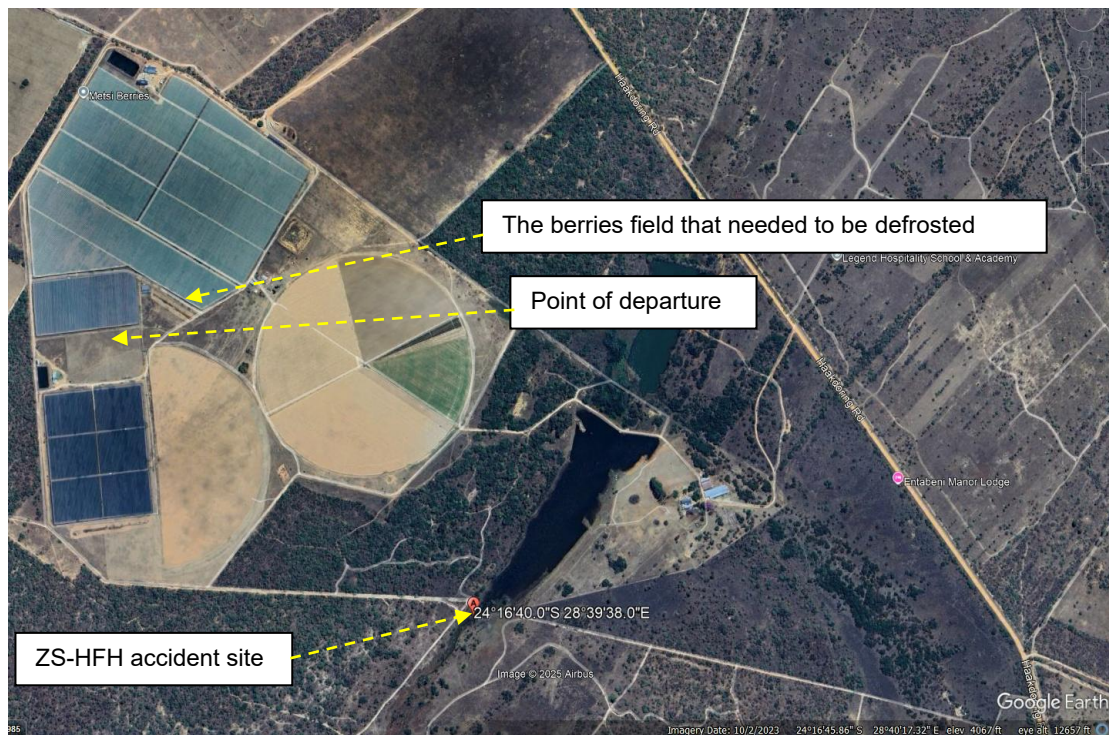
- 1.1.5 The accident occurred in a flooded ditch which stretched through the borders of Metsi Berries Farm in Modimolle-Mookgopong at Global Positioning System (GPS) co-ordinates determined to be S24°16'45.86'' E28°40'17.32'', at an elevation of 4 067 feet (ft).

Figure 2: An aerial view of the berries field that needed to be defrosted, the departure point, and the approximate accident site (red mark). (Source: Google Earth)

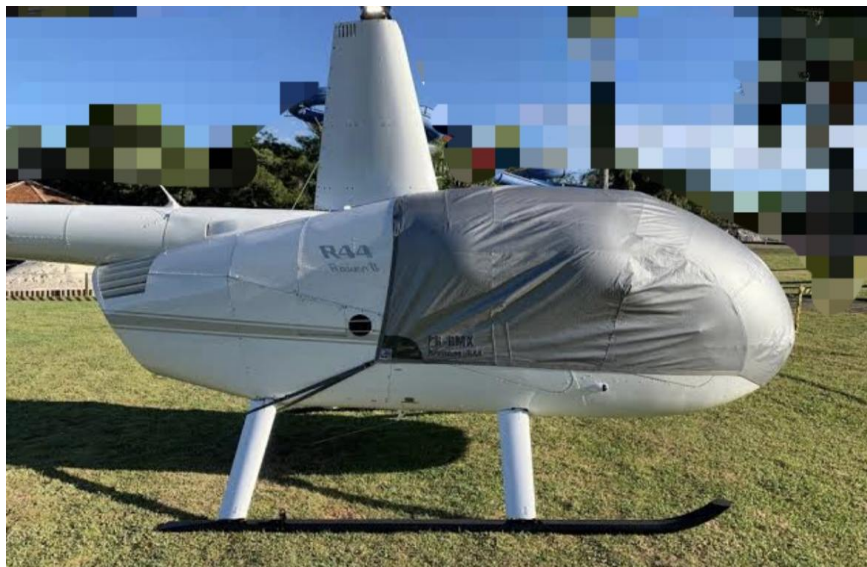
- 1.1.3 The manager did not recall the pilot cleaning or removing the frost off the windshield. Before the pilot started the engine, the manager had already driven off to the field where the crops needed to be defrosted, which was approximately 50 metres (m) from where the helicopter was parked. The pilot and the manager each used a portable two-way radio to communicate. The manager described the night around the accident flight as dark with no moon. After a few minutes, the manager heard the engine being started as he waited for the helicopter to arrive. The helicopter lifted off and all appeared normal because the pilot did not report any defects or technical difficulties. To his surprise, the helicopter did not fly north towards the 30.2-hectare berries field where defrosting was required; it flew south-easterly. According to the manager, in less than two minutes, the helicopter lights were out of his line of sight and behind some tall trees. He then heard a loud bang, approximately 600m from where the helicopter had lifted off. He immediately ran to his vehicle and drove towards the direction from which the loud bang had come. Upon arrival, he used his torch to scan the area, and he spotted the helicopter that was almost fully submerged in a flooded ditch; the tail boom was tilted up. He then called out to the pilot, but there was no response. Furthermore, there was no movement around the accident site.

Figure 13: An example of the Robinson R44 helicopter with the windshield cover on. (Source: <https://encryptedtbn0.gstatic.com/images?q=tbn:ANd9GcSkjXKaE75LIUYYVz5czVYg9QJMV63VBJmdfQ&usqp=CAU>)
