LIMITED OCCURRENCE INVESTIGATION REPORT – FINAL

Reference Number	CA18/2/3/10591					
Classification	Accident		Date	13 June 2025	Time	0839Z
Type of Operation	Private (Part 91)					
Location						
Place of Departure	Private Airstrip, Koppieskraal Pan, Northern Cape Province		Place of Intended Landing	Private Airstrip, Koppieskraal Pan, Northern Cape Province		
Place of Occurrence	Private Airstrip in Koppieskraal Pan, Northern Cape Province					
GPS Co-ordinates	Latitude	26°56'52.12"S	Longitude	20°18'32.27"E	Elevation	2 674 ft
Aircraft Information						
Registration	ZS-OYW					
Make; Model; S/N	Piper; PA-32R-301T (Serial No: 3257319)					
Damage to Aircraft	Substantial		Total Aircraft Hours	808.9		
Pilot-in-command						
Licence Type	Private Pilot Licence (PPL)		Gender	Male		Age 69
Licence Valid	Yes	Total Hours	746.1		Total Hours on Type	694.8
Total Hours 30 Days	6.4		Total Flying on Type Past 90 Days		6.4	
People On-board	1+2		Injuries	0		Fatalities 0 Other (on ground) 0

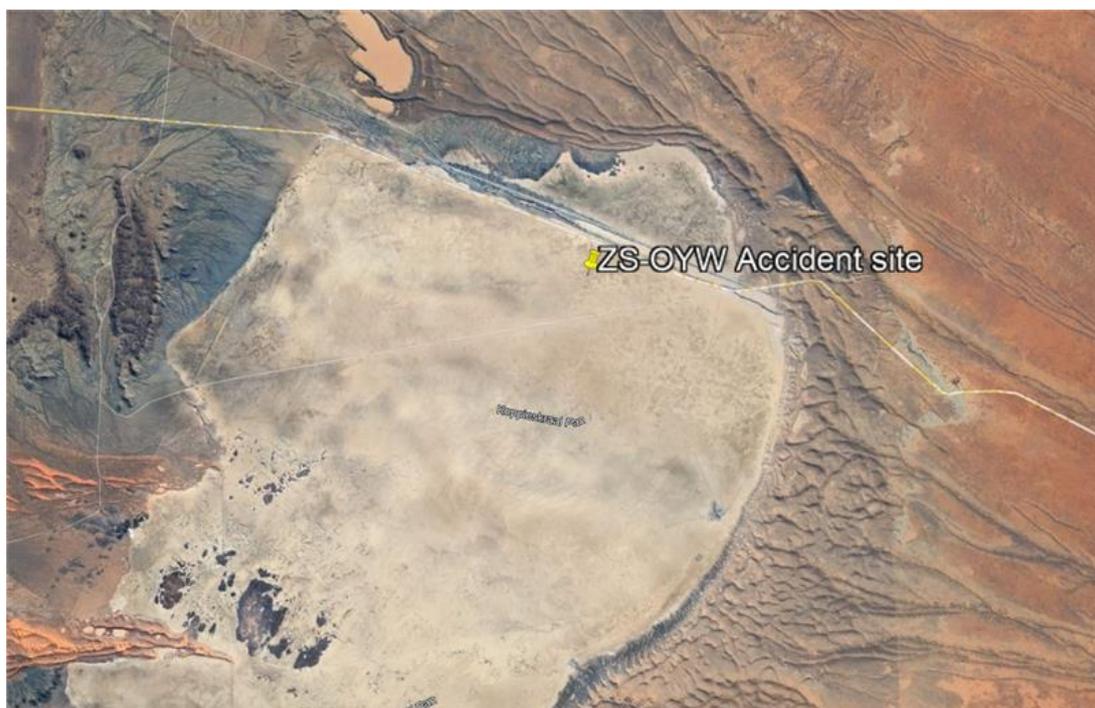
Meanwhile, the fuel bowser driver was contacted via a cellular phone and instructed to cross over the RWY01 to refuel several other aircraft that had parked on the left side of the runway. The driver, who was positioned on the right side of RWY 01, observed two of the three aircraft that took off and waited approximately 5 minutes to ensure that there was no visible aircraft activity before crossing over the runway. *The driver was not issued a radio to communicate with air traffic during the event or crossing of the runway.* The driver assumed that the runway was clear and proceeded to enter RWY 01. However, shortly thereafter, he observed an aircraft approaching on the runway during its take-off roll.

According to the ZS-OYW pilot, during the take-off roll whilst the aircraft was approximately 400 metres (m) from the threshold, he spotted the fuel bowser as it entered the runway from the right. The pilot attempted to avoid the vehicle by veering slightly to the left but despite the manoeuvre, the aircraft's right wing struck the truck and the aircraft's wing detached from the fuselage. Moreover, the left main landing gear collapsed, and the aircraft skidded on the ground before it stopped on the runway.

Figure 1: The accident site. (Source: Google Earth)

1. It is recommended that organisers of temporary airstrip events equip all ground vehicles, including fuel bowzers, with operational very high frequency (VHF) radios tuned to the event frequency to enable drivers to monitor and co-ordinate with aircraft and ground personnel. A simple, written event safety plan should be developed to define responsibilities, communication channels and operational procedures with all pilots and ground staff briefed before operations begin.
2. It is recommended that designated runway crossing points be established at temporary airstrip events, controlled by a trained marshal in direct radio contact with airborne and taxiing aircraft. Vehicle crossings should only be permitted once the marshal confirms the runway is clear, ensuring safe separation between aircraft operations and ground vehicle movements.
