LIMITED OCCURRENCE INVESTIGATION REPORT – FINAL

Reference Number	CA18/2/3/10594						
Classification	Accident		Date	3 August 2025		Time	0932Z
Type of Operation	Private (Part 94)						
Location							
Place of Departure	Worcester Airport (FAWC), Western Cape Province		Place of Intended Landing	Worcester Airport (FAWC), Western Cape Province			
Place of Occurrence	Theewaterskloof Local Municipality, Western Cape Province						
GPS Co-ordinates	Latitude	34° 08' 33.10" S	Longitude	19° 03' 06.41" E	Elevation	650 ft	
Aircraft Information							
Registration	ZT-GAE						
Make; Model; S/N	DG Flugzeugbau; DG800B (S/N: 8-87B23)						
Damage to Aircraft	Substantial			Total Aircraft Hours	1985		
Pilot-in-command							
Licence Type	Glider Pilot Licence (GPL)		Gender	Male		Age	73
Licence Valid	Yes	Total Hours	1983.4		Total Hours on Type	1068	
Total Hours 30 Days	8.2		Total Flying on Type Past 90 Days	16.7			
People On-board	1+0	Injuries	0	Fatalities	0	Other (on ground)	0

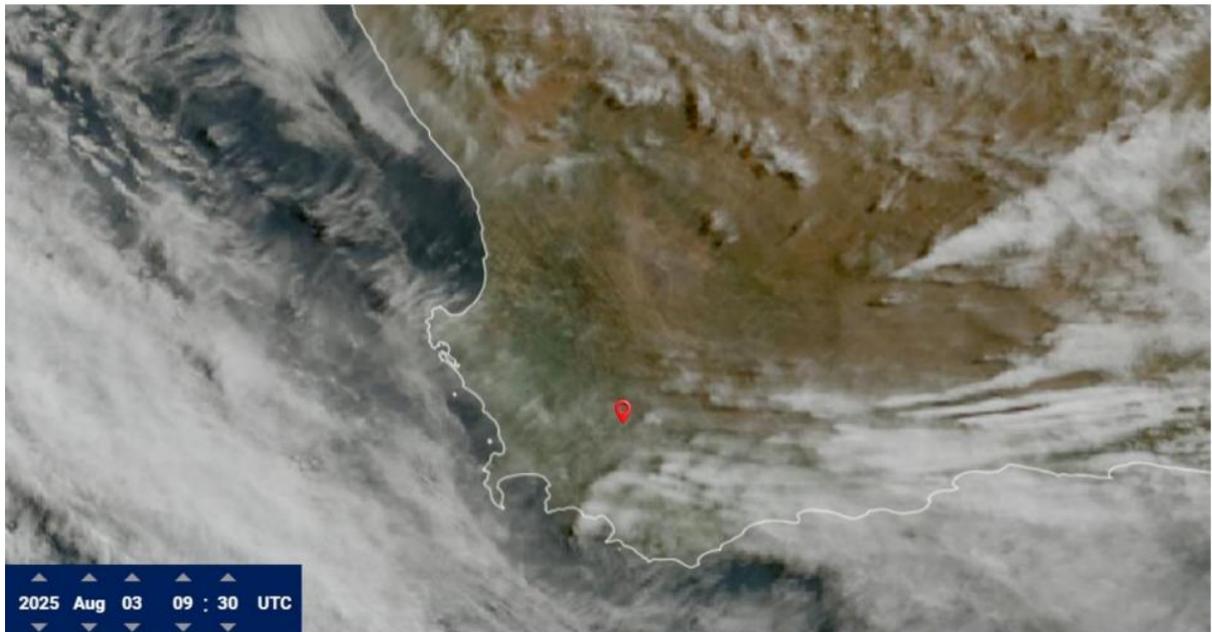
Figure 2: The MeteoSat Third Generation (MTG) True Colour RGB satellite imagery was taken at 09:30 Z on 03 August 2025 (copyright Eumetsat).

The satellite imagery above indicates that there were no significant clouds; only high-level clouds at the time of the accident. The forecast indicated the possibility of severe mountain waves and turbulence from the surface to about 8000 ft, as well as moderate turbulence between 18000 ft and

24000 ft. A warning was issued about severe mountain waves forecasted nearest to the area (site) and time of the accident.
