**LIMITED OCCURRENCE INVESTIGATION REPORT – FINAL**

<b>Reference Number</b>	CA18/2/3/10604						
<b>Classification</b>	Accident		<b>Date</b>	11 September 2025		<b>Time</b>	0704Z
<b>Type of Operation</b>	Agriculture (Part 137)						
<b>Location</b>							
Place of Departure	Eenboom Farm Airstrip, Swartland, Western Cape Province		Place of Intended Landing		Eenboom Farm Airstrip, Swartland, Western Cape Province		
Place of Occurrence	Eenboom Farm Airstrip, Swartland, Western Cape Province						
GPS Co-ordinates	Latitude	33°09'36.4" S	Longitude	18°35'28.6" E	Elevation	2 473.8 ft	
<b>Aircraft Information</b>							
Registration	ZS-OGP						
Make; Model; S/N	Air Tractor; AT-402A (Serial Number: 402A-1057)						
Damage to Aircraft	Substantial			Total Aircraft Hours	13 006,5		
<b>Pilot-in-command</b>							
Licence Type	Commercial Pilot Licence (CPL)		Gender	Male		Age	42
Licence Valid	Yes	Total Hours	1 838		Total Hours on Type	113.5	
Total Hours 30 Days	44.60		Total Flying on Type Past 90 Days		113.5

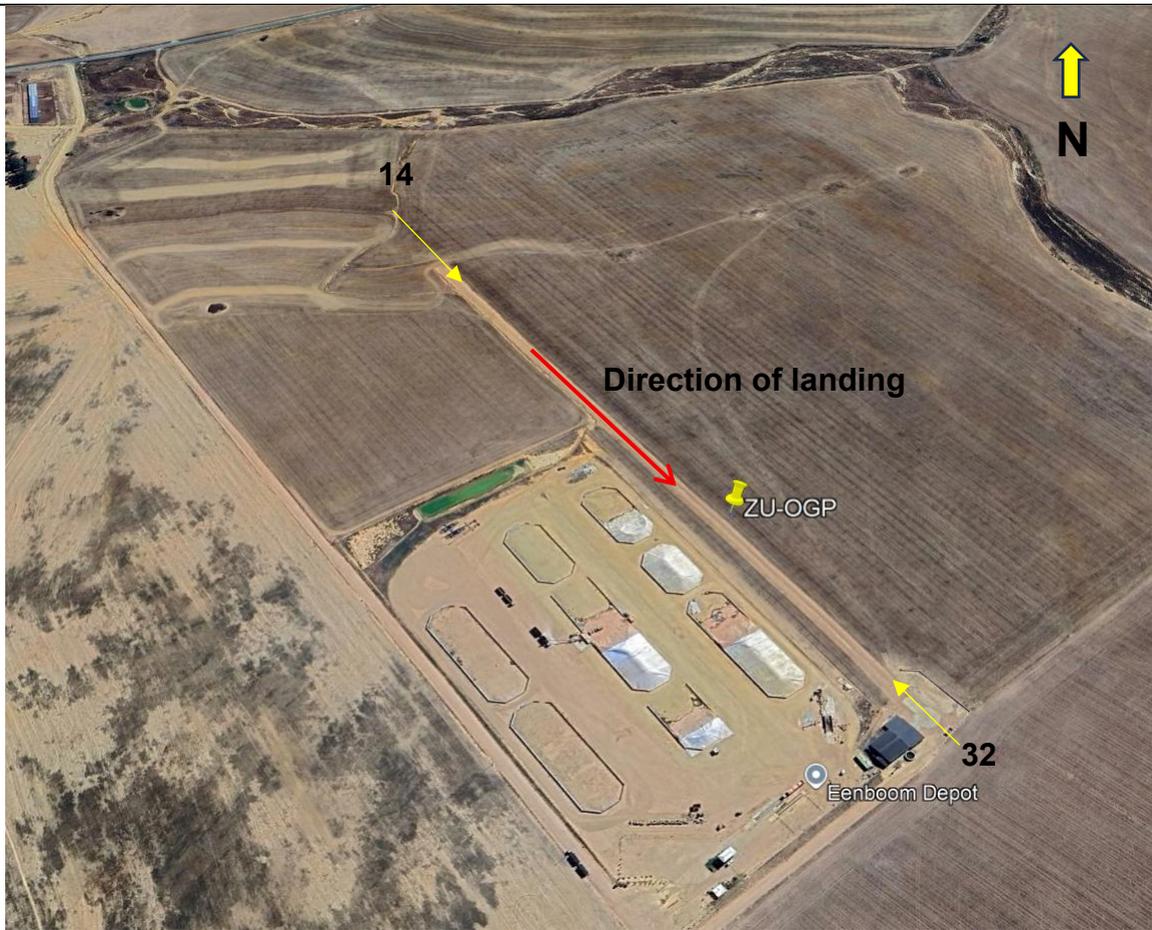
**Figure 1:** An aerial view of the airstrip, the direction of landing (red arrow) and the approximate area where the aircraft came to a stop. Runway 14 was in use at the time of the accident. (Source: Google Earth)

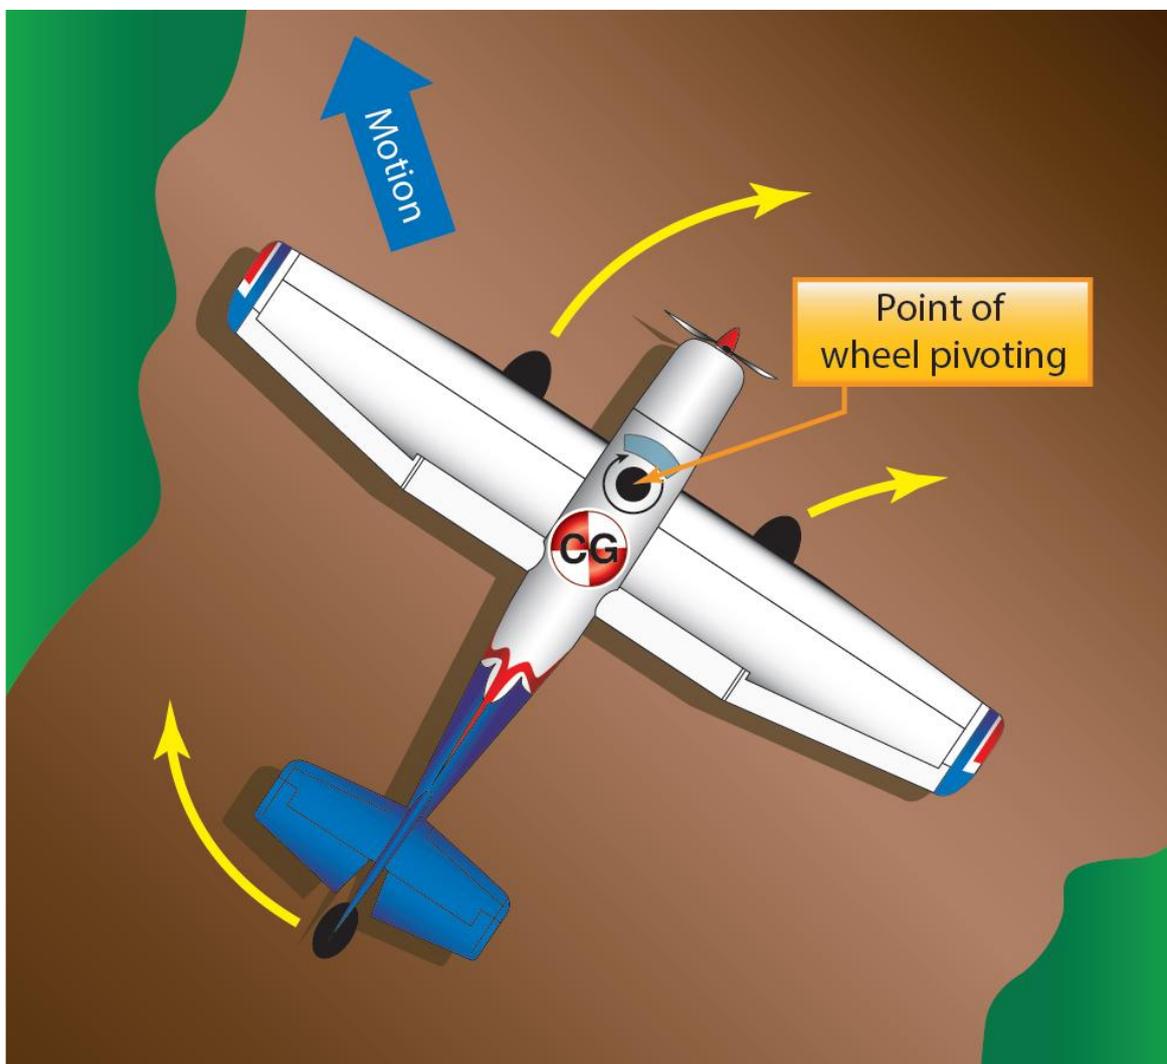
**Figure 5:** Effect of center-of-gravity (CG) on directional control.
