LIMITED OCCURRENCE INVESTIGATION REPORT – FINAL

Reference Number		CA18/2/3/10605					
Classification	Accident	Date	4 October 2025			Time	1200Z
Type of Operation	Private (Part 94)						
Location							
Place of Departure	Vleesbank Private Farm Airstrip, Western Cape Province			Place of Intended Landing	Vleesbank Private Farm Airstrip, Western Cape Province		
Place of Occurrence	On a grass-covered runway at Vleesbank Private Farm Airstrip, Western Cape Province						
GPS Co-ordinates	Latitude	33° 29' 35.39" S	Longitude	018° 59' 3.69" E	Elevation	264 ft	
Aircraft Information							
Registration	ZU-EMD						
Make; Model; S/N	Magni; Gyroplane-M22 (Serial Number: 22063904)						
Damage to Aircraft	Substantial			Total Aircraft Hours	705.5		
Pilot-in-command							
Licence Type	National Pilot Licence (NPL)		Gender	Male	Age	47	
Licence Valid	Yes	Total Hours	46.4		Total Hours on Type	18.8	
Total Hours 30 Days	5.6		Total Flying on Type Past 90 Days			13.8	
People On-board	1+1	Injuries	0	Fatalities	0	Other (on ground)	0

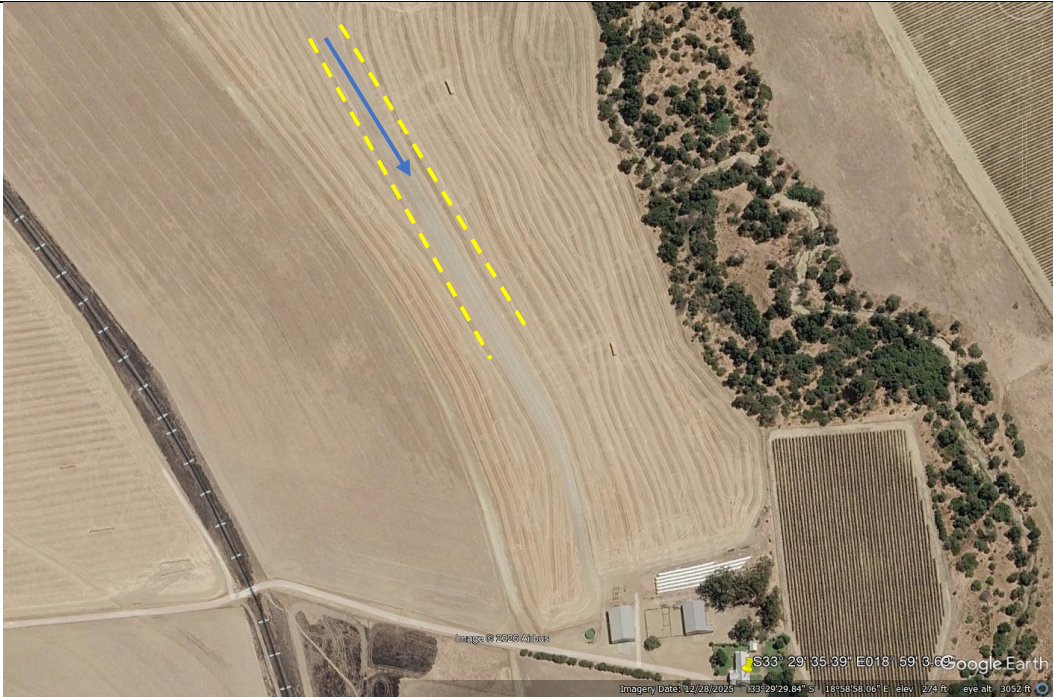
Figure 1: The grass runway at Vleesbank Farm (yellow lines) and the Gyroplane's direction of landing. (Source: Google Earth)
