**LIMITED OCCURRENCE INVESTIGATION REPORT – FINAL**

<b>Reference Number</b>	CA18/2/3/10615						
<b>Classification</b>	Accident		<b>Date</b>	11 November 2025		<b>Time</b>	1245Z
<b>Type of Operation</b>	Training (Part 141)						
<b>Location</b>							
Place of Departure	Springs Airfield (FASI), Gauteng Province		Place of Intended Landing	Springs Airfield (FASI), Gauteng Province			
Place of Occurrence	Runway 03 at Springs Airfield (FASI), Gauteng Province						
GPS Co-ordinates	Latitude	26° 14' 58" S	Longitude	28° 23' 54" E	Elevation	5 340ft	
<b>Aircraft Information</b>							
Registration	ZS-ISI						
Make; Model; S/N	Piper; PA-28-180 (Serial Number: 28-474)						
Damage to Aircraft	Substantial			Total Aircraft Hours	8 291.8		
<b>Pilot-in-command</b>							
Licence Type	Student Pilot Licence (SPL)		Gender	Female		Age	20
Licence Valid	Yes	Total Hours	42.3		Total Hours on Type	42.3	
Total Hours 30 Days	9.7		Total Flying on Type Past 90 Days	10.6			
<b>People On-board</b>	1+0	<b>Injuries</b>	0	<b>Fatalities</b>	0	<b>Other (on ground)</b>	0

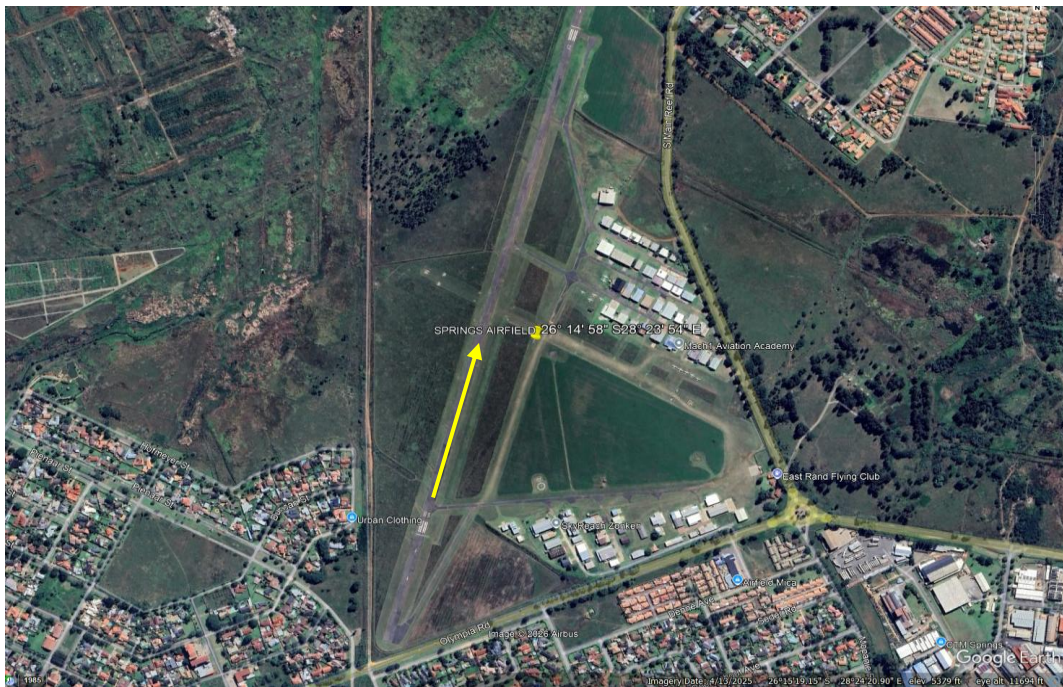
**Figure 1:** The yellow arrow indicates the landing direction. (Source: Google Earth)

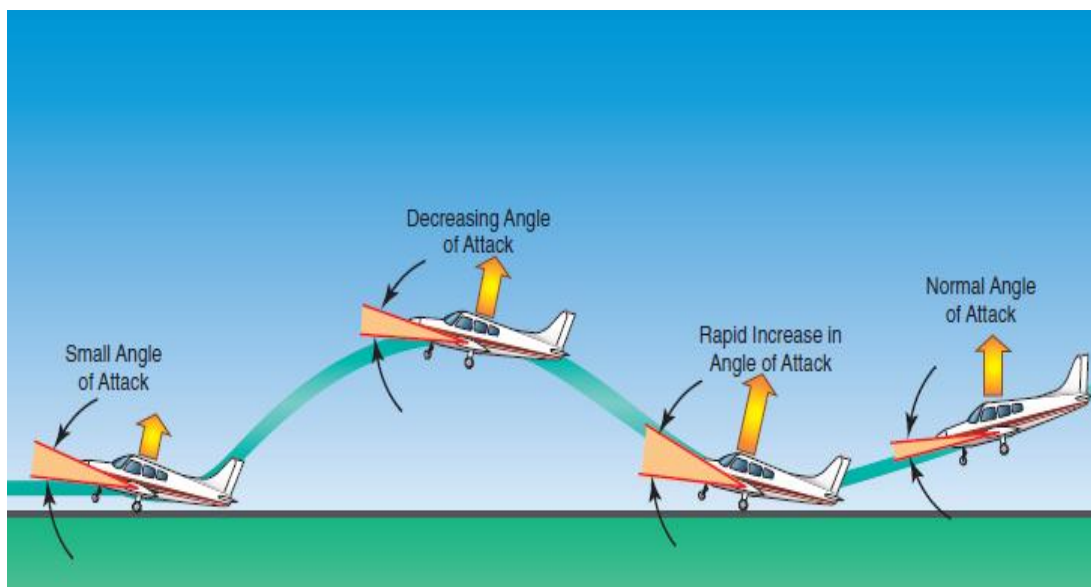
*When the aeroplane contacts the ground with a sharp impact as the result of an improper attitude or an excessive rate of sink, it tends to bounce back into the air. When a bounce is severe, the safest procedure is to execute a go-around immediately. No attempt to salvage the landing should be made. Full power should be applied while simultaneously maintaining directional control and lowering the nose to a safe climb attitude. The go-around procedure should be continued even though the airplane may descend, and another bounce may be encountered. It would be extremely foolish to attempt a landing from a bad bounce since airspeed diminishes very rapidly in the nose-high attitude, and a stall may occur before a subsequent touchdown could be made.*

**Illustration 1:** A depiction of a bounce. (Source: FAA-Aeroplane Flying Handbook)
