## LIMITED OCCURRENCE INVESTIGATION REPORT – FINAL

<b>Reference Number</b>	CA18/2/3/10628						
<b>Classification</b>	Accident		<b>Date</b>	30 December 2025		<b>Time</b>	1000Z
<b>Type of Operation</b>	Training (Part 141)						
<b>Location</b>							
Place of Departure	Secunda Aerodrome (FASC), Mpumalanga Province		Place of Intended Landing		Secunda Aerodrome (FASC), Mpumalanga Province		
Place of Occurrence	On Runway 25 at Vlakspruit Farm Airstrip						
GPS Co-ordinates	Latitude	26°35'49.3" S	Longitude	29°17'18.8" E	Elevation	5 421 ft	
<b>Aircraft Information</b>							
Registration	ZS-ETL						
Make; Model; S/N	Cessna; 172H (Serial Number: 172-55746)						
Damage to Aircraft	Substantial			Total Aircraft Hours	16 339.1		
<b>Pilot-in-command</b>							
Licence Type	Student Pilot Licence (SPL)		Gender	Male		Age	18
Licence Valid	No	Total Hours	52.1		Total Hours on Type	5.4	
Total Hours 30 Days	2.9		Total Flying on Type Past 90 Days		5.4		
<b>People On-board</b>	1 + 0	<b>Injuries</b>	0	<b>Fatalities</b>	0	<b>Other (on ground)</b>	0

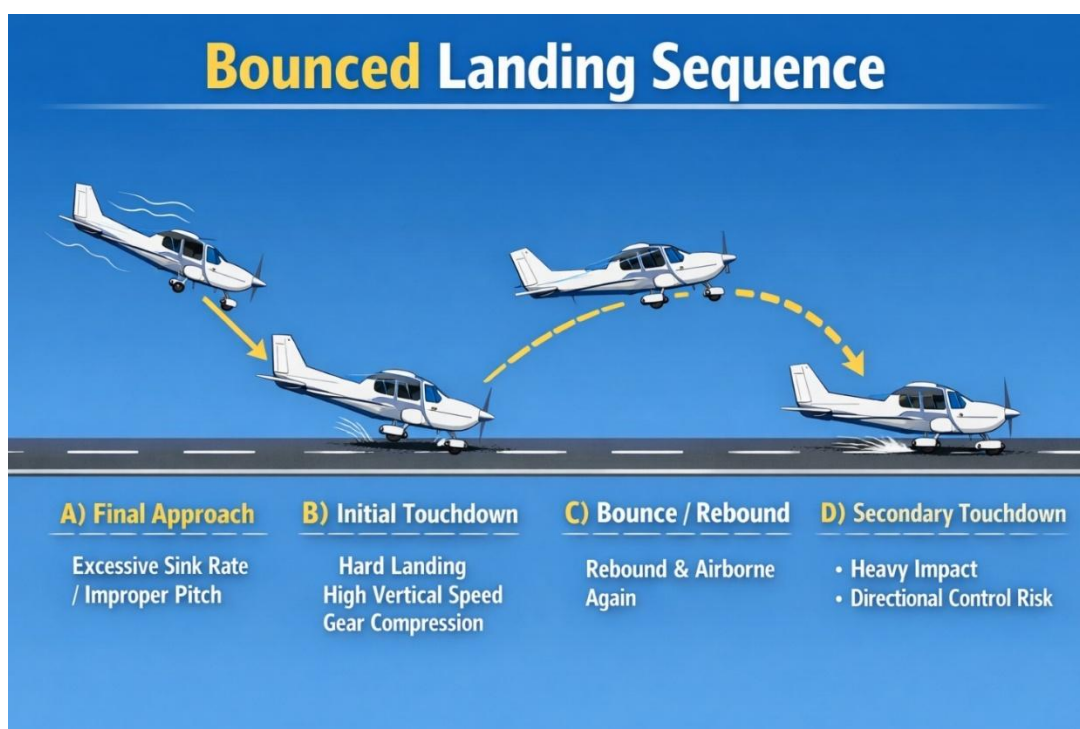
Figure 3: Illustration of a bounced landing sequence.

The aircraft approaches the runway with excessive airspeed, insufficient flare or improper pitch attitude. Gusty or turbulent conditions may further destabilise the approach.

The aircraft contacts the runway with a high rate of descent or nose-low attitude. The landing gear compresses rapidly, storing energy in the shock struts.

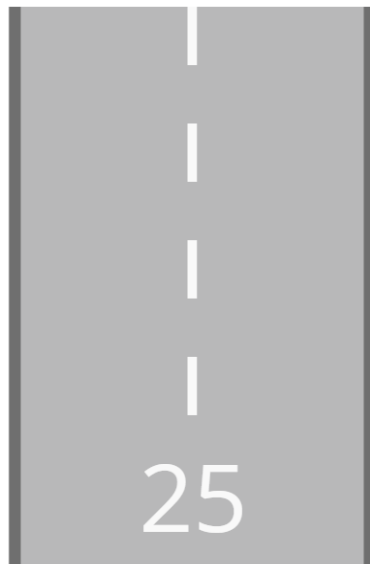
Wind: 28007KT

Headwind: 6.06 KT

Crosswind RHS: 3.5 KT

Based on the POH, the aircraft was certified to safely handle direct crosswinds of up to 15 miles per hour (mph) (13 knots). The crosswind component was approximately 3.5 knots, and it was well within the operational safety limits.
