## AIRCRAFT ACCIDENT REPORT AND EXECUTIVE SUMMARY

| | | | | <b>Reference:</b> | | CA18/2/3/10634 | |
| <b>Aircraft Registration</b> | ZS-EXR | <b>Date of Accident</b> | 4 February 2026 | | <b>Time of Accident</b> | 0530Z | |
| <b>Type of Aircraft</b> | Piper PA-28-140 Cherokee | | <b>Type of Operation</b> | | Training (Part 141) | | |

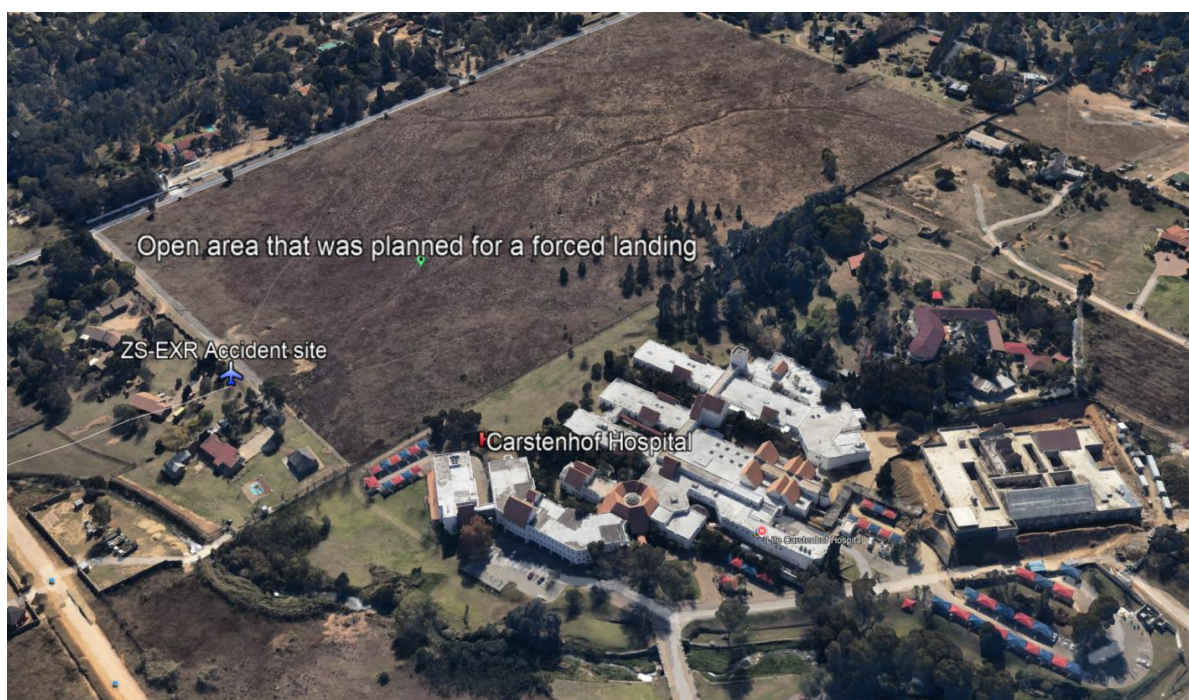
**Figure 5:** Overview of the accident site. (Source: Google Earth)

1.12.1. The aircraft lost height above a residential property in Austin View and crashed near a field behind Carstenhof Hospital. The property had tall trees.

1.12.2. After the engine failed during the downwind leg, the FI opted to conduct a forced landing on an open field. However, the aircraft, which was descending, was unable to clear the residential property next to the field and it clipped the treetops in its path. This was evidenced by a trail of broken branches along its projected flight path as it continued in a downward trajectory.
