## AIRCRAFT ACCIDENT REPORT AND EXECUTIVE SUMMARY

| <b>Aircraft Registration</b> | <b>ZS-PWN</b> | <b>Date of Accident</b> | 14 February 2026 | | <b>Time of Accident</b> | 0838Z | |
| <b>Type of Aircraft</b> | Cessna U206F | | | <b>Type of Operation</b> | Air Transport Operations (Part 135) | | |

| <b>Reference Number</b> | : CA18/3/2/10636 |

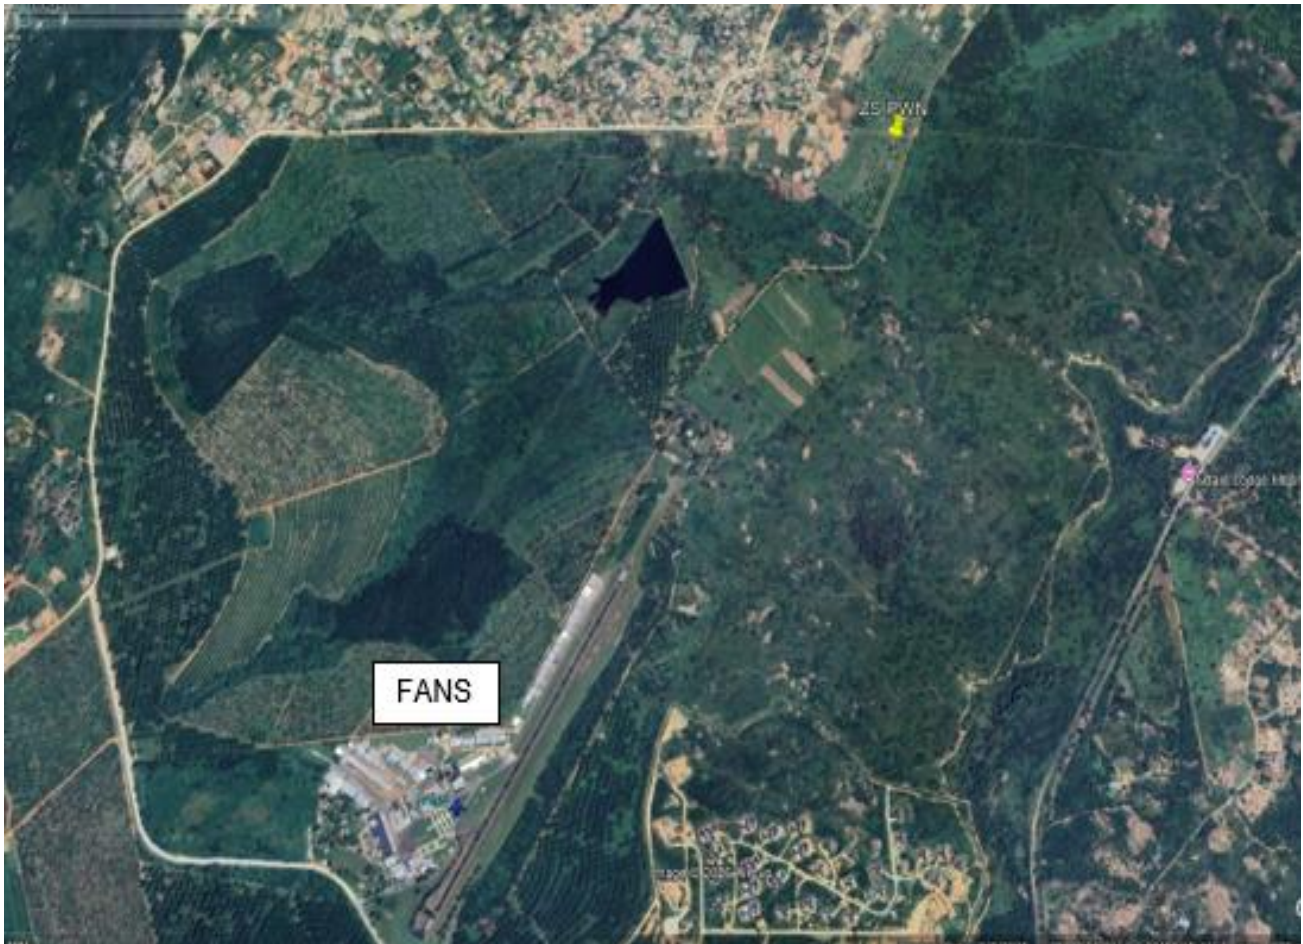
- 1.1.10. The accident occurred during daylight at Global Positioning System (GPS) co-ordinates determined to be 25°29'03.83" South 030°55'24.15" East, at an elevation of 2 610ft.

**Figure 1:** The aircraft was forced landed 0.84 nautical miles from FANS's Runway 22 threshold.  
(Source: Google Earth)

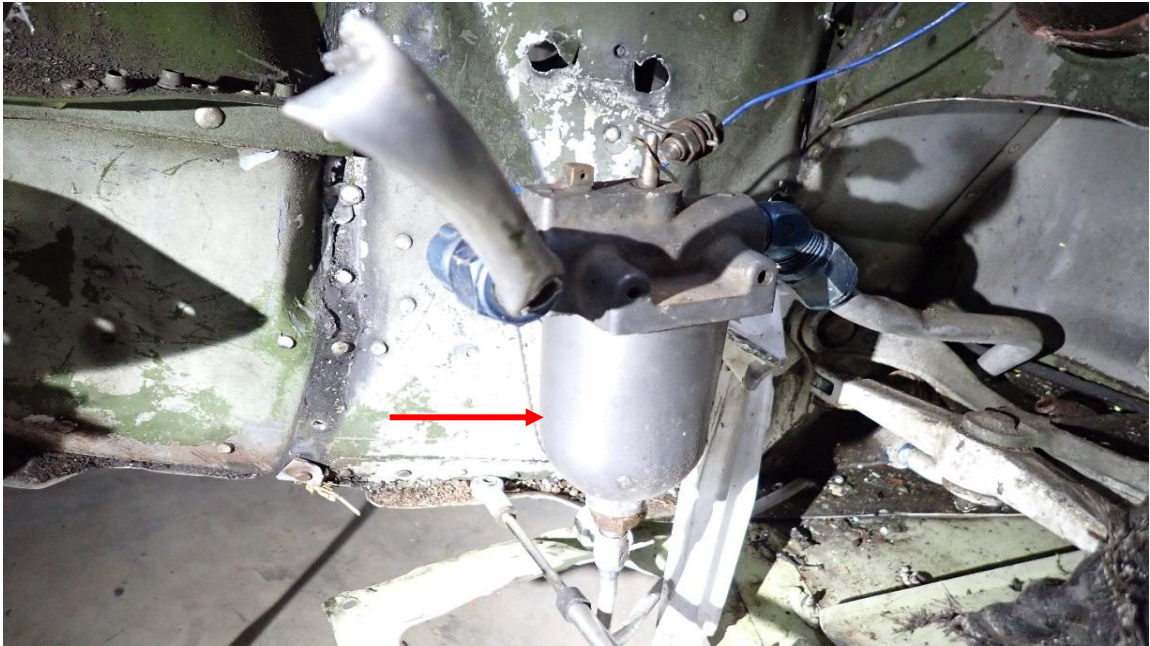
The fuel strainer was removed and inspected; the bowl contained fuel and a small amount of sediment. The filter assembly gasket was found misaligned (see Figures 11 and 12), partially restricting fuel passage to the engine-driven fuel pump.

**Figure 10:** The fuel strainer secured to the airframe (inside the nose gear wheel well).

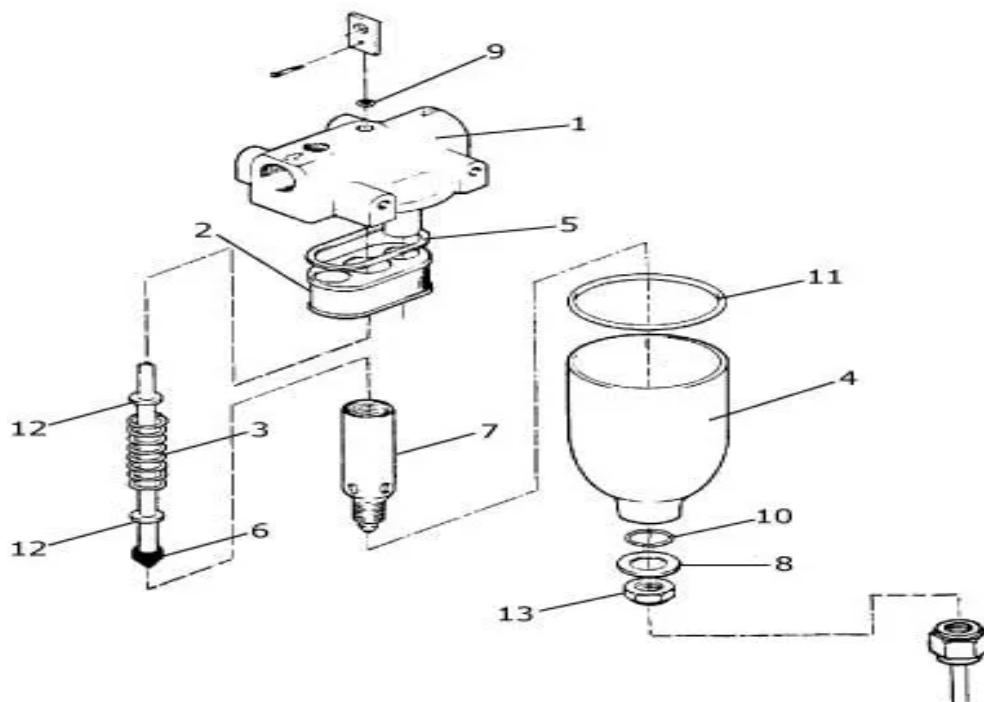
**Diagram 1:** Fuel strainer and associated components.

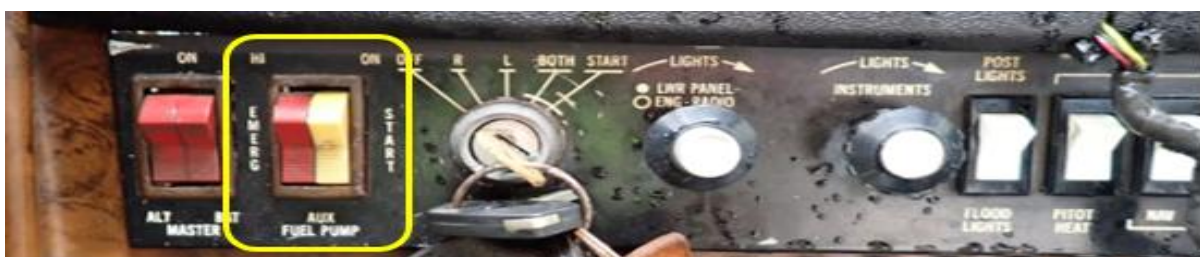
**Figure 13:** The auxiliary fuel pump switch in the cockpit of ZS-PWN.
