LIMITED OCCURRENCE INVESTIGATION REPORT – FINAL

Reference Number	CA18/2/3/10639						
Classification	Accident	Date	25 February 2026	Time	0747Z		
Type of Operation	Aerial Work Operations (Part 137)						
Location							
Place of Departure	Denneoord Aerial Fire Base, George, Western Cape Province		Place of Intended Landing	Knysna Highway Aerodrome, Western Cape Province			
Place of Occurrence	On Runway 13, Knysna Highway Aerodrome, Western Cape Province						
GPS Co-ordinates	Latitude	33°57'01.18" S	Longitude	022°58'35.67" E	Elevation	785 feet	
Aircraft Information							
Registration	ZS-PFS						
Make; Model; S/N	Cessna, U206 (Serial Number: U206-0323)						
Damage to Aircraft	Substantial		Total Aircraft Hours	12 218.6			
Pilot-in-command							
Licence Type	Commercial Pilot Licence		Gender	Male		Age	53
Licence Valid	Yes	Total Hours	1 226.2		Total Hours on Type	107.5	
Total Hours 30 Days	34.2		Total Flying on Type Past 90 Days	20.7			
People On-board	1 + 0	Injuries	0	Fatalities	0	Other (on ground)	0

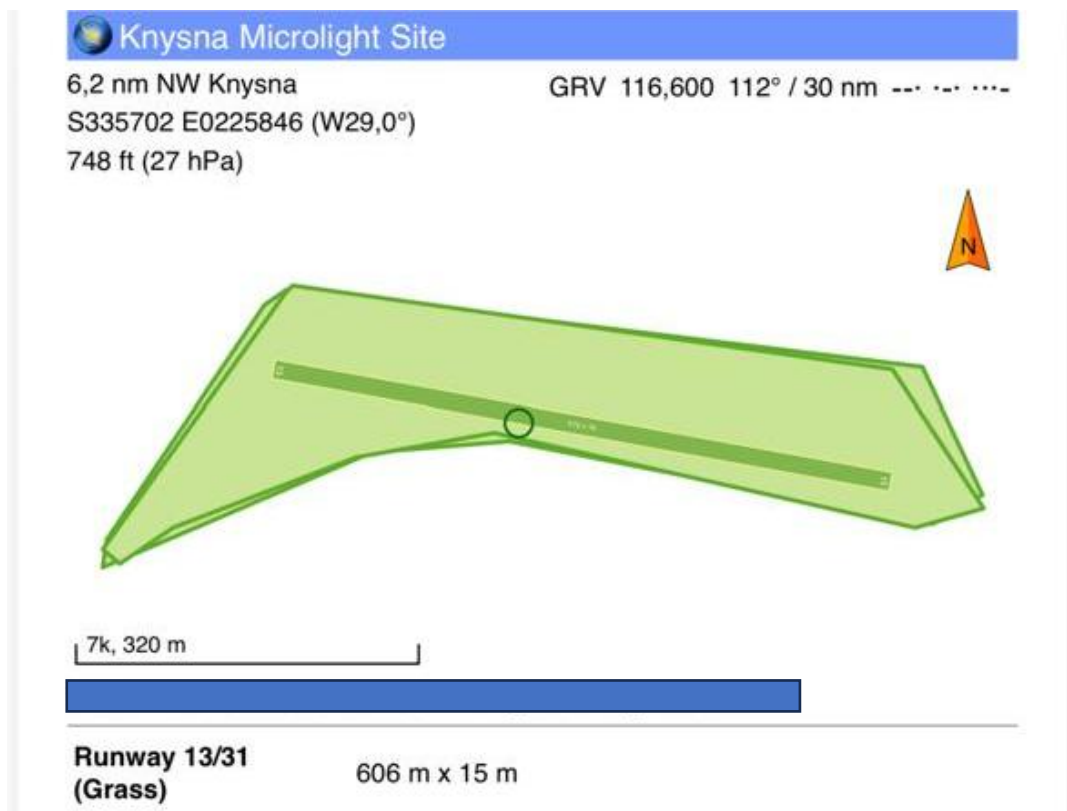
Diagram 1: Aerodrome layout chart.

The Knysna Highway Aerodrome is unlicensed. It has a single runway with a grass-covered surface orientated 13/31. The runway is 606m long and 15m wide.
