## LIMITED OCCURRENCE INVESTIGATION REPORT – FINAL

| <b>Reference Number</b> | CA18/2/3/10645 | | | | | | |
| Registration | ZU-CKU | | | | | | |
| Make; Model; S/N | Jabiru SP (Serial Number: 421) | | | | | | |

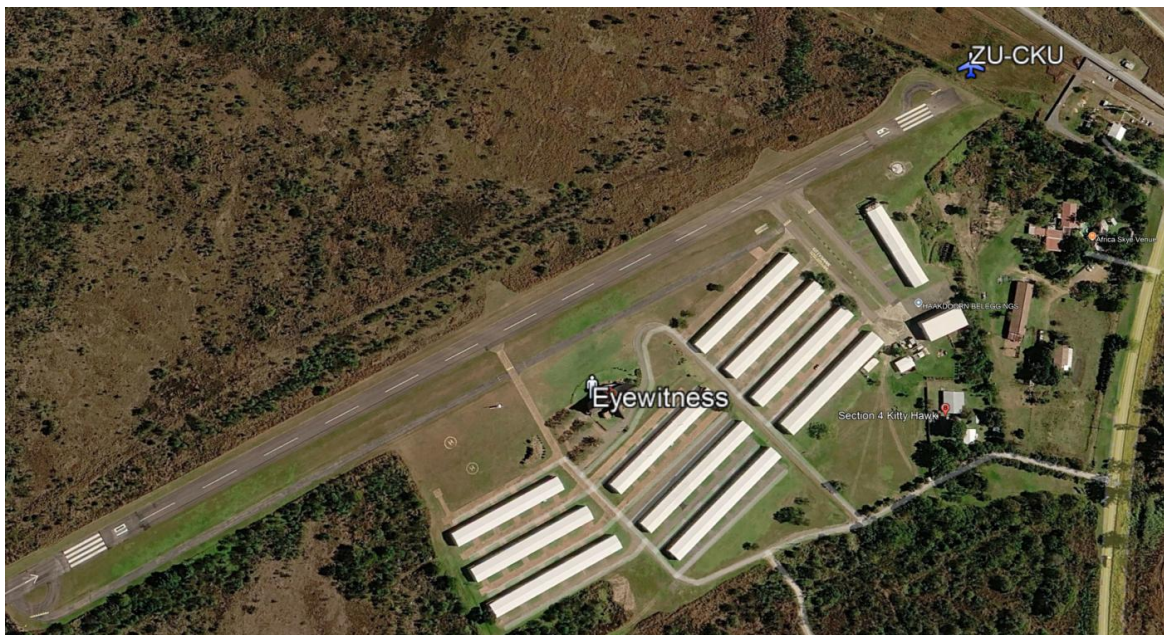
An eyewitness who was seated outside the clubhouse at FAKT stated that he saw the aircraft as it became airborne from Runway 01, climbing to approximately 200ft before the engine stopped. He stated that the aircraft's nose lowered before it impacted the ground beyond the threshold of Runway 19, penetrated the perimeter fence, and came to a stop approximately 50m beyond the runway threshold facing west. The eyewitness was the first person at the accident site. The pilot was conscious; he reported severe back pain and a laceration to his lower left leg. Other people from the aerodrome who came to assist administered first aid to the pilot to control the bleeding whilst awaiting the emergency medical personnel to arrive at the scene. The pilot was later transported to the hospital, where it was confirmed that he sustained a lower back injury which required surgery.

The aircraft was substantially damaged during the impact sequence, including the collapse of the landing gear.

**Figure 1:** The yellow pin indicates the position where the aircraft came to rest. (Source: Google Earth)

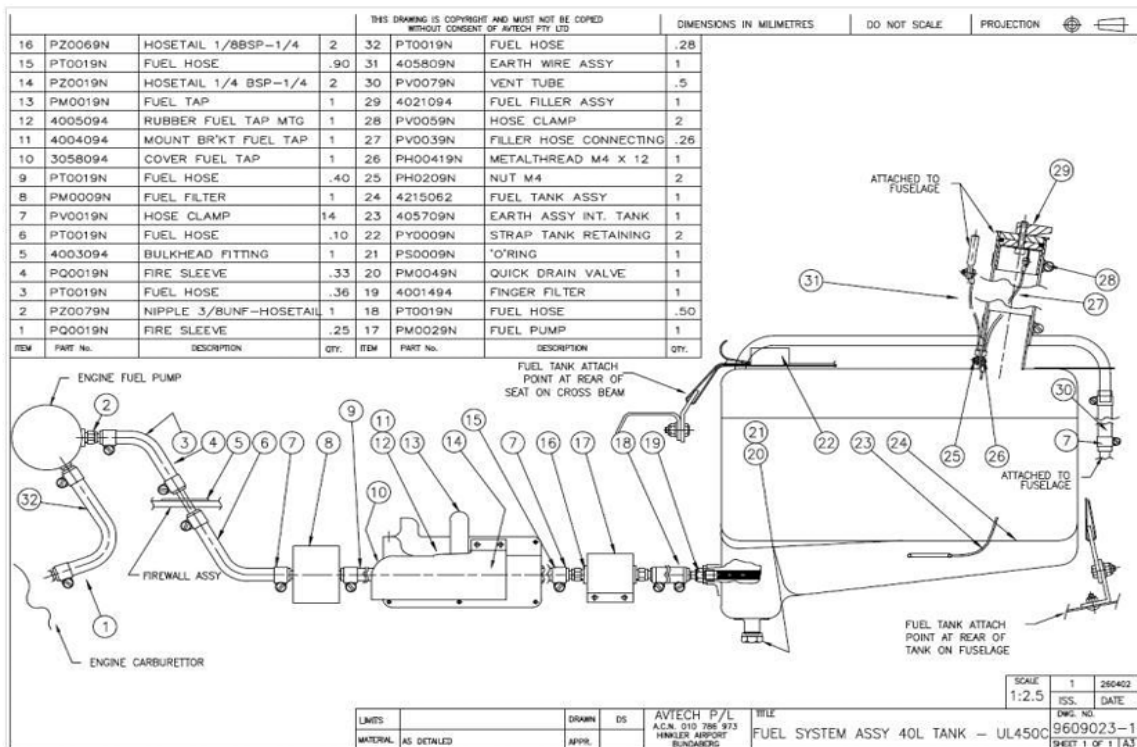
**Figure 7:** The aircraft fuel system. (Source: Jabiru Aircraft Technical Manual)
