## LIMITED OCCURRENCE INVESTIGATION REPORT – FINAL

| <b>Reference Number</b> | CA18/2/3/10652 | | | | | | |
| Registration | ZS-ISU | | | | | | |
| Make; Model; S/N | Piper Cherokee, PA-28-180 (Serial Number: 28-7305561) | | | | | | |

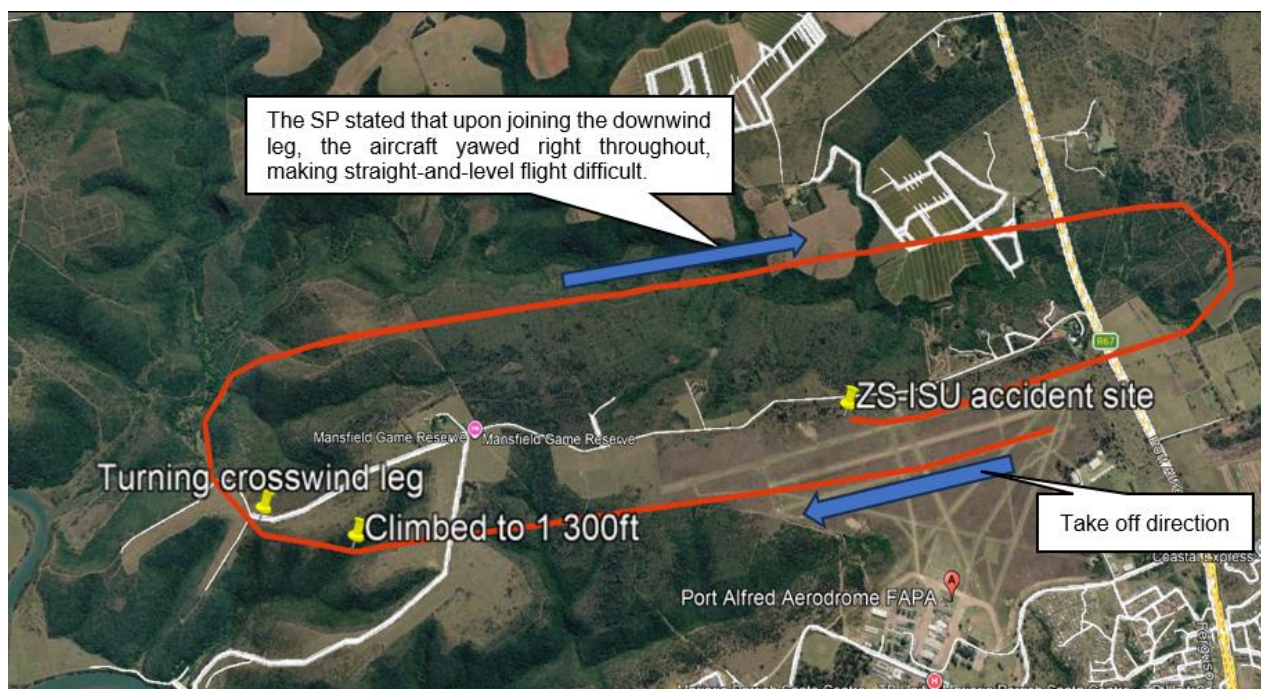
**Figure 1:** An aerial view of the airport and the approximate accident site. The red line traces the flight path from take-off to landing. (Source: Google Earth)
