## LIMITED OCCURRENCE INVESTIGATION REPORT – FINAL

| <b>Reference Number</b> | CA18/2/3/10654 | | | | | | |
| Registration | ZS-VET | | | | | | |
| Make; Model; S/N | Cessna, 172M Skyhawk (Serial Number: 172-60769) | | | | | | |

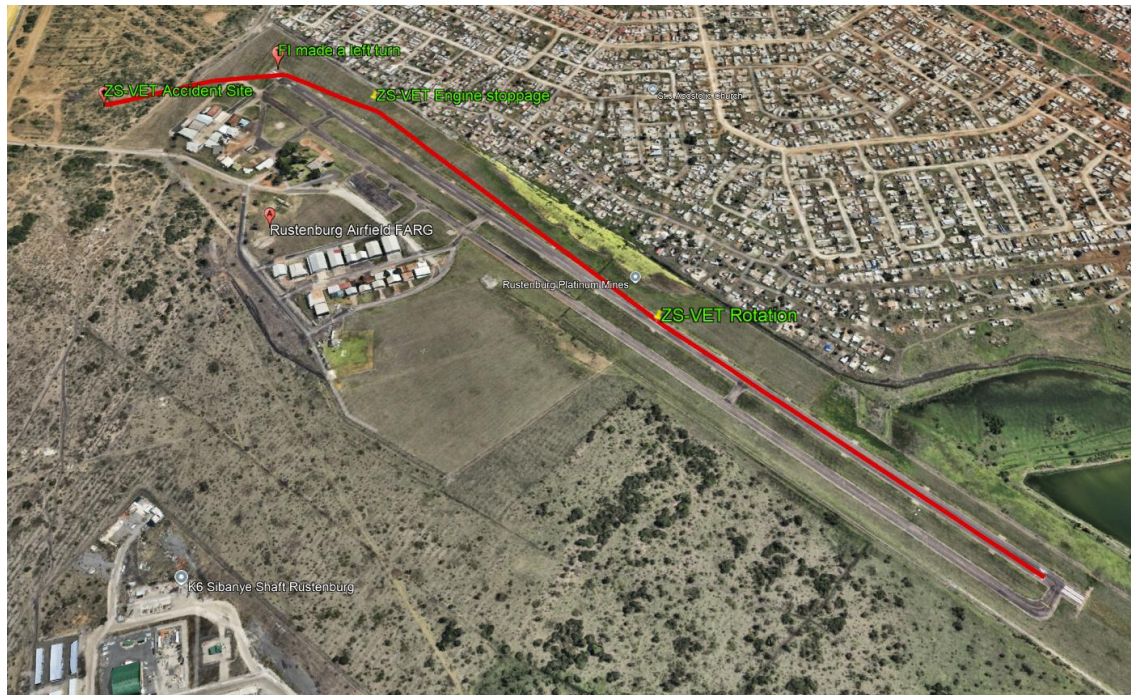
**Figure 1:** An aerial view of FARG. The red line shows the take-off direction and the approximate flight path.  
(Source: Google Earth)
