## LIMITED OCCURRENCE INVESTIGATION REPORT – FINAL

| <b>Reference Number</b> | CA18/2/3/10671 | | | | | | | |
| Registration | ZS-JGD | | | | | | | |
| Make; Model; S/N | Piper; PA28-180 Cherokee (S/N: 28-7405169) | | | | | | | |

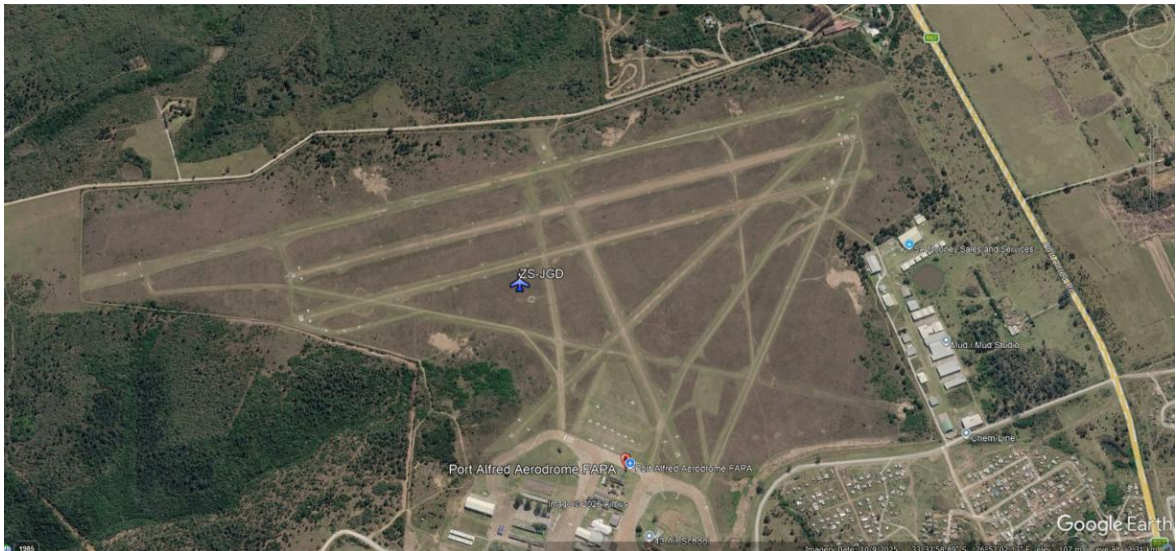
**Figure 1:** The aerodrome layout and the approximate final position of ZS-JGD. (Source: Google Earth)

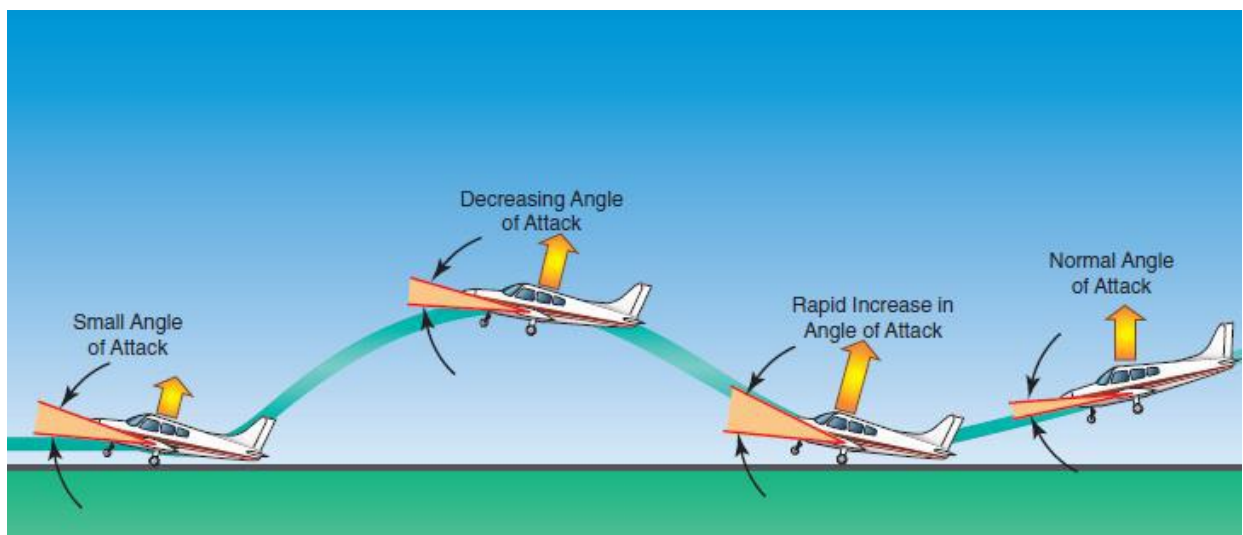
*A bounce during touchdown happens when an aircraft contacts the runway hard, usually because of an incorrect landing attitude or excessive rate of descent during flare. The sharp impact can force the tail down, suddenly increasing the wing's angle-of-attack and lift, causing the aircraft to rebound into the air. The severity of the bounce depends mainly on the aircraft's speed at touchdown and how much the pitch attitude changes.*

*A slight bounce may be corrected by adding enough power to cushion the next touchdown while smoothly adjusting to the correct landing attitude. If there is a crosswind, the pilot must maintain crosswind correction, lowering the upwind wing further as speed reduces.*

*A severe bounce should not be salvaged. The safest action is to immediately execute a go-around by applying full power, maintaining directional control, and lowering the nose to a safe climb attitude, even if the aircraft briefly descends or bounces again.*

**Figure 5:** An illustration of a bounce sequence. (Source: Source: FAA-Airplane Flying Handbook, Chapter 8)
