AIRCRAFT INCIDENT REPORT AND EXECUTIVE SUMMARY

Reference:		CA18/3/2/1339	
Aircraft Registration	ZS-DDT	Date of Incident	3 March 2021			Time of Incident	1655Z
Type of Aircraft	Hawker 4000			Type of Operation		Private (Part 91)	
Pilot-in-command Licence Type	Airline Transport Pilot Licence (ATPL)		Age	49		Licence Valid	Yes
Pilot-in-command Flying Experience	Total Flying Hours		6 615			Hours on Type	1 000
Last Point of Departure		Cape Town International Airport (FACT), Western Cape Province					
Next Point of Intended Landing		Plettenberg Bay Airport (FAPG), Western Cape Province					
Damage to Aircraft		Minor					
Location of the incident site with reference to easily defined geographical points (GPS readings if possible)							
Approximately 80 metres from the threshold of Runway 30 at Global Positioning System coordinates determined to be 34°05'20.59" South 023°20'13.97" East at an elevation of 470 feet							
Meteorological Information		Surface wind 200°/1kt; temperature: 21° C; dew point: 17° C; QNH 1014 hPa;

Reference Number : CA18/3/2/1339
Name of Owner/Operator : Rocklight Investments (PTY) LTD
Manufacturer : Hawker Beechcraft
Model : 4000
Nationality : South Africa
Registra

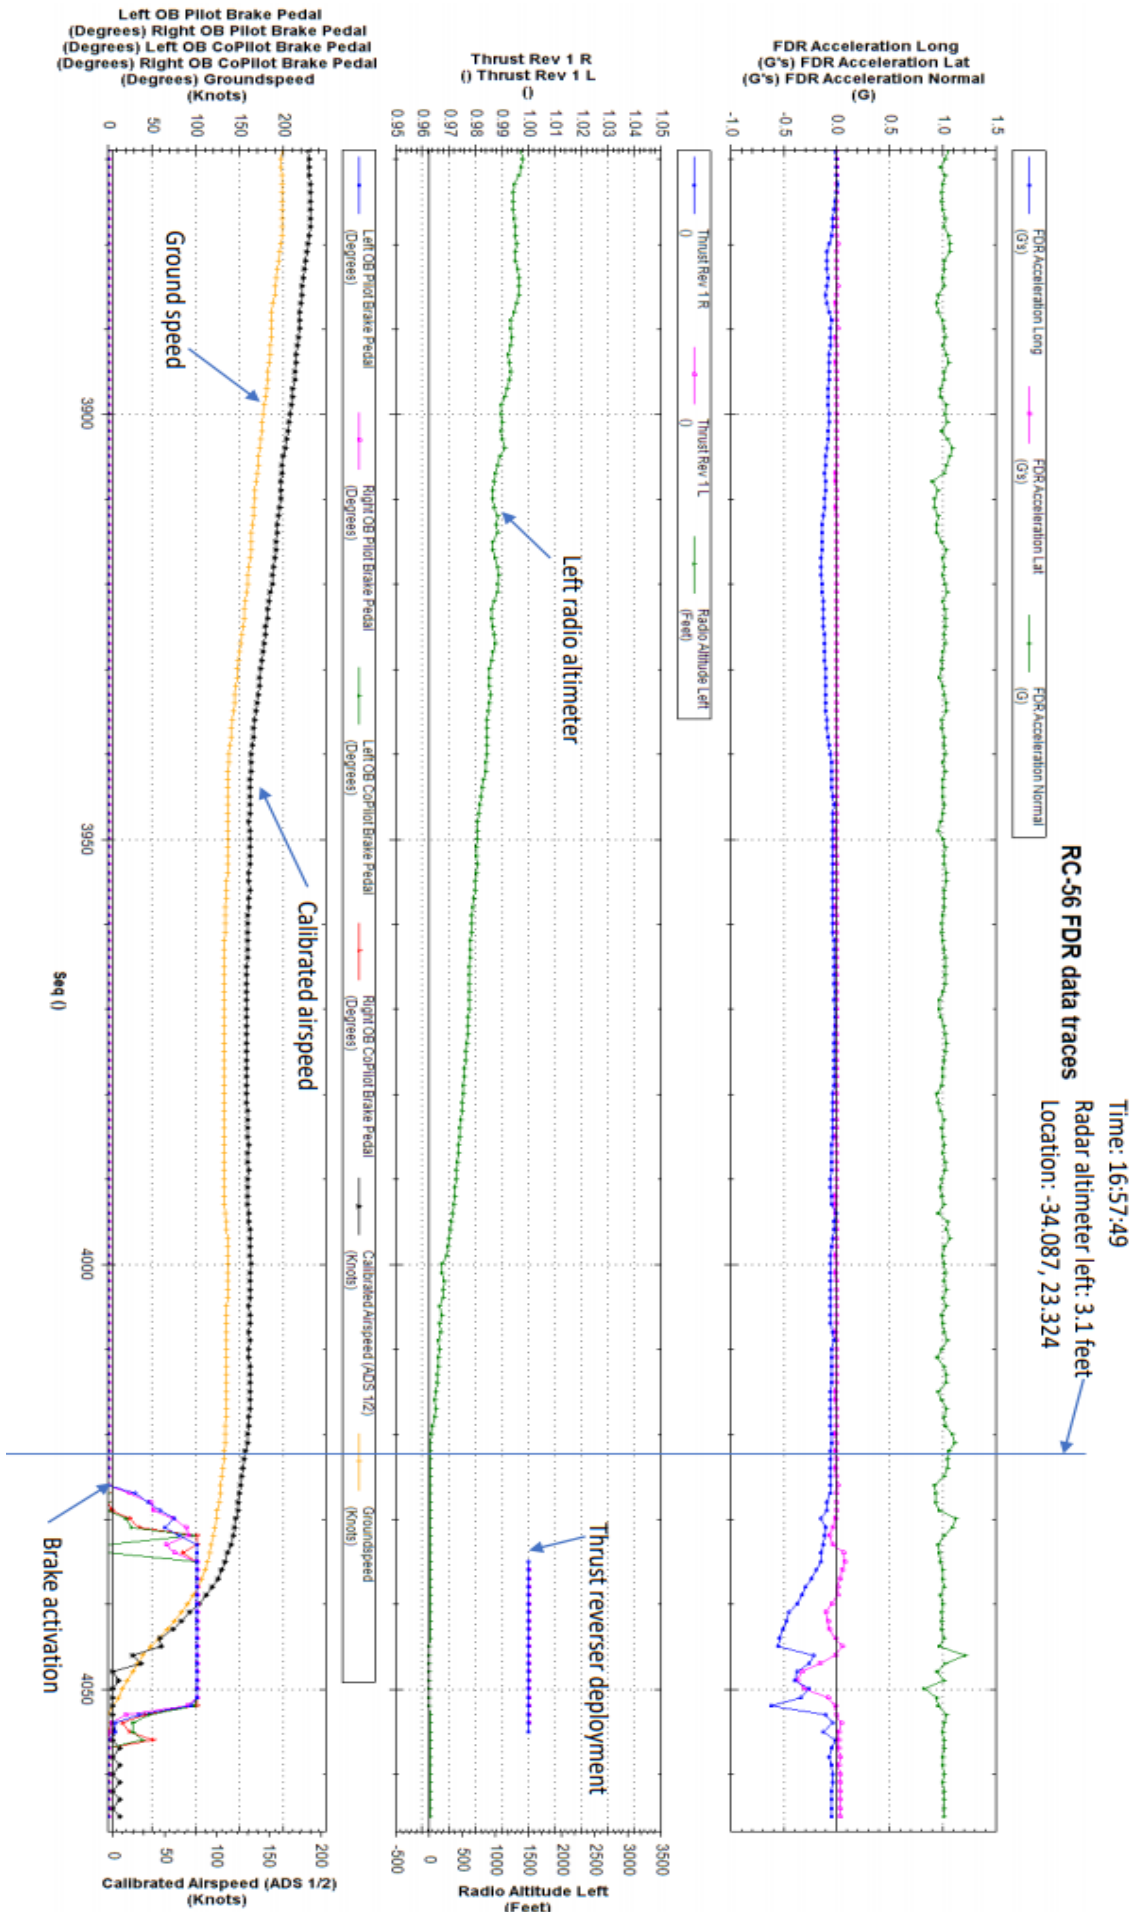
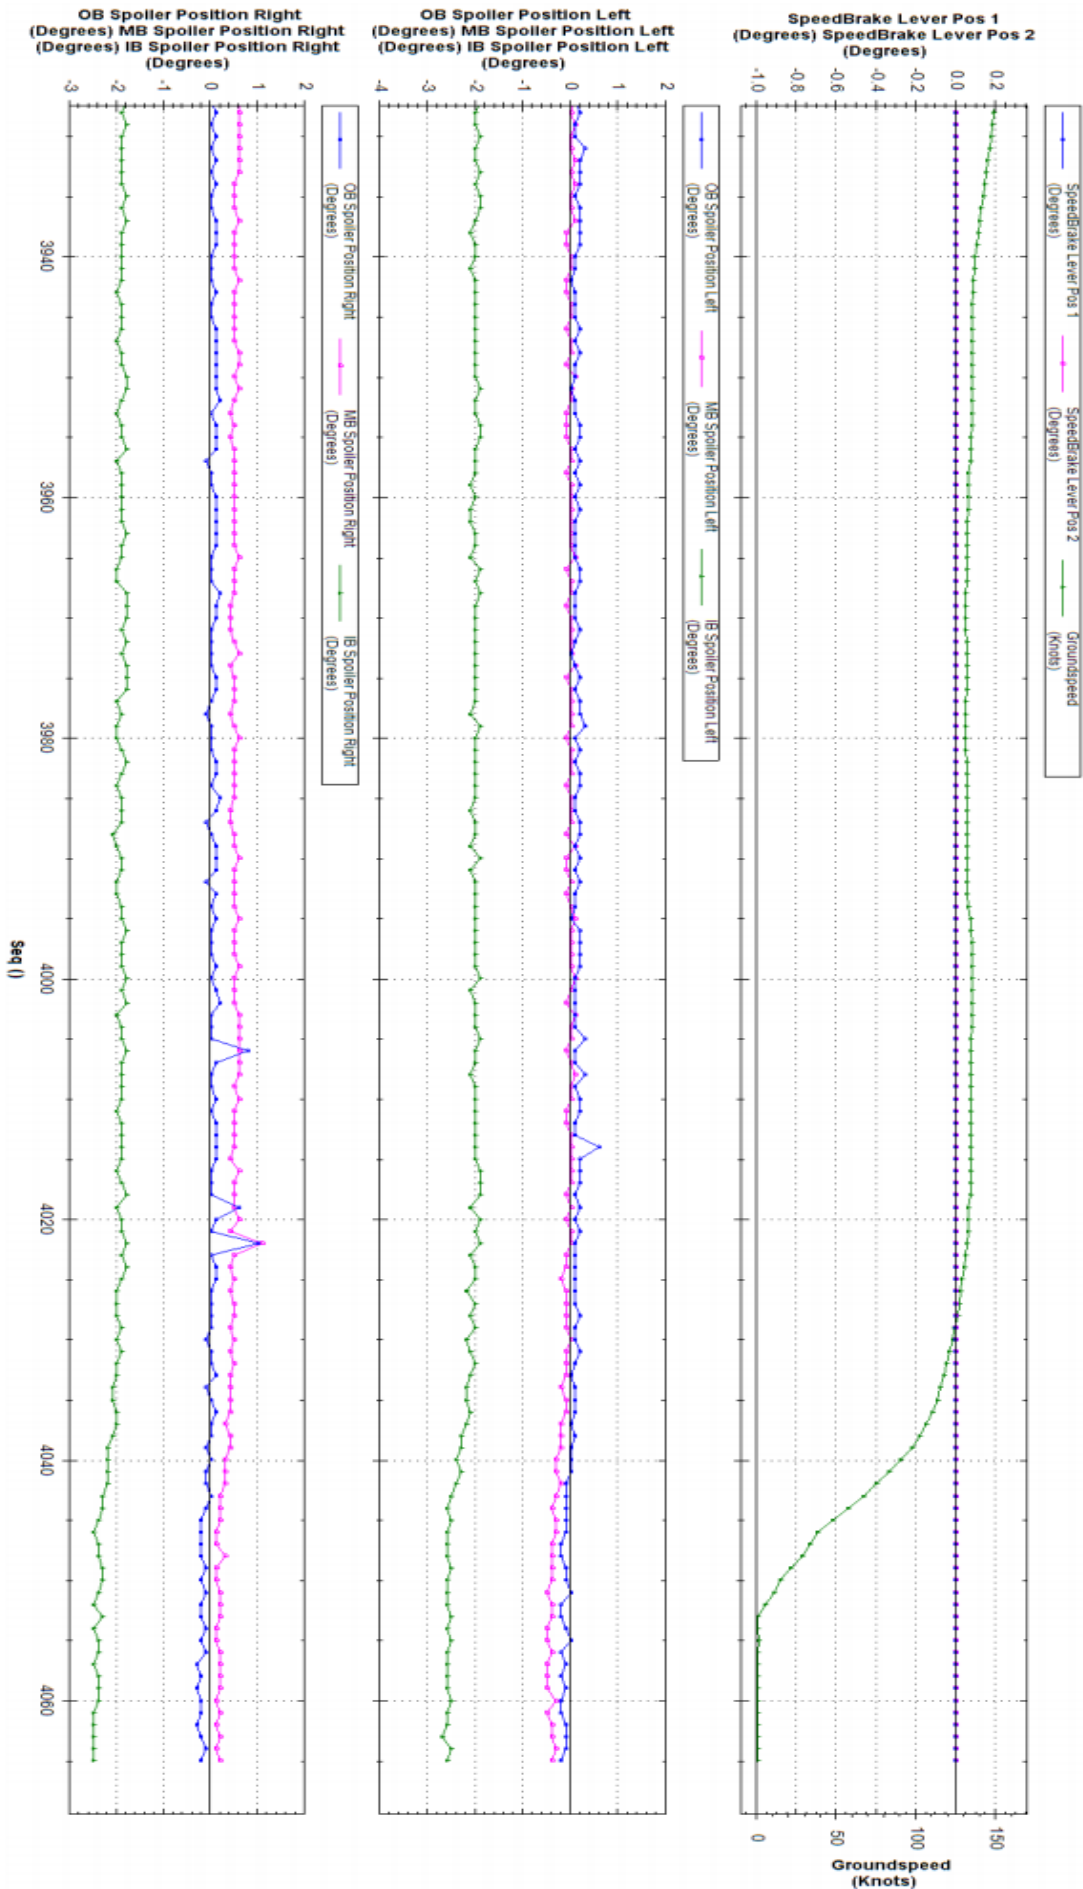
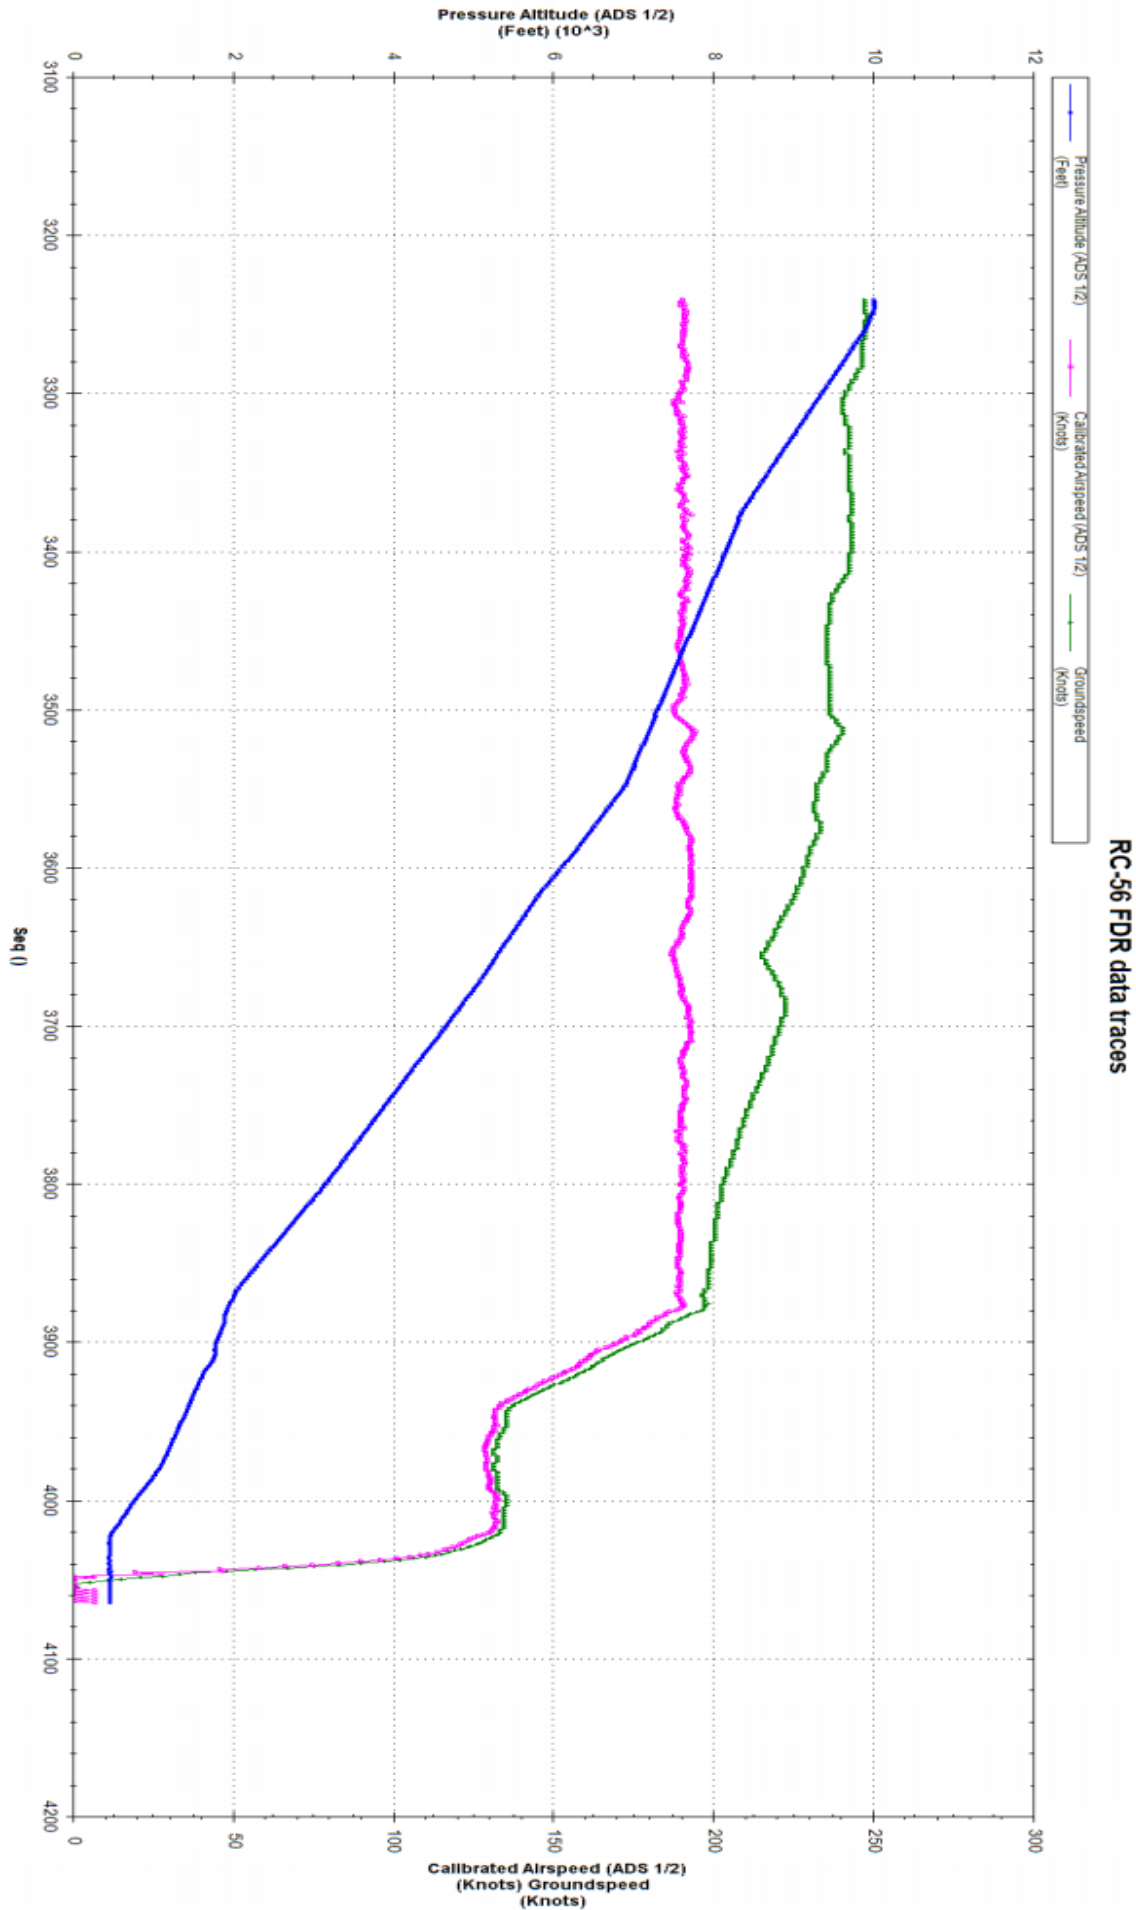
RC-56 FDR data traces

- *The brake pedals were not activated until almost halfway down the runway. The thrust reversers were not activated until the last quarter of the runway.*
- *Pressure was not applied to the brake pedals until almost halfway down the runway. The aircraft's ground speed decreased after the brakes were applied. The aircraft's rate of deceleration increased after the thrust reversers were deployed.*
- *The second and third charts (Figures 5 and 6 below) show the spoiler positions. The spoilers did not deploy upon landing. This could have been caused by the flight crew not arming the ground spoilers before landing.*
