AIRCRAFT SERIOUS INCIDENT REPORT AND EXECUTIVE SUMMARY

Reference:		CA18/3/2/1398	
Aircraft Registration	ZU-FWM	Date of Incident	4 July 2022		Time of Incident	1645Z	
Type of Aircraft	Windlass Aquila 912		Type of Operation		Training (Part 141)		
Pilot-in-command Licence Type		National Pilot Licence	Age	63	Licence Valid	Yes	
Pilot-in-command Flying Experience		Total Flying Hours		7850	Hours on Type	3000	
Last Point of Departure		Oudtshoorn Aerodrome, Western Cape Province					
Next Point of Intended Landing		Oudtshoorn Aerodrome, Western Cape Province					
Damage to Aircraft		Minor					
Location of the incident site with reference to easily defined geographical points (GPS readings if possible)							
Oudtshoorn Aerodrome in the Western Cape Province, at Global Positioning System (GPS) co-ordinates determined to be 33°36'05.97" South 022°11'10.94" East, at an elevation of 1063 feet (ft)							
Meteorological Information		Wind direction: 120; Wind speed: 8kts; Visibility: CAVOK; Temperature: 20°C; Cloud cover: 0 OCTAS; Cloud base: Clear; Dew point: 11°C; QNH: 1021hPa

Reference Number	: CA18/3/2/1398
Occurrence Category	: Serious Incident
Type of Operation	: Training (Part 141)
Name o

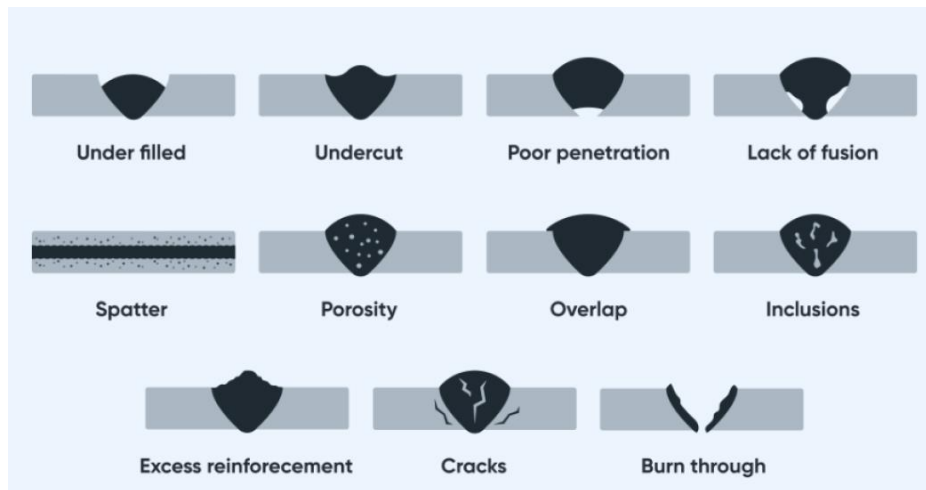
Figure 4: Welding defects. (Source: University of Pretoria)

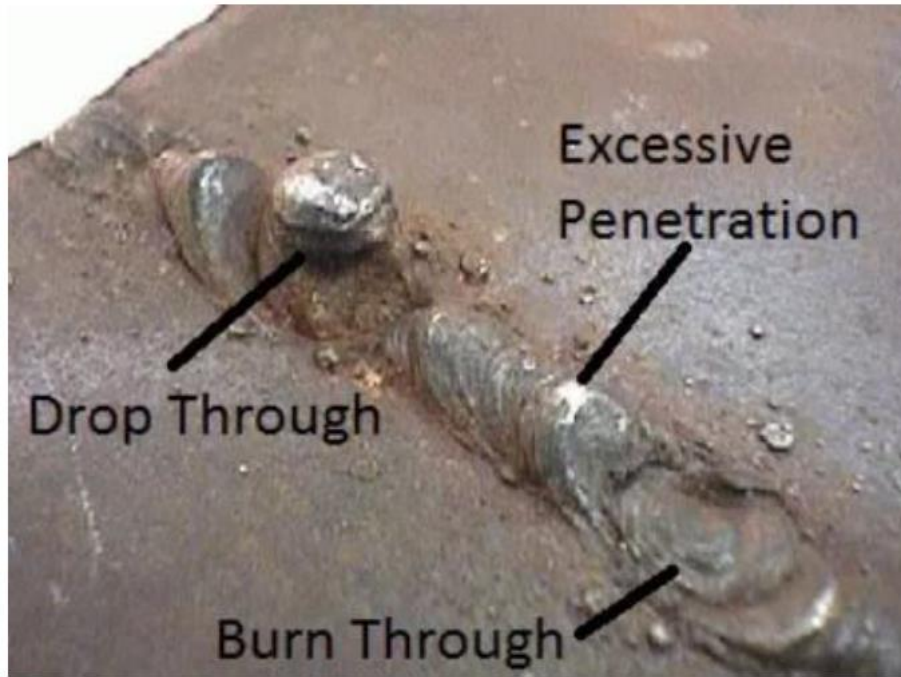
*When there is an application of excessive heat during welding, the process may blow holes through the centre of the metal. This type of weld defect is called a **burn-through**. It's a common welding defect for thin metal sheets with less than 1/4-inch thickness. It might occur when the welding settings are too high and/or the torch movement is too slow.*

Figure 5: Appearance of Burn-Through. (Source: University of Pretoria Report)
