LIMITED OCCURRENCE INVESTIGATION REPORT – FINAL

Reference Number	CA18/3/2/1419						
Classification	Serious Incident	Date	30 June 2023			Time	1830Z
Type of Operation	Training (Part 141)						
Location							
Place of Departure	Chief Dawid Stuurman International Airport (FAPE), Eastern Cape Province		Place of Intended Landing			Chief Dawid Stuurman International Airport (FAPE), Eastern Cape Province	
Place of Occurrence	On Runway 34 at Grahamstown Airport (FAGT), Eastern Cape Province						
GPS Co-ordinates	Latitude	33° 17'16.39"S	Longitude	26°30'07.08"E	Elevation	2 111 ft	
Aircraft Information							
Registration	ZS-OVY						
Make; Model; S/N	Piper Aircraft Corp; PA28-161 (Warrior III) (Serial Number: 2842156)						
Damage to Aircraft	Substantial			Total Aircraft Hours	11 695.3		
Pilot-in-command							
Licence Type	Commercial Pilot Licence (CPL)		Gender	Male		Age	28
Licence Valid	Yes	Total Hours	654.8		Total Hours on Type	554	
Total Hours 30 Days	6.8		Total Flying on Type Past 90 Days			97.8

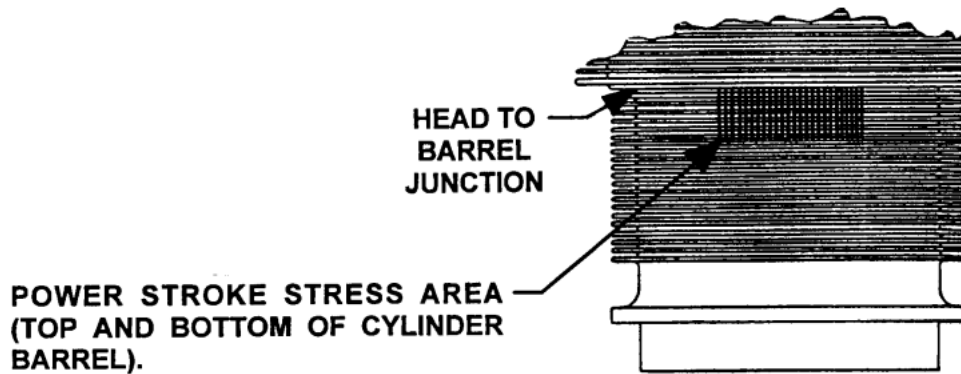
Figure 6: The cylinder barrel. (Source: SB96-12)

The engine malfunctioned due to power loss caused by a cylinder head failure due to the fatigue crack. The crack started in an area located between the cylinders on the lower side that is covered by inter cylinder baffles. The compression test showed good results. The cylinder fatigue crack is similar to those failures that were recalled by the manufacturer,

Power Stroke Stress Area of the Cylinder Barrel (see Figure 6)

Following the issuance of the SB B06-01 E and AD 2009-26-12, the operators are still experiencing cracks on cylinder heads. Therefore, it is recommended that the manufacturer conducts further research to prevent future failures/cracks in cylinder heads or reduce the time between overhaul (TBO) from 2200 hours to 1500 hours.
