**AIRCRAFT SERIOUS INCIDENT REPORT AND EXECUTIVE SUMMARY**

<b>Reference:</b>		CA18/3/2/1421	
<b>Aircraft Registration</b>	G-XLEH	<b>Date of Serious Incident</b>	12 July 2023		<b>Time of Serious Incident</b>	1804Z
<b>Type of Aircraft</b>	Airbus A380-841		<b>Type of Operation</b>		Air Transport (Part 121)	
<b>Pilot-in-command Licence Type</b>		Airline Transport Pilot Licence	<b>Age</b>	53	<b>Licence Valid</b>	Yes
<b>Pilot-in-command Flying Experience</b>		<b>Total Flying Hours</b>		20 000.0	<b>Hours on Type</b>	4 300.0
<b>Last Point of Departure</b>		O.R. Tambo International Aerodrome (FAOR), South Africa				
<b>Next Point of Intended Landing</b>		Heathrow International Aerodrome (EGLL), United Kingdom				
<b>Damage to Aircraft</b>		Minor				
<b>Location of the site concerning easily defined geographical points (GPS readings if possible)</b>						
Approximately 60nm south of the ETMIT waypoint (GPS position: 24°12'32.23" South 027°45'36.32" East)						
<b>Meteorological Information</b>		Surface wind: 030°/11 knots, temperature: 11°C, dew point: 3°C, CAVOK

<b>Reference Number</b>	: CA18/3/2/1421
<b>Occurrence Category</b>	: Serious Incident (Category 1)
<b>Type of Operation</b>	: Ai

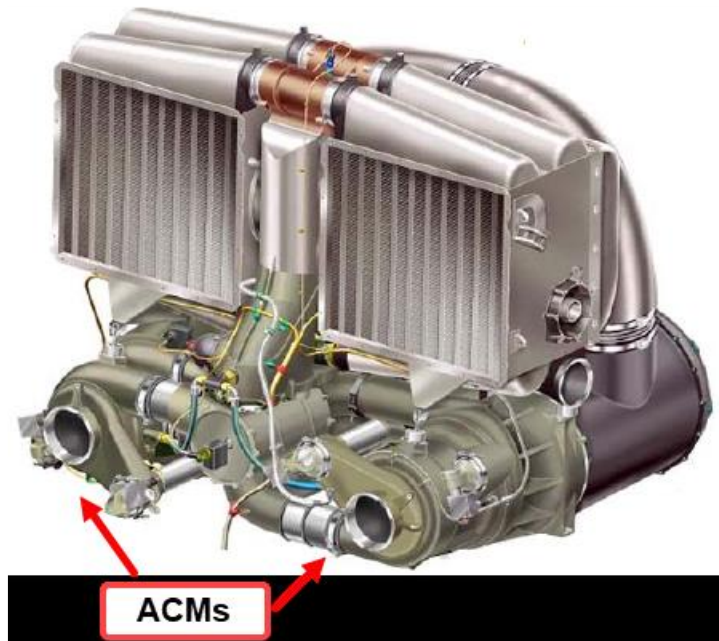
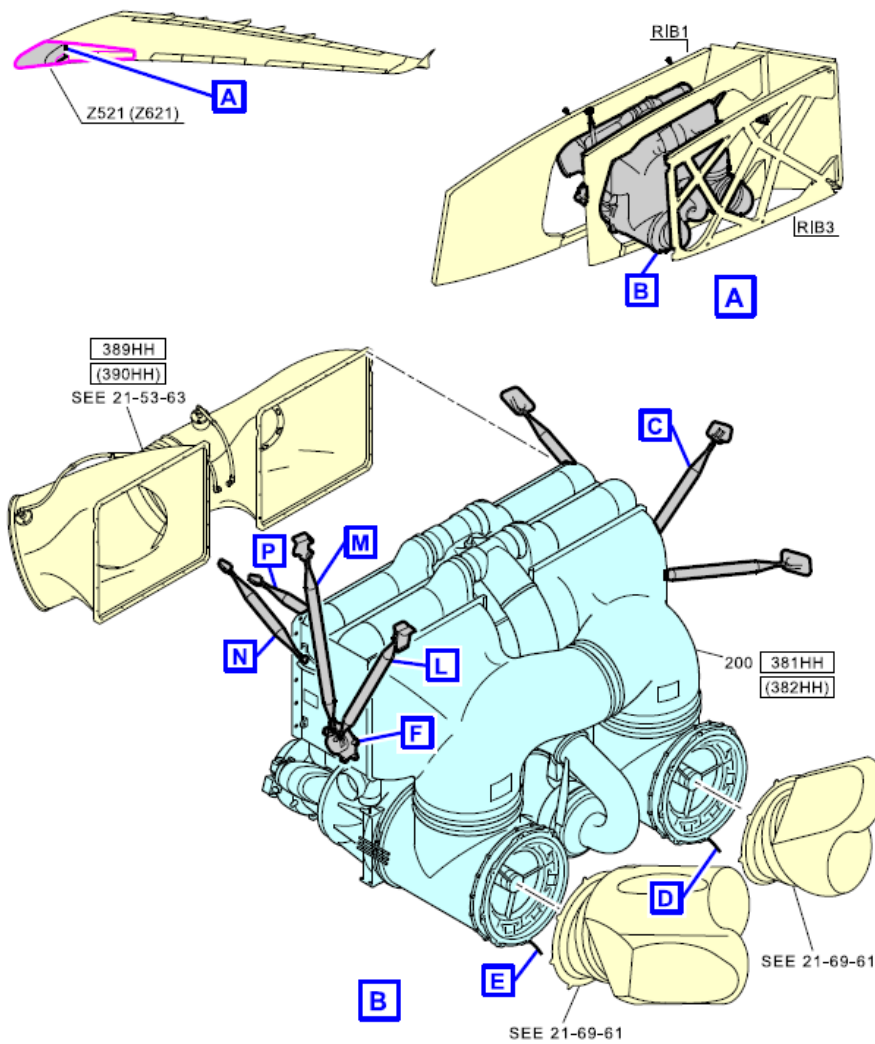
**Figure 2:** The illustration shows the AGU (light blue) with two ACMs coupled and lined abreast. AGU 1 is fitted to the left side of the aircraft where the fuselage and wing structure meet.

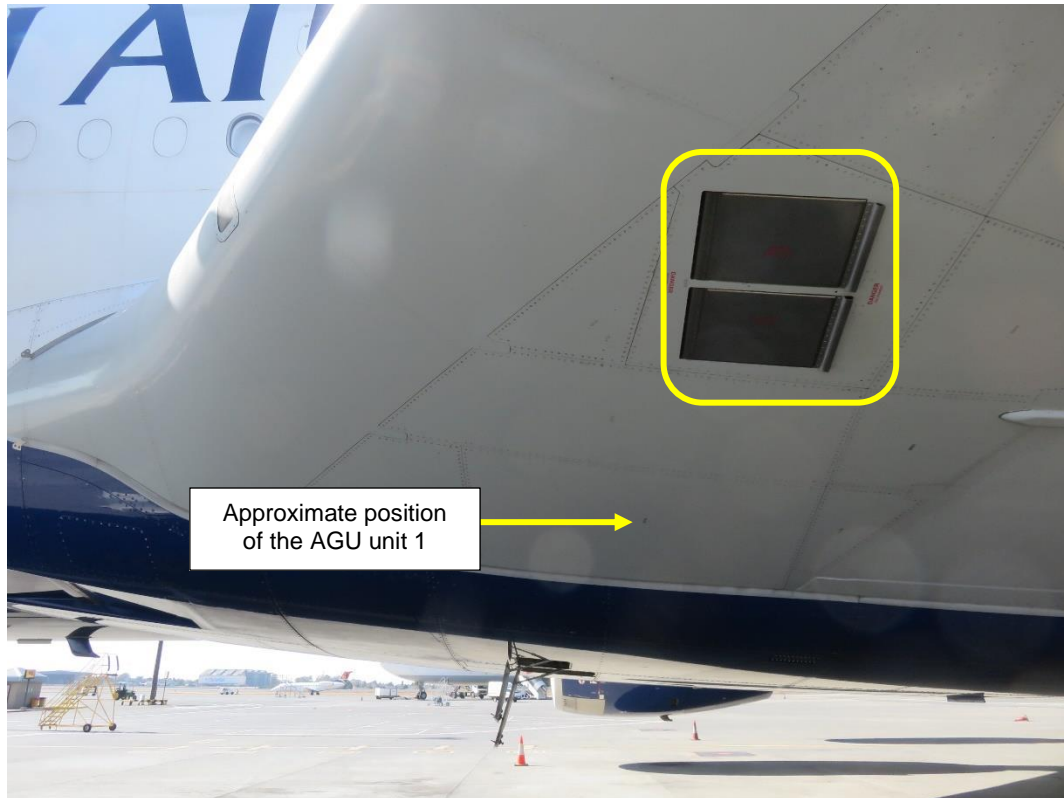
**Figure 3:** The yellow window indicates the ram air (hot air) doors for AGU 1 (left side).  
The yellow arrow points to the approximate position of the AGU.

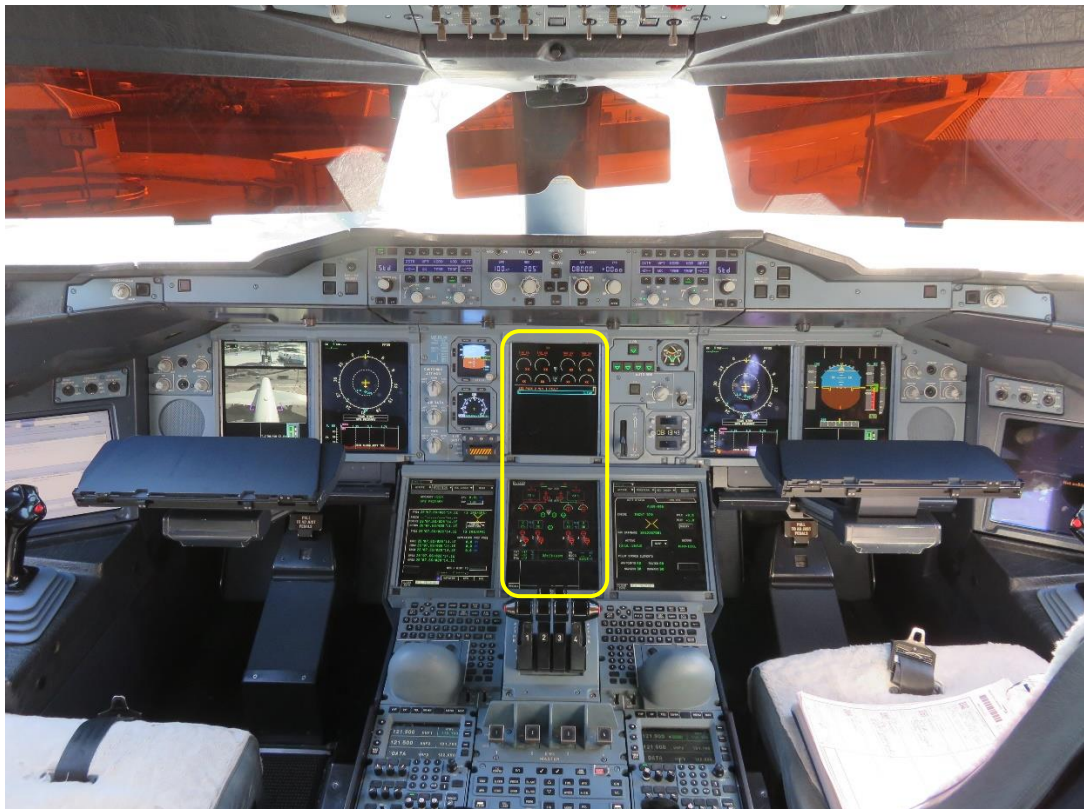
**Figure 14:** ECAM displayed in the yellow window in the cockpit of the Airbus A380, G-XLEH.
