AIRCRAFT SERIOUS INCIDENT REPORT AND EXECUTIVE SUMMARY

Reference:		CA18/3/2/1426					
Aircraft Registration		ZS-TWF & ZS-CPL	Date of Incident		13 August 2023		Time of Incident		1510Z		
Type of Aircraft		Pilatus PC 12 and Cessna 172		Type of Operation		Private (Part 91)					
Pilot-in-command Licence Type		Commercial Pilot Licence (CPL) and Private Pilot Licence (CPL)		Age		25 and 27		Licence Valid		Yes	
Pilot-in-command Flying Experience			Total Flying Hours			2 154.5 and 1 49.7		Hours on Type		462.7 and 123.2	
Last Point of Departure		Welkom Aerodrome (FAWM) and O.R. Tambo International Airport (FAOR)									
Next Point of Intended Landing		Lanseria International Airport (FALA)									
Damage to Aircraft		None									
Location of the incident site with reference to easily defined geographical points (GPS readings if possible)											
At 6 000 ft on right downwind Runway 07 at FALA Lanseria International Airport (FALA)											
Meteorological Information		Wind velocity: 220° at 11KT; Temperature: 26°C; Dew Point: -09°C; Visibility: ≥10000m; Cloud: CAVOK; QNH: 1023 hPa

Probable Cause/s and/or Contributory Factors											
Loss of vertical separation due to an instrument e

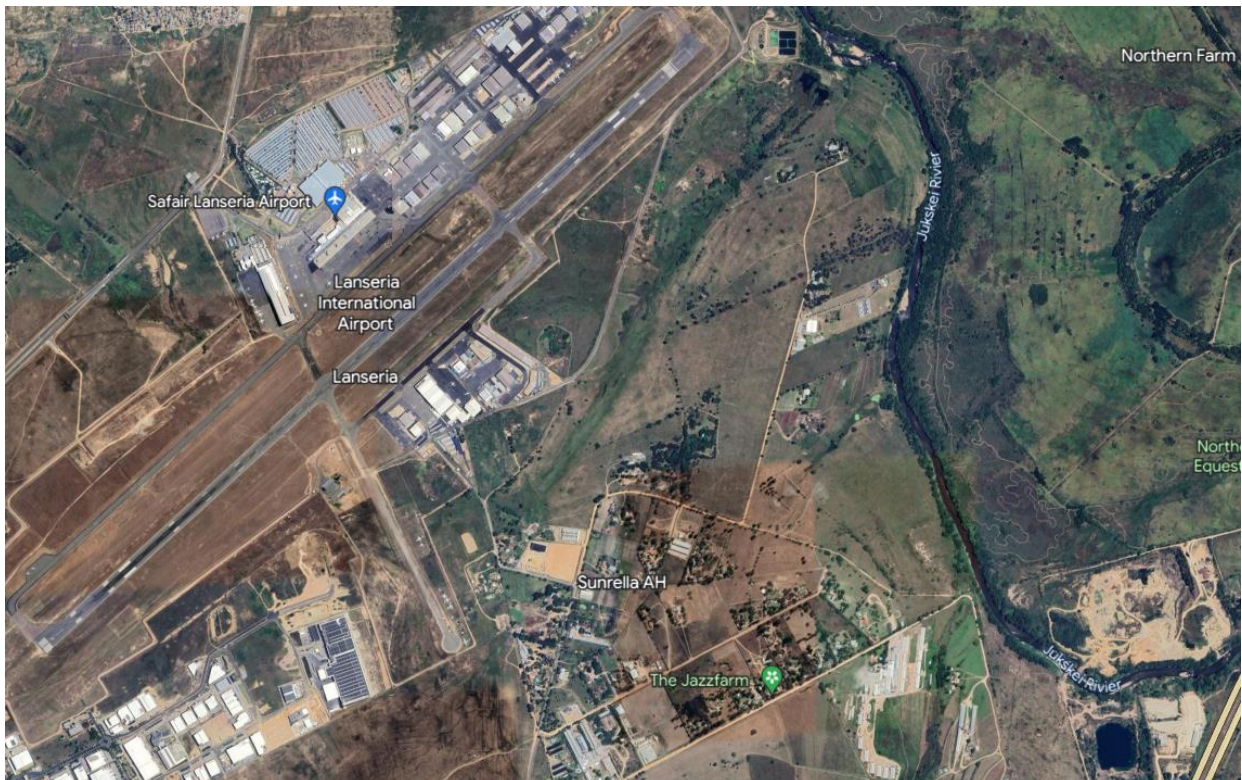
1.1.7. The reduced vertical separation serious incident between 5 700ft and 6 000ft occurred on right downwind RWY 07 at FALA.

Figure 2: An overview of FALA. (Source: Google Earth)
