LIMITED OCCURRENCE INVESTIGATION REPORT – FINAL

Reference Number	CA18/2/3/1431						
Classification	Serious Incident	Date	30 September 2023			Time	0710Z
Type of Operation	Training (Part 141)						
Location							
Place of Departure	Morningstar Aerodrome, Western Cape Province		Place of Intended Landing	Morningstar Aerodrome, Western Cape Province			
Place of Occurrence	Morningstar						
GPS Co-ordinates	Latitude	33°45'44.37" S	Longitude	018°32'54.69" E	Elevation	200 ft	
Aircraft Information							
Registration	ZU-AXT						
Make; Model; S/N	Bushbaby Explorer (Serial Number 023)						
Damage to Aircraft	Minor			Total Aircraft Hours	550		
Pilot-in-command							
Licence Type	Airline Transport Pilot Licence (ATPL)		Gender	Male		Age	68
Licence Valid	Yes	Total Hours	27601		Total Hours on Type	4.2	
Total Hours 30 Days	36.33		Total Flying on Type Past 90 Days	1.33			
People On-board	2+0	Injuries	0	Fatalities	0	Other (on ground)	0
What Happened							
<p>On Saturday morning, 30 September 2023, an instructor and a student pilot on-board a Bushbaby Explorer with registration ZU-AXT were engaged in circuit training at Morningstar Aerodrome, Western Cape province. Visual meteorological conditi

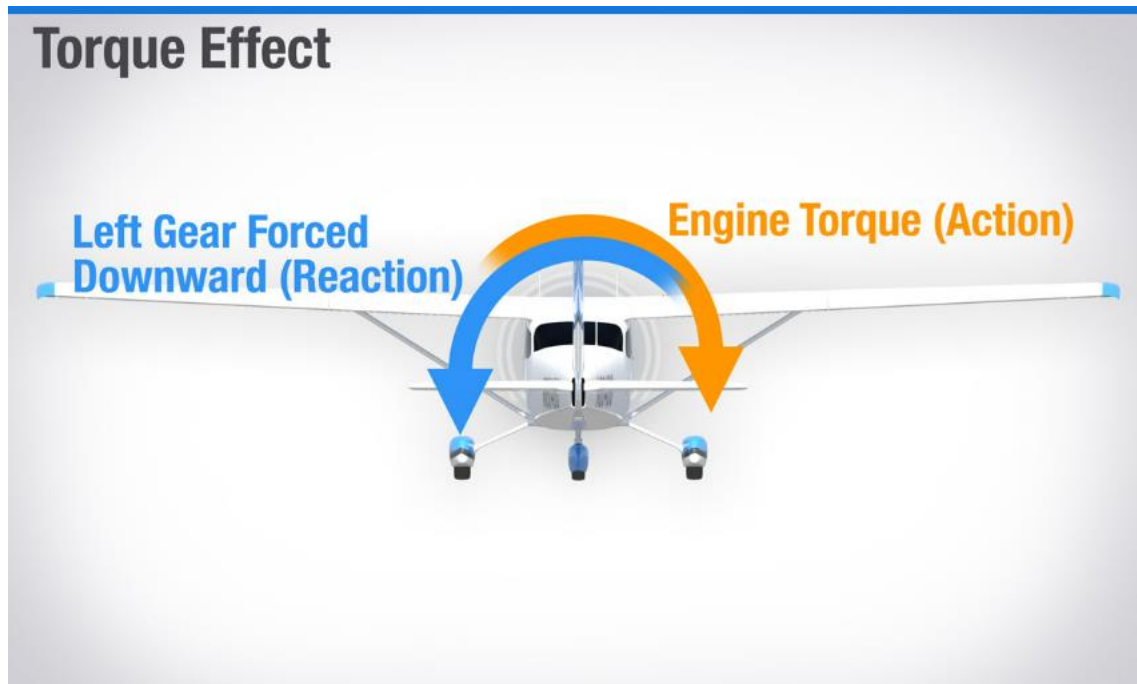
Figure 4: Illustration of the torque effect. (Source: <https://www.boldmethod.com>)

Torque effect explanation (Source: <https://www.boldmethod.com>)

Most western aircraft have engines that rotate clockwise when viewed from the cockpit. That is where torque comes into play. As you throttle up your engine for take-off, the right-turning direction of your engine and propeller forces the left side of your airplane down toward the runway. When the left side of the airplane is forced down onto the runway, the left tyre has more friction with the ground than the right tyre, making your aircraft want to turn left.

The student pilot failed to compensate for the torque effect, which resulted in the aircraft drifting to the left and the wing scraping the runway.
