AIRCRAFT SERIOUS INCIDENT REPORT AND EXECUTIVE SUMMARY

Reference:		CA18/3/2/1432	
Aircraft Registration	ZS-SPO&ZS-SLY	Date of Incident	8 November 2023		Time of Incident	1037Z	
Type of Aircraft	Cessna 172M (ZS-SPO)		Type of Operation		Training Flight (Part 141)		
Type of Aircraft	Cessna 172M (ZS-SLY)		Type of Operation		Private Flight (Part 91)		
Pilot-in-command Licence Type (ZS-SPO)		Student Pilot Licence (SPL)	Age	31	Licence Valid	Yes	
Pilot-in-command Licence Type (ZS-SLY)		Private Pilot Licence (PPL)	Age	23	Licence Valid	Yes	
Pilot-in-command Flying Experience (ZS-SPO)		Total Flying Hours	40		Hours on Type	22.9	
Pilot-in-command Flying Experience (ZS-SLY)		Total Flying Hours	123		Hours on Type	112.6	
Last Point of Departure (Both Aircraft)		Wonderboom Airport (FAWB), Gauteng Province					
Next Point of Intended Landing (ZS-SPO)		Wonderboom Airport (FAWB), Gauteng Province					
Next Point of Intended Landing (ZS-SLY)		Vereeniging Airport (FAVV), Gauteng Province

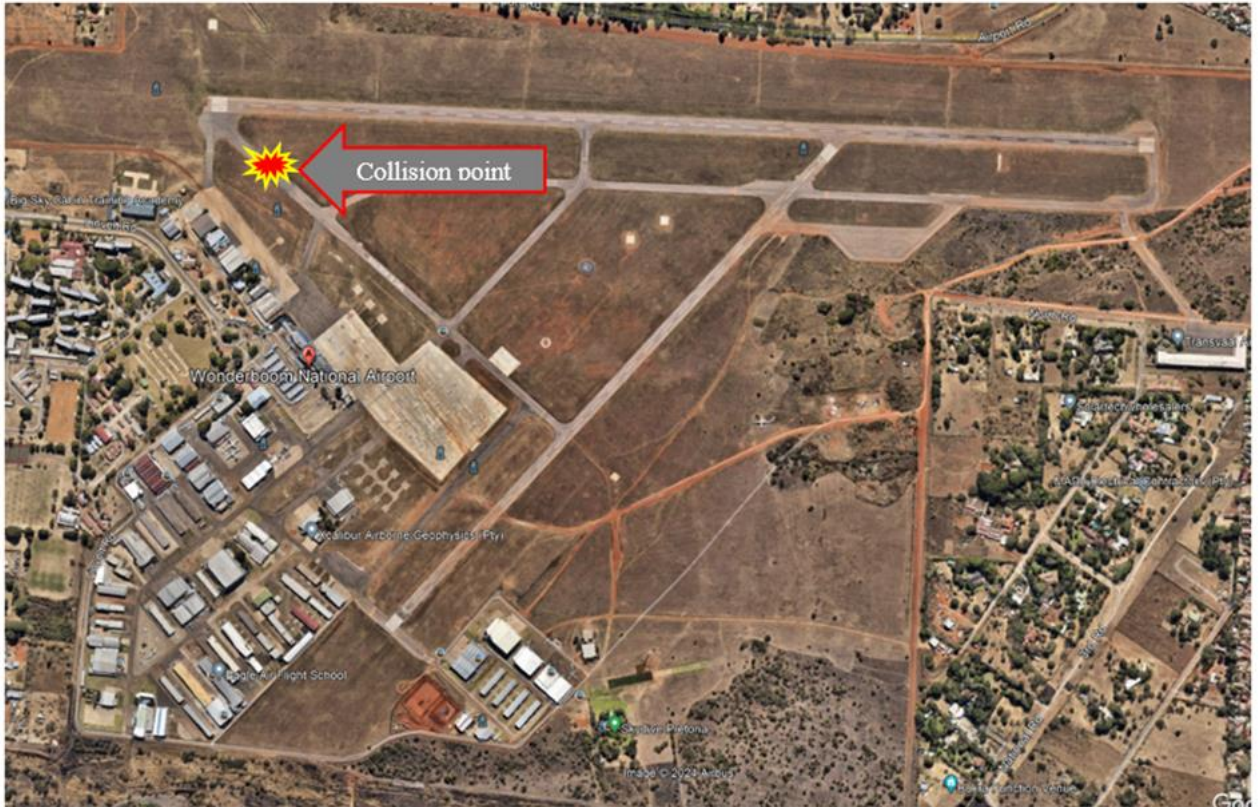
- 1.1.9. The incident occurred during daylight under visual flight rules at Global Positioning System (GPS) co-ordinates determined to be 25°39'17.17"S 028°12'52.35"E at an elevation of 4 055 feet (ft).

Figure 1: The aerial view of the incident site. (Source: Google Earth)
