LIMITED OCCURRENCE INVESTIGATION REPORT – FINAL

Reference Number	CA18/3/2/1440						
Classification	Serious Incident	Date	17 February 2024	Time	1200Z		
Type of Operation	Training (Part 141)						
Location							
Place of Departure	Bram Fischer International Airport (FABL), Free State Province		Place of Intended Landing	Springs Aerodrome (FASI), Gauteng Province			
Place of Occurrence	Open field, approximately 20 nautical miles (nm) north-east of FABL						
GPS Co-ordinates	Latitude	28°57'86.9" S	Longitude	26°25'8.86" E	Elevation	5 337ft	
Aircraft Information							
Registration	ZS-PWR						
Make; Model; S/N	Construzioni Aeronautiche; Tecnam P-92 (Serial Number: 1651)						
Damage to Aircraft	None		Total Airframe Hours	613.6			
Pilot-in-command							
Licence Type	Commercial Pilot Licence (CPL)		Gender	Female		Age	24
Licence Valid	Yes	Total Hours	259.2		Total Hours on Type	6.6	
Total Hours 90 Days	8.9		Total Flying Hours on Type Past 30 Days	0.8			
People On-board	2 + 0	Injuries	0	Fatalities	0	Other (on ground)	0

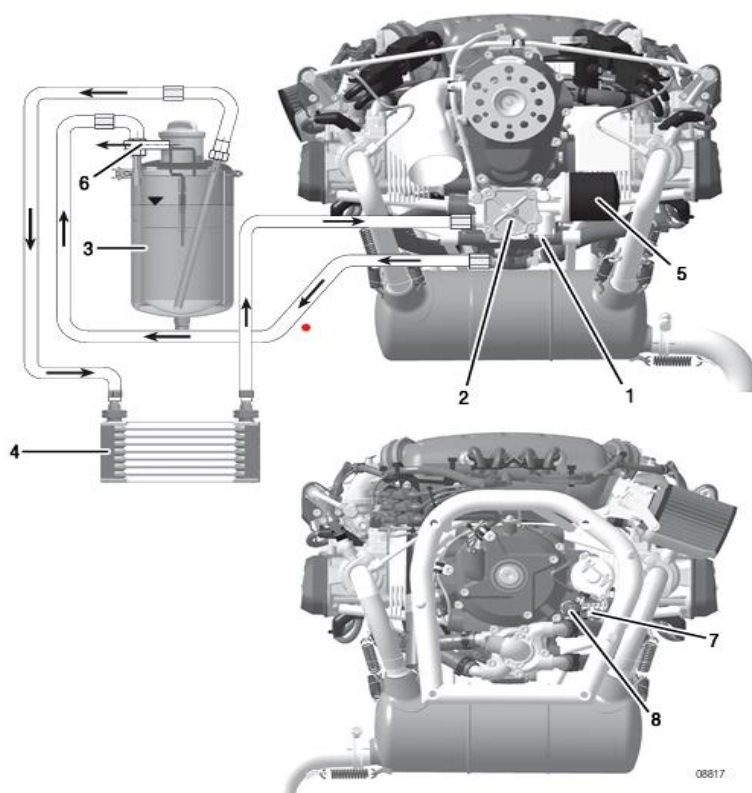
The engine is provided with a dry sump forced lubrication system with a main oil pump with integrated pressure regulator. The oil pump sucks the oil from the oil tank via the oil cooler and forces it through the oil filter to the points of lubrication in the engine. The surplus oil emerging from the points of lubrication accumulates on the bottom of crankcase and is forced back to the oil tank by the piston blow-by gases. The oil pump is driven by the camshaft. The oil circuit is vented via bore on the oil tank. The oil temperature sensor for reading of the oil temperature is located on the crankcase, on

the mag side of the engine. The oil pressure sensor for reading of the oil pressure is located on the ignition housing.

| 1 Pressure regulator | 2 Oil pump |
