**AIRCRAFT SERIOUS INCIDENT REPORT AND EXECUTIVE SUMMARY**

<b>Reference:</b>		CA18/3/2/1442			
<b>Aircraft Registration</b>	ZS-CMK	<b>Date of Incident</b>	26 March 2024	<b>Time of Incident</b>	0920Z		
<b>Type of Aircraft</b>	Bombardier CL-600-2B19	<b>Type of Operation</b>		Commercial (Part 121)			
<b>Pilot-in-command Licence Type</b>	Airline Transport Licence (ATPL)	<b>Age</b>	64	<b>Licence Valid</b>	Yes		
<b>Pilot-in-command Flying Experience</b>		<b>Total Flying Hours</b>	18 357	<b>Hours on Type</b>	624.1		
<b>Last Point of Departure</b>	O.R. Tambo International Airport (FAOR), Gauteng Province						
<b>Next Point of Intended Landing</b>	George Airport (FAGG), Western Cape Province						
<b>Damage to Aircraft</b>	Substantial						
<b>Location of the incident site with reference to easily defined geographical points (GPS readings if possible)</b>							
En route to George Airport (FAGG) at FL300							
<b>Meteorological Information</b>	Wind direction: 150°; Wind speed: 07kts; Temperature: 22°C; Dew Point: 15°C; Cloud Cover: Few 0300VC 045; Cloud Base: 4 500ft; Visibility: CAVOK; QNH: 1015hPa

**Reference Number** : CA18/3/2/1442  
**Occurrence Category** : Category 1  
**Type of

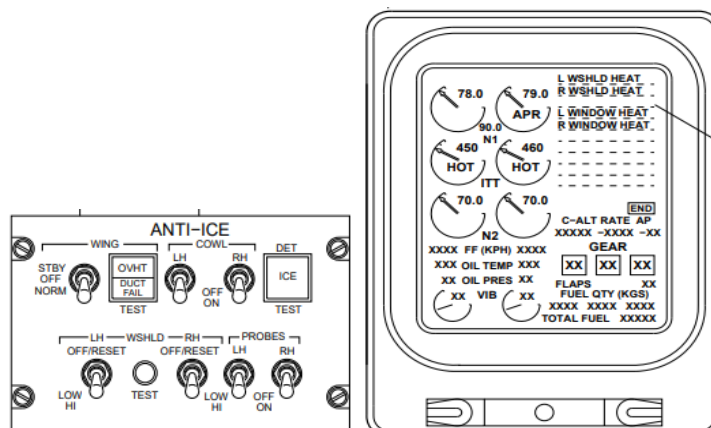
Figures 4 and 5: The anti-ice panel and EICAS.

The heater system for the windshields and side windows uses electrical power for the anti-icing and de-misting procedures. The windshields and side windows have electrical heater elements and temperature sensors built into their laminated glass construction. Overtemperature and a no-heat condition is detected by the sensors. If a no-heat condition occurs, the engine indication and crew alerting system (EICAS) is alerted. The system is monitored and controlled by four temperature controllers.

The controllers have an overtemperature circuit which is different from the normal HI or LOW control circuit. This circuit is a safety circuit that will isolate the heater from its power source at a set temperature level. The overtemperature circuit uses a temperature sensor that is identical to the sensor used in the normal control circuit. If there is a heater failure on a windshield or a side window, the MASTER CAUTION lights flash on the glareshield. A message is also shown on the primary display page of EICAS. The message is shown in the colour amber and will show the window heater that is defective. When the TEST switch on the anti-ice panel is pressed in, a 28-volt-dc signal will start a test procedure. This test will show that the temperature controllers, sensors, and heaters as a system are operational. The test circuits are as follows:

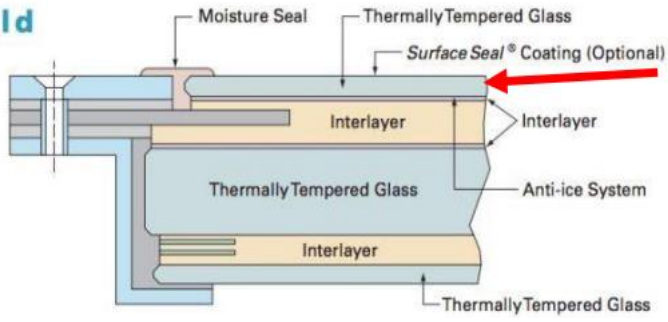
Diagram 1: Schematic: Generic windshield construction.

*The visual inspection revealed multiple fractures originating from the bottom right-side area (pilot's view) and extending in two directions (Photos 1 and 2, red circle, red arrows). Extensive delamination was noted between the outer glass layer (Diagram 1) and the interlayer at the anti-icing heating element interface (Photos 2 and 3, blue demarcation). This will be detrimental to the effectiveness of the heating element while in operation, resulting in a temperature gradient between the outer and the inner sections of the glass layer inducing (applied) stresses. Selected areas revealed indications of recent delamination (Photo 3, blue dashed lines) most probably induced following the initial failure of the outer glass layer. At the point of initiation, clear indications of discolouring of the polymer interlayer were noted suggesting electrical arcing involving the heating element (Photo 3, yellow circle). The initial fracture originated from the delaminated zone and at the point of arcing. The arcing would have further increased the temperature gradient within a small area resulting in increased stresses exceeding the designed limits (compression/tension region) of the Tempered Glass layer. Inspection of the windshield seals and outer frame revealed no clear indication/s of excessive wear and/or incorrect fitting (Photo 4).*
