AIRCRAFT SERIOUS INCIDENT REPORT AND EXECUTIVE SUMMARY

Reference:		CA18/3/2/1446	
Aircraft Registration	ZS-PKB	Date of Accident	16 April 2024		Time of Accident	0553Z	
Type of Aircraft	Beechcraft 1900D			Type of Operation	Commercial (Part 135)		
Pilot-in-command Licence Type	Airline Transport Pilot Licence (ATPL)		Age	28	Licence Valid	Yes	
Pilot-in-command Flying Experience	Total Flying Hours		2 361.0		Hours on Type	602.5	
Last Point of Departure	O.R. Tambo International Airport (FAOR), Gauteng Province						
Next Point of Intended Landing	Venetia Mine Airfield (FAVM), Limpopo Province						
Damage to Aircraft	Minor						
Location of the accident site with reference to easily defined geographical points (GPS readings if possible)							
FAVM Runway 08 at Global Positioning System (GPS) co-ordinates 22°26'56.33" South 029°20'06.06" East, at an elevation of 2 315 feet (ft)							
Meteorological Information	Surface wind: 190°/12 knots: temperature, 24°C; dew point: 11°C

Probable Cause							
Incorrect approach speed (Vref) for flapless landing configuration resulted in a high sink rate and, thus, the subsequent hard landing on the gravel area, about 3m before the threshold of the Run

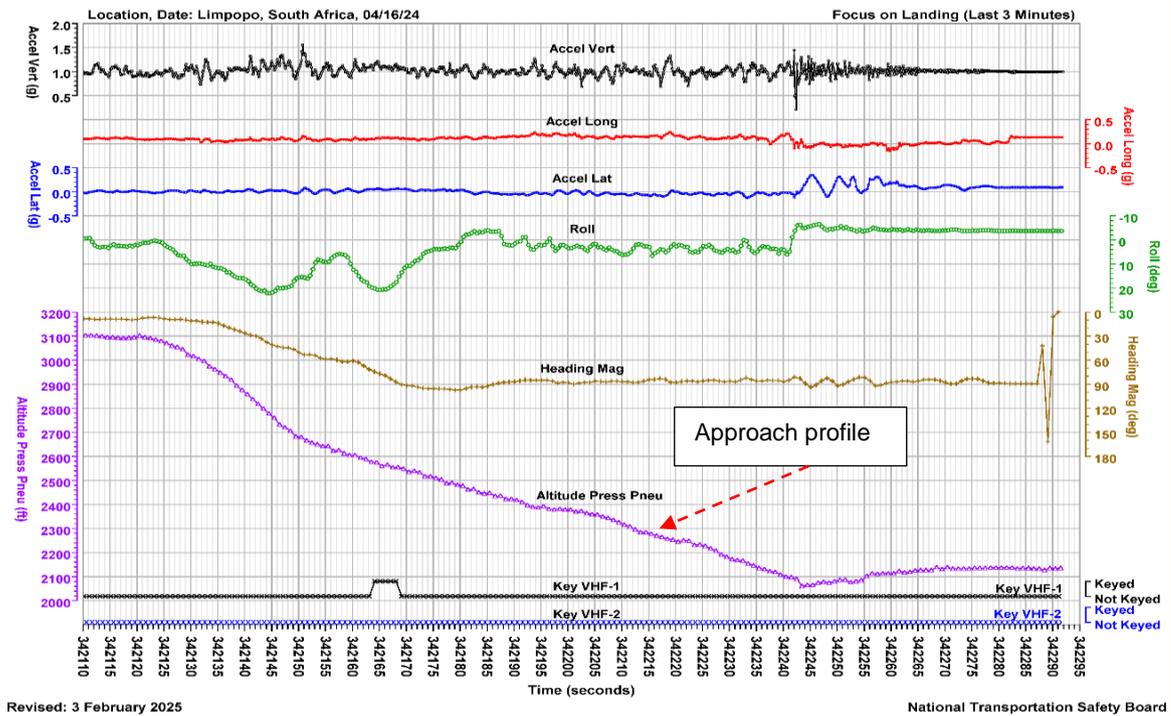
- 1.16.2 The engineers removed the flight recorders that were fitted to the aircraft. Their batteries were removed before they were sent to the National Transportation Safety Board (NTSB) engineering laboratory in the USA for read-out. The CVR was successfully downloaded and the data was reliable. However, the FDR could not download as expected; therefore, it was downloaded using the lab's surrogate method of recording. Only eight parameters were decoded and validated. The downloaded FDR data was also reliable; however, data from the pitch angle and indicated airspeed during the final approach were invalid and were not included on the graph below.

- 1.16.3 According to the downloaded FDR data, take-off, cruise and climb were uneventful. At 342.123 seconds, a descent was commenced at top of descent. The approach was recorded; however, the FDR did not record the position of the flaps. The CVR audio was made available to the investigation team during which the crew was heard performing the pre-landing checks in accordance with the POH prescriptions. The FO was heard asking the captain: *Can I give you flaps?* The captain's response was: *"Remember we don't have flaps", meaning that the flaps were INOP.*

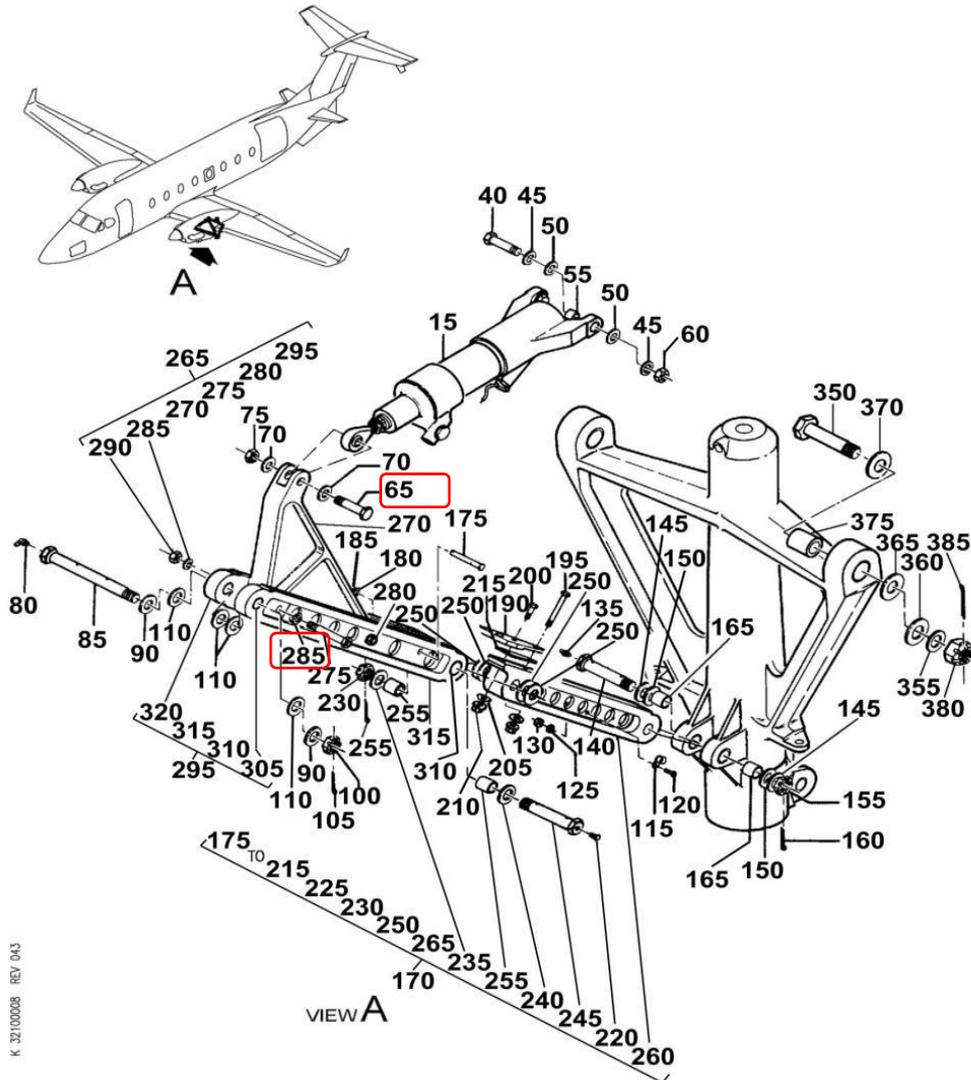
E10561

1.18.3 The Illustrated Parts Catalogue (IPC) below shows the left main gear and the explanation of some of the part numbers.
